APP or Accelerator Pedal Position sensor

This information is from Mike McGee known as OregonJag on Jaguarforums.com

I thought I would share what seems so far to be a successful repair to my '97 throttle body APP. There tends to be a lot of traffic on this forum regarding problems with the TB and my [car](#) was not immune to them. This turned into quite an epistle so I've broken it up into entries of symptoms, removal and testing, alleged repair and results.

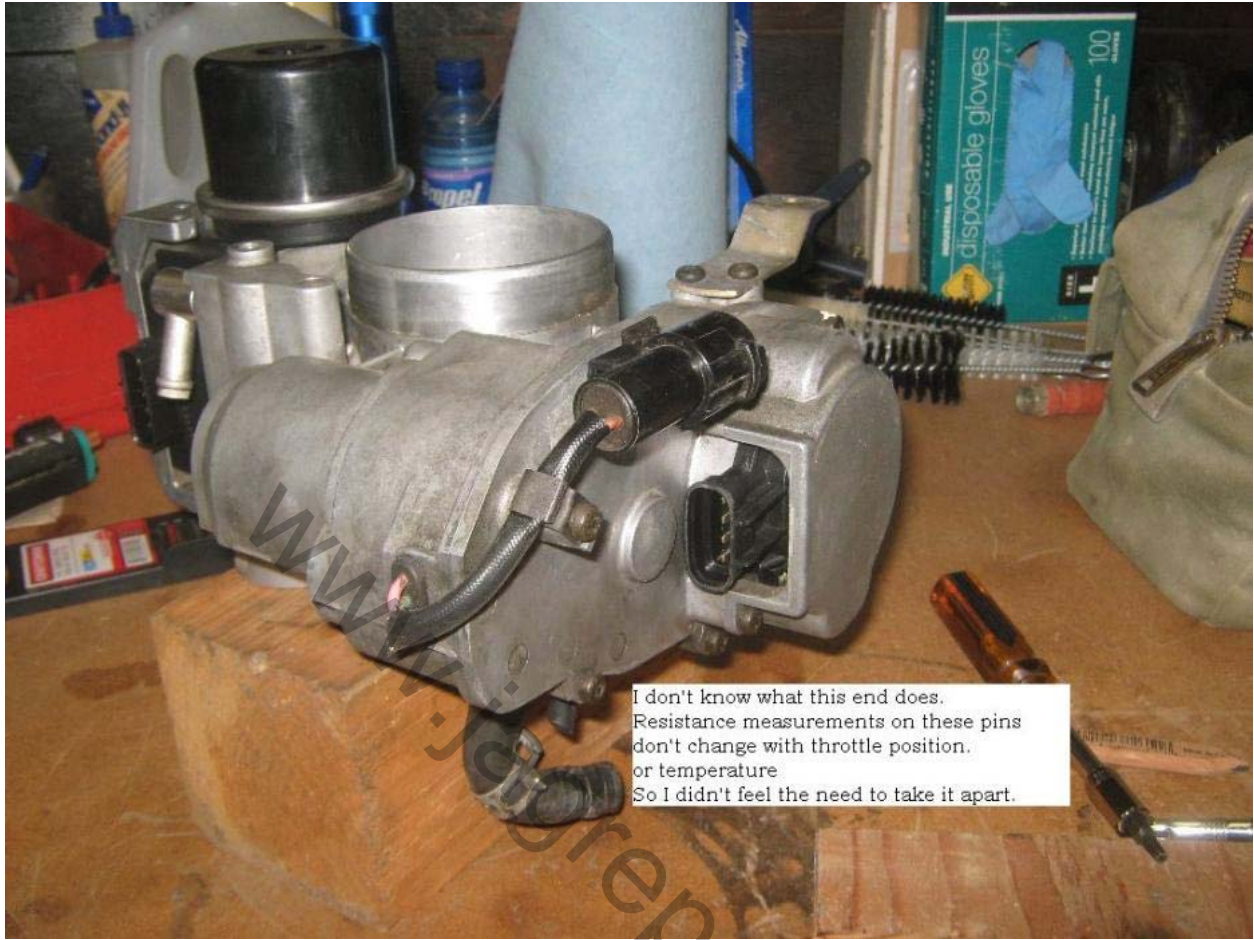
I don't know what this end does.
Resistance measurements on these pins
don't change with throttle position,
or temperature
So I didn't feel the need to take it apart.

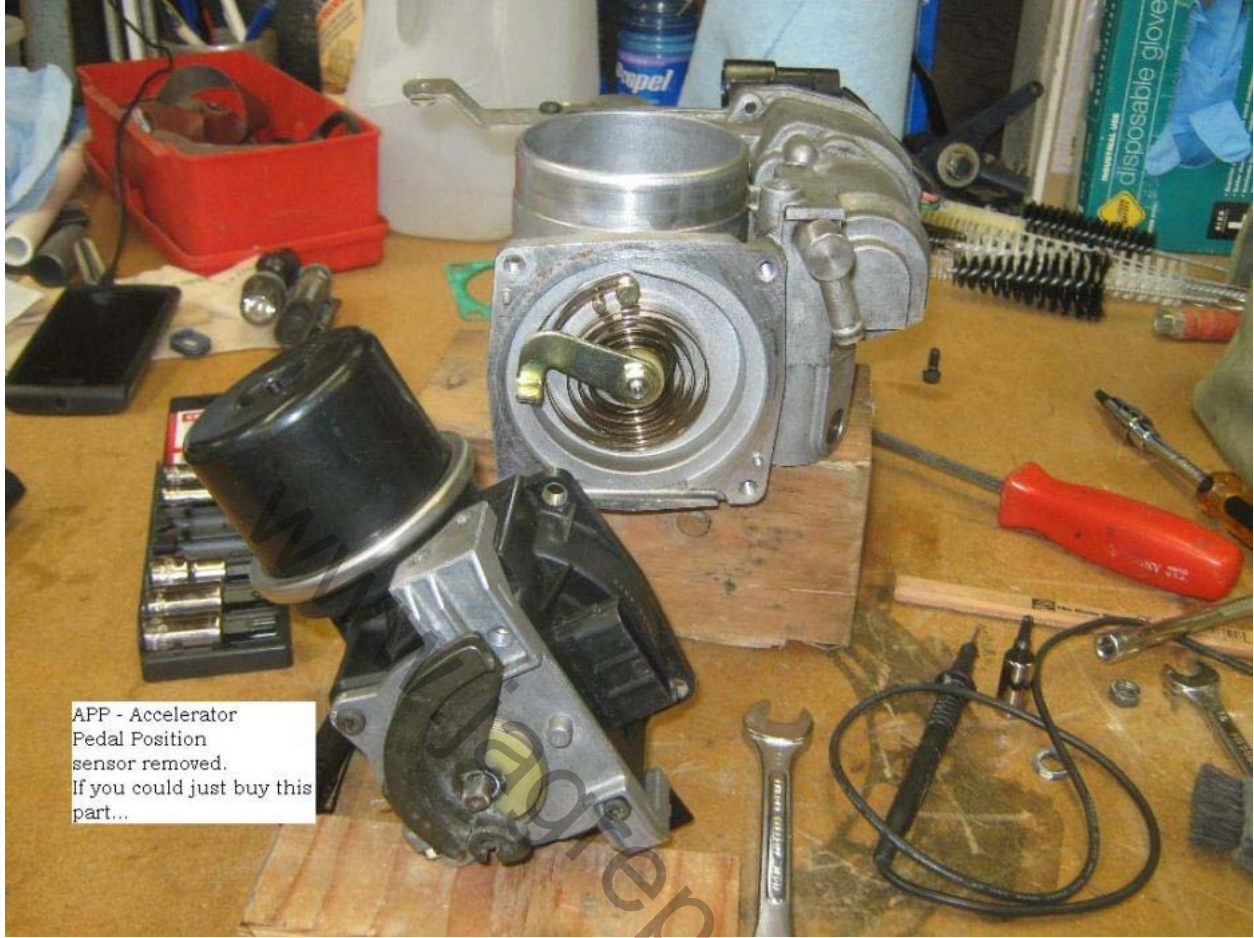
APP - Accelerator
Pedal Position
sensor removed.
If you could just buy this
part...

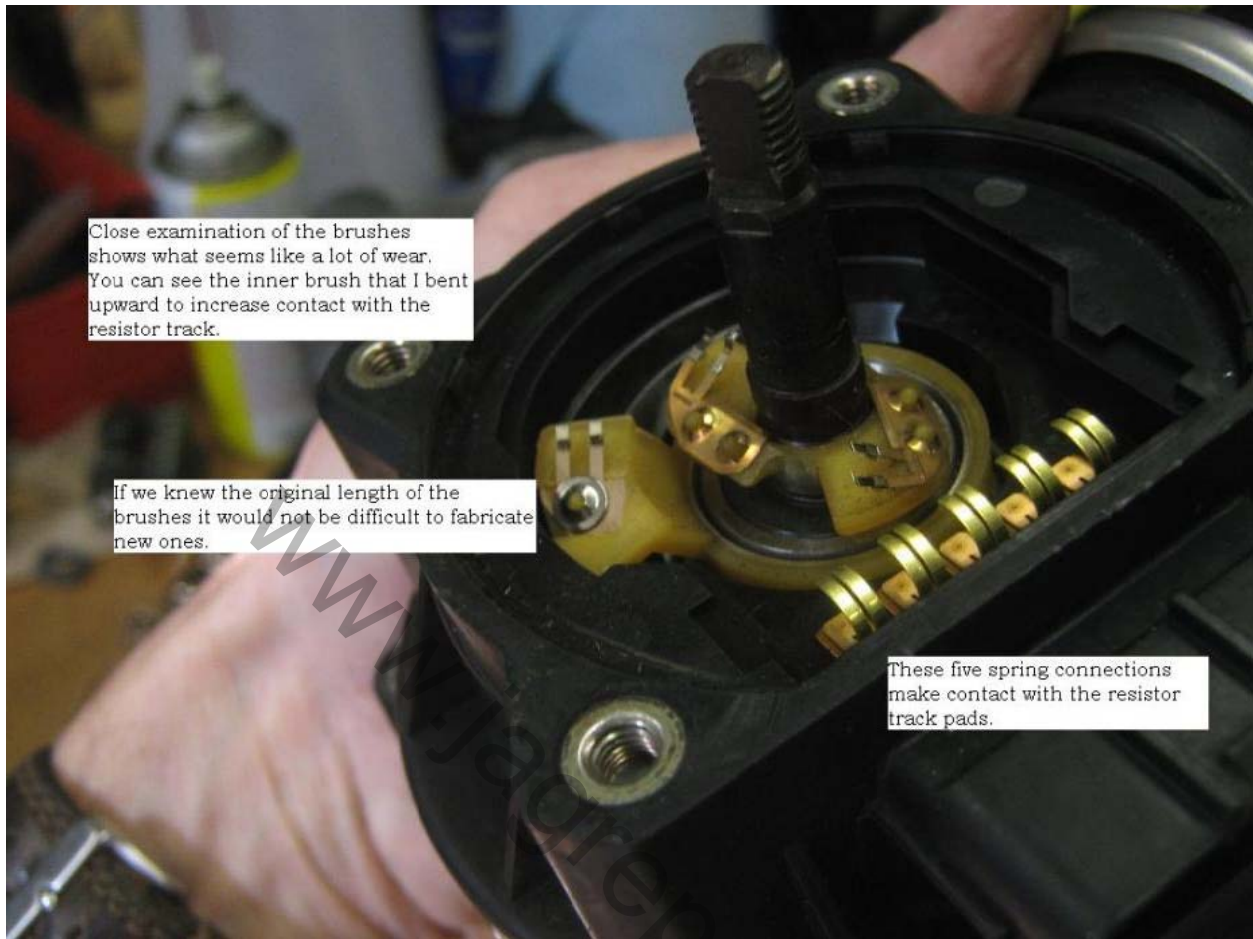
Removed the APP sensor case from the throttle body and opened it up. More complex than I expected but staring at the circuits and seeing where the top and bottom pins lead you can see where the problem would be located. Using a magnifying glass to stare at the pieces I could see that the six tiny brushes were showing their 15 years and 145k miles of wear. It was a fair guess that one of the brushes was not making contact when the TB was hot and barely making contact when cold. Using my finger and lightly touching the brushes revealed one was particularly weak.

Three pairs of brushes that act like jumpers across the three pairs of resistor tracks. All connected to the computer through the 5 pin plug.

Throttle position sensor resistor tracks
Pins 1 and 5 sense the throttle arm position
On this unit the problem connection was with the most inside brush on the right side as you look at the picture

My "fix" was simply to bend the weak brush up a bit taller so it would have more contact force on the resistor tracks that make up the position sensors. Not seeing anything else that might be a problem I cleaned the assembly with tuner cleaner and reassembled.

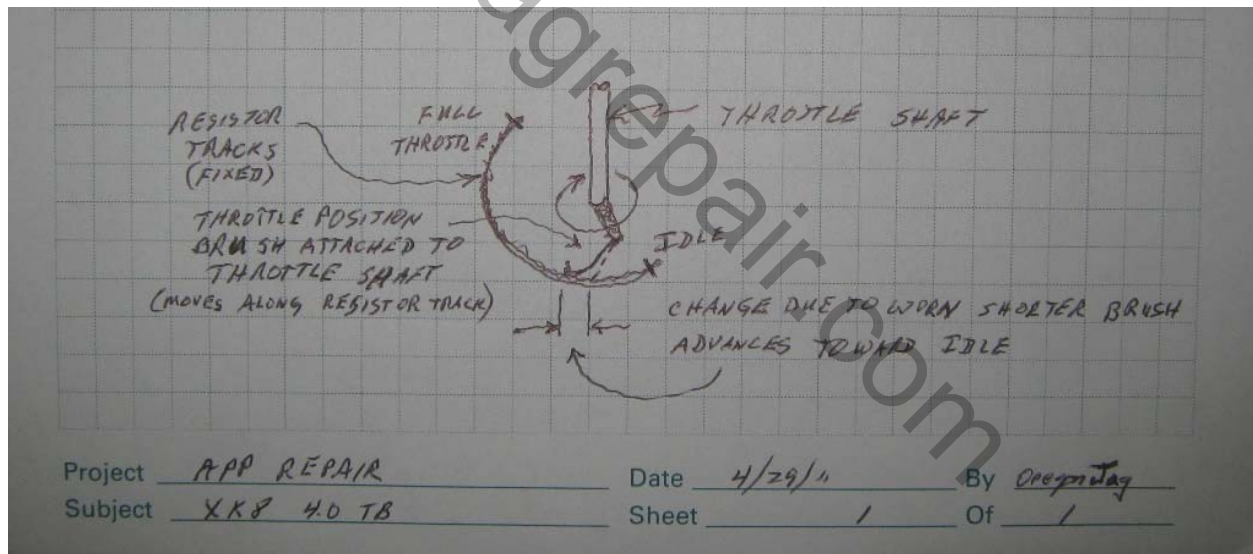
I suspect the worn brushes in the APP sensor have actually changed their "calibration". The contact point on the resistor tracks has advanced towards the idle position as the brush gets shorter due to wear. See the attached sketch. This change over time may have put the brush out of range on the resistor track. It would be nice to know what the original length of the brushes was.

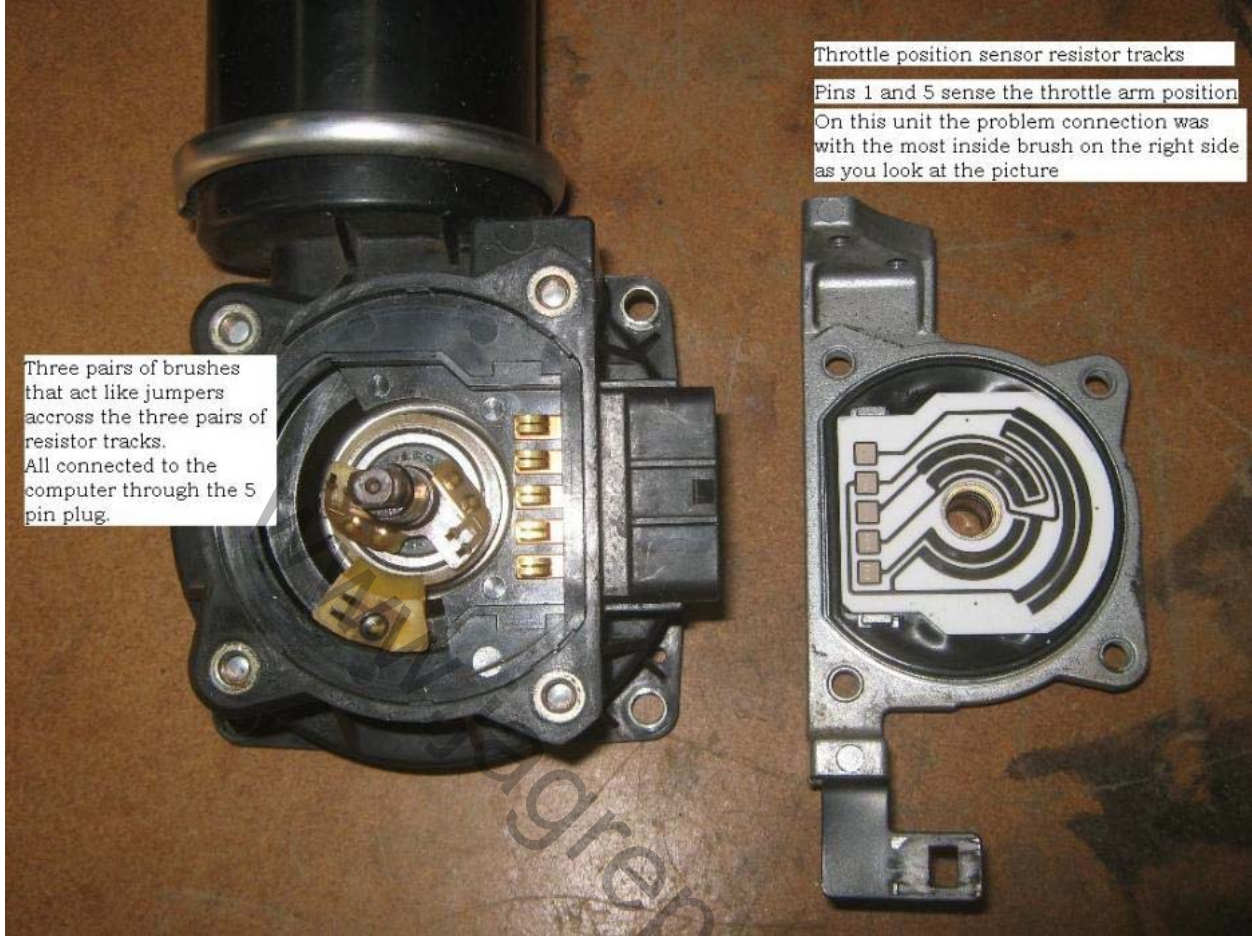
Three pairs of brushes that act like jumpers across the three pairs of resistor tracks. All connected to the computer through the 5 pin plug.

Throttle position sensor resistor tracks
Pins 1 and 5 sense the throttle arm position
On this unit the problem connection was with the most inside brush on the right side as you look at the picture

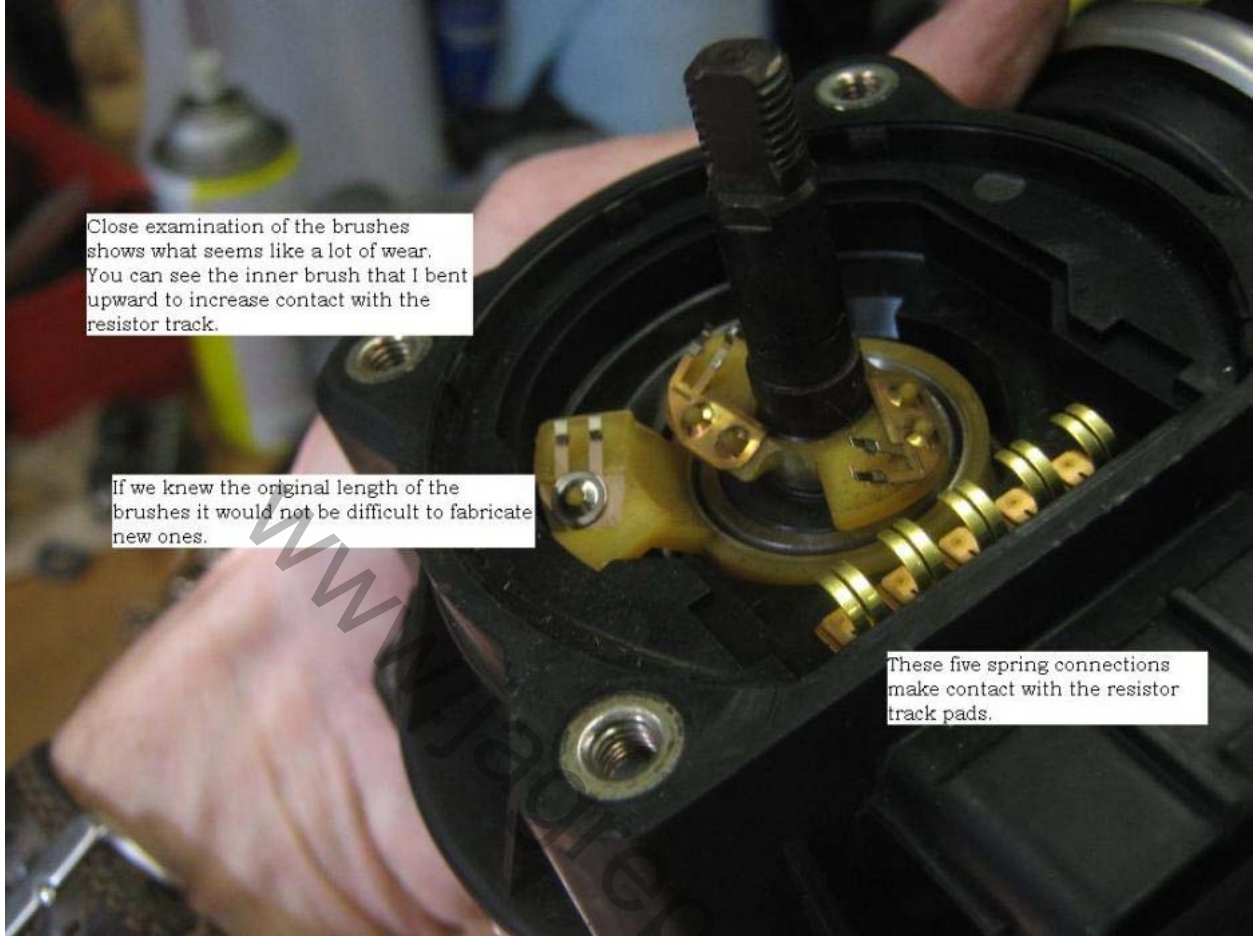
Close examination of the brushes shows what seems like a lot of wear. You can see the inner brush that I bent upward to increase contact with the resistor track.

If we knew the original length of the brushes it would not be difficult to fabricate new ones.

These five spring connections make contact with the resistor track pads.
