© D. Jensen 2006	REPLACEMENT OF V8 SECONDARY TIMING CHAIN TENSIONERS	V. 1.0 June 2006
Distribution: www.jag-lovers.com

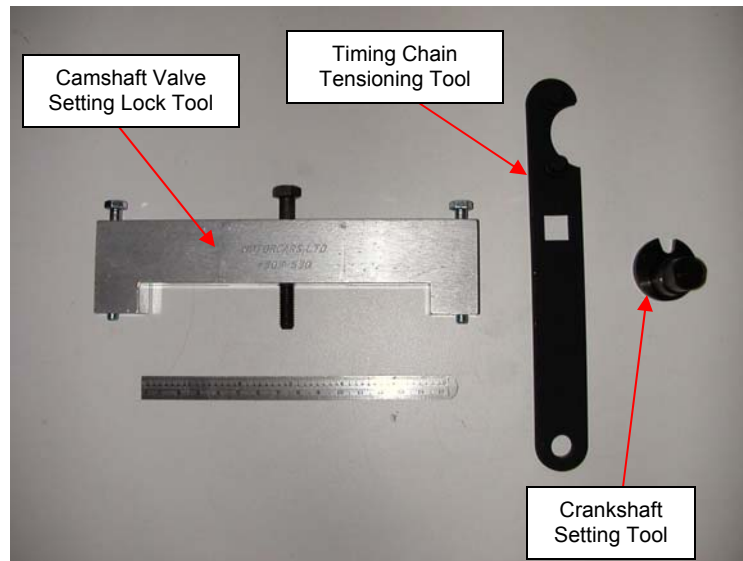
Fig. 1 Special tools

The most important tool, in my judgment, is the Camshaft Valve Setting Lock Tool (\$125; see Fig. 1) (the 6-in. ruler is there to show scale only). I was not convinced that a homemade tool that I could make would preclude the cams from rotating as the sprockets were retorqued following tensioner replacement. I believe this is important since the V8 camshafts and sprockets are not splined as they are on earlier Jag engines. The Jag tool really locks the cams in place, with no uncertainty as to their alignment. Note that I did not buy two locking tools since I was replacing the tensioners one side at a time and thus did not need to lock both sides simultaneously.

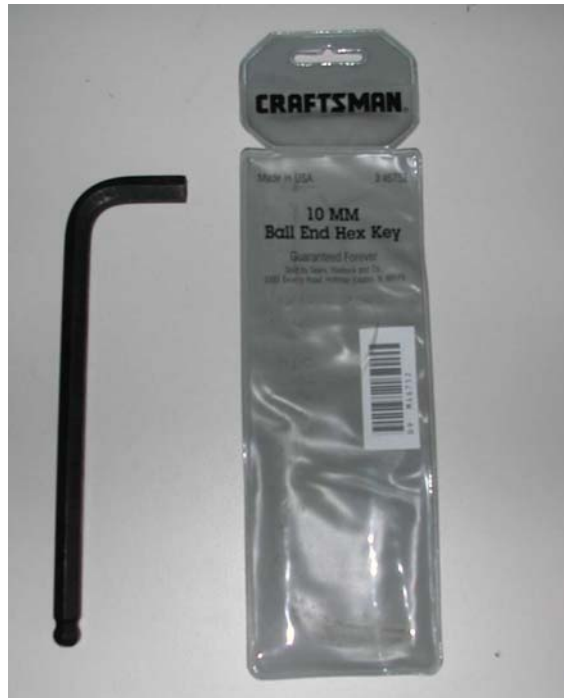
Fig. 2 Craftsman 10-mm ball-ended hex key

The other tool described in the instructions is a 10-mm, ball-ended, hexagon drive bit, available from Snap On for ~\$30. Since I happened to be near Sears before starting this work, I checked to see if they had a comparable tool. Not surprisingly, they didn't, but they did have a hex key (\$5) (see Fig. 2). I merely cut off the "L" portion of the wrench and used a 10-mm socket to drive the hex. It worked great. Note that a flat-ended hexagon drive vs. ball-ended drive will not work when changing only the secondary tensioners. It might work when replacing the chains and primary tensioners where removal of the timing ("engine front") cover allows straight-on access to the cam sprockets. However, when doing the secondary tensioners only, this is not the case. The hexagon drive enters at a slight angle due to the presence of the timing cover, enough so to require the use of the ball-ended drive.

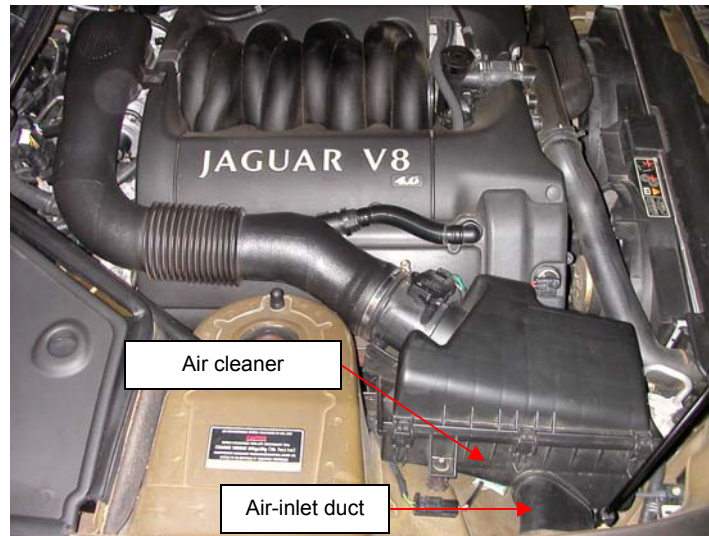
Figure 3 shows the right-hand side of the engine compartment before the start of disassembly. The arrangement of the air filter and duct seems very similar to that of the X308 XJ8 and was removed easily in accord with the instructions. I found that a long screwdriver was helpful in disconnecting the two inboard clips helping hold the air-cleaner cover in place. As may be apparent from Figs. 3 and 4, it was also necessary to remove the air-cleaner housing in its entirety to provide access when working on this side of the engine. A helpful hint is that the air-inlet duct can be loosened from and pushed into the air-cleaner housing by squeezing two tabs on the duct. This simplifies removal of the housing.

Fig. 3 Right-side view of engine bay with air filter and intake tube in place

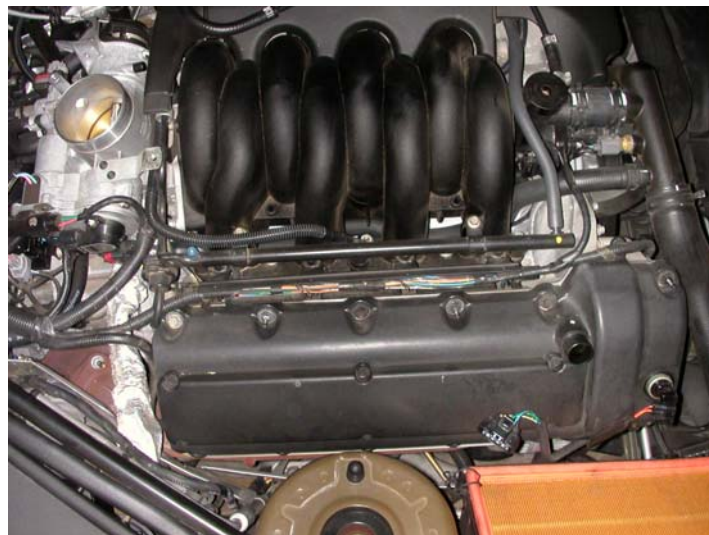
Fig. 4 Right-side view of engine bay with intake tube and right-side engine cover removed. Note the air filter and body are still in place.

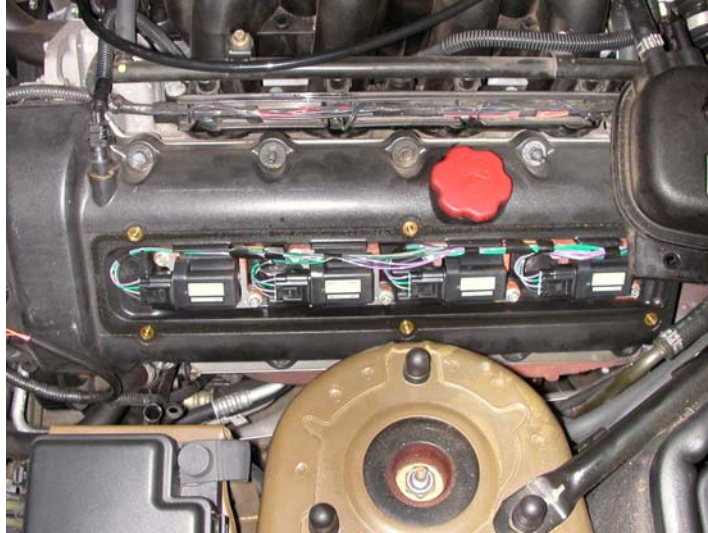
Figure 5 shows the left side of the engine bay with the engine cover, coil-on-plug cover and oil dipstick removed. I had no difficulty removing the 8-mm nut holding the oil-level indicator tube to the cam-cover stud, but I could not wiggle the tube free from the engine. I chose to let it remain loose versus work to remove it entirely.

Fig. 5 Left side view at start of disassembly
