Vertical Seam Separation –  
Center Console Side Panel Trim –  
Repair Procedure

MODEL 2004 MY  
XJ range  
VIN G00442-G09005

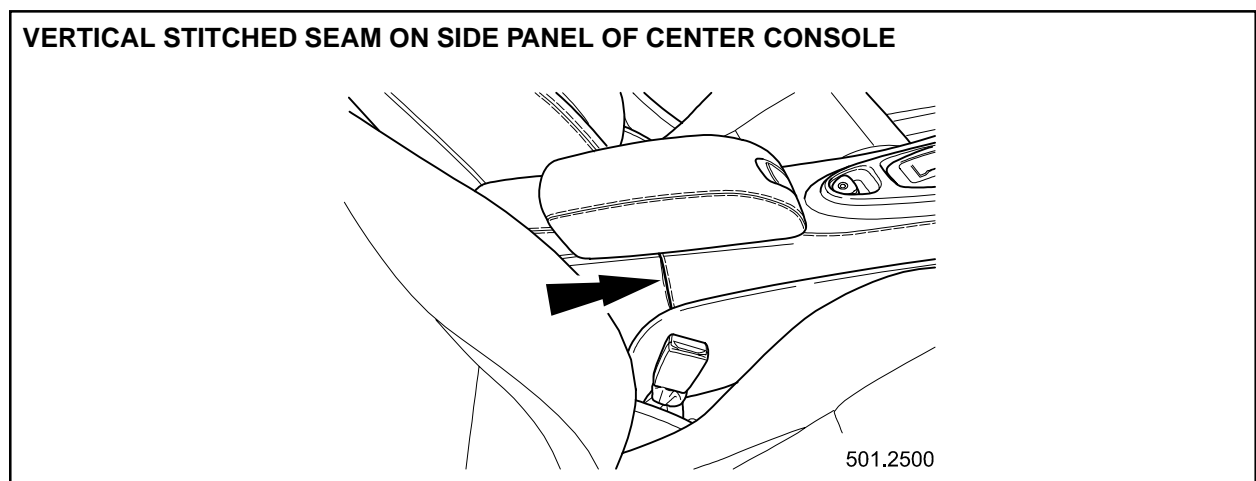
ILLUSTRATION 1

Owners of some 2004 MY XJ range vehicles within the above VIN range, may complain about the side panel trim of the center console separating next to the vertical sewn seam. This is caused by the material not being correctly adhered to the center console. It is not a split in the material.

**Note:** Center console side panel vertical stitched seam (Illustration 1).

To eliminate the issue outlined in the summary above, the center console side panel trim should be re-adhered to the center console panel.
