TECHNICAL BULLETIN

Fuel Filler Cap Seal Durability – Revised Seal Ring – Service Action S515 2005 MY S-TYPE

Service Action S515

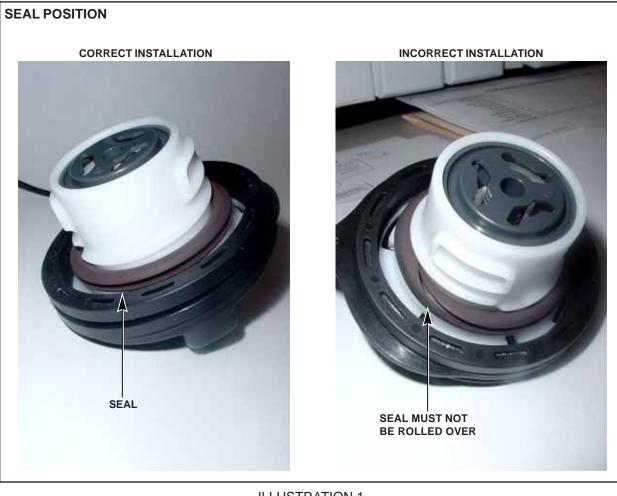
ILLUSTRATION 1

A concern has been identified on a small number of 2005 MY S-TYPE vehicles. The fuel tank filler cap seal is soft and does not provide an adequate or durable seal, resulting in fuel vapor escaping and illumination of the Malfunction Indicator Lamp (MIL) on the instrument panel.

- 1. Open fuel filler flap.
- 2. Unscrew fuel filler cap.
- 3. Remove seal using a suitable pick.
- 4. Install fuel filler cap seal. Make sure that the seal is fully seated and that the seal is not twisted.
