Sedan Range

05.1-31

TECHNICAL BULLETIN

DTCs P1176, P1177, P1178, P1179 –
Adaptive Fuelling System –
Diagnostic Procedure

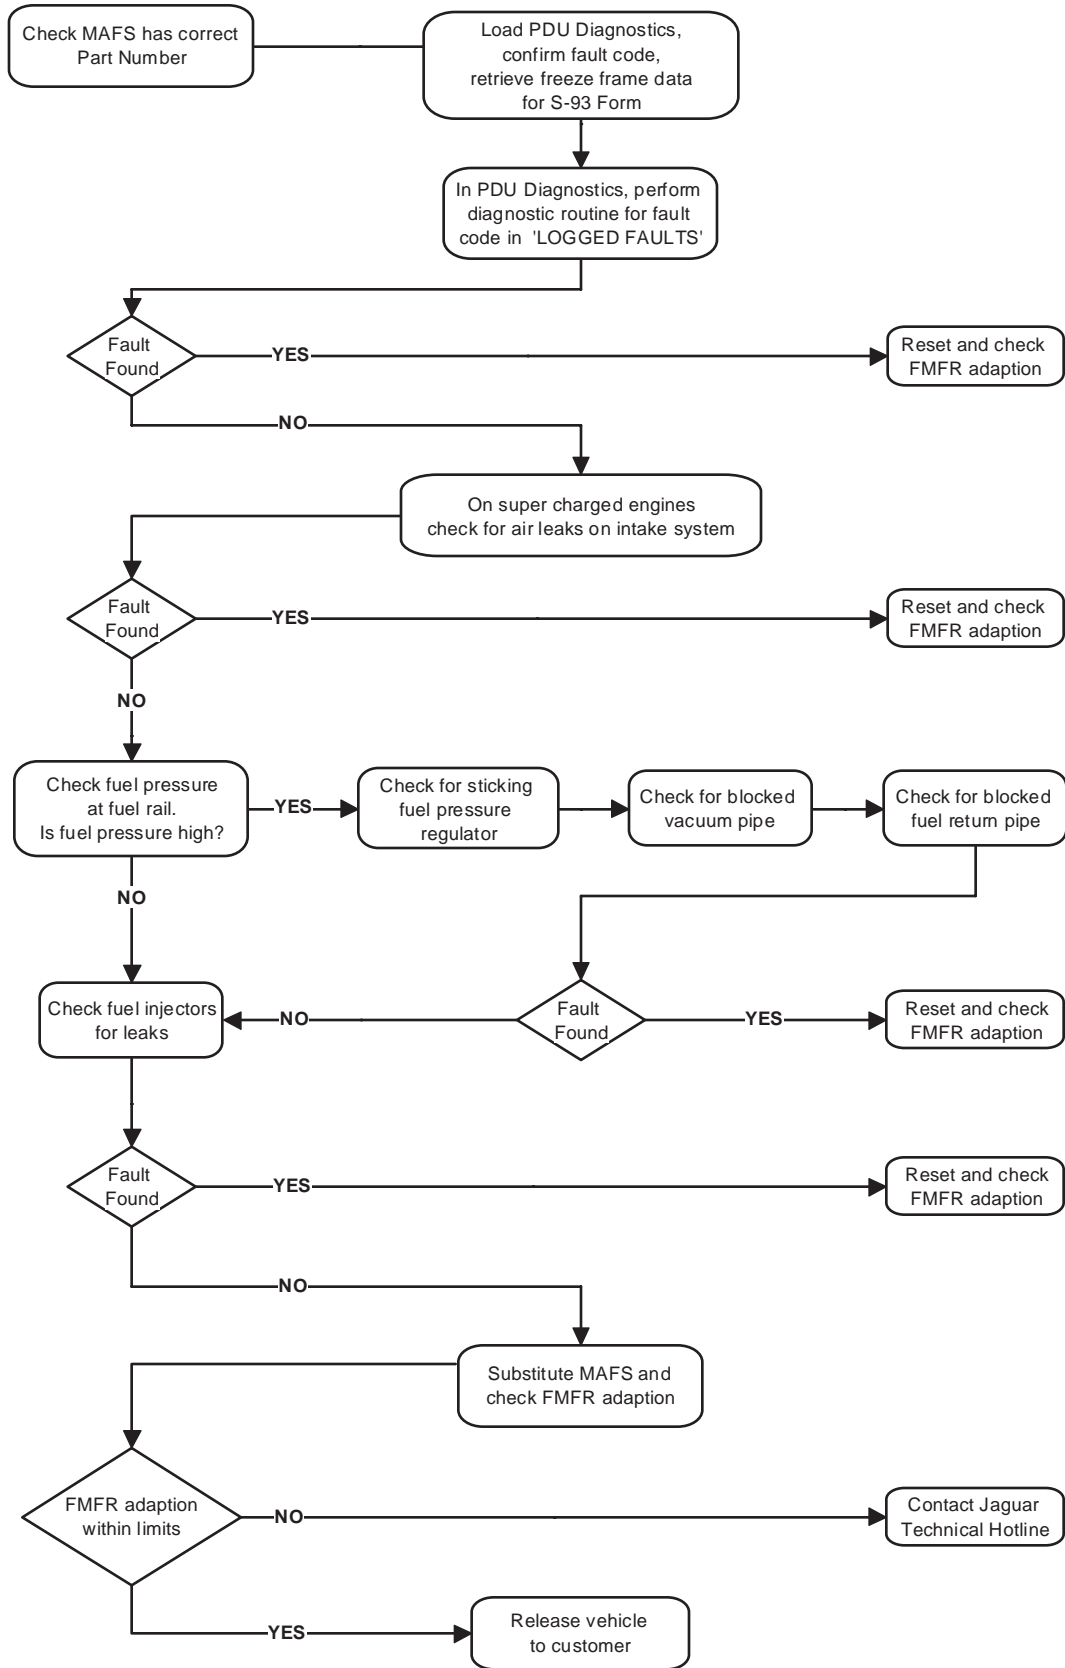
OBD II - DTC P1177 - rich fuelling trim - long term (FMFR)

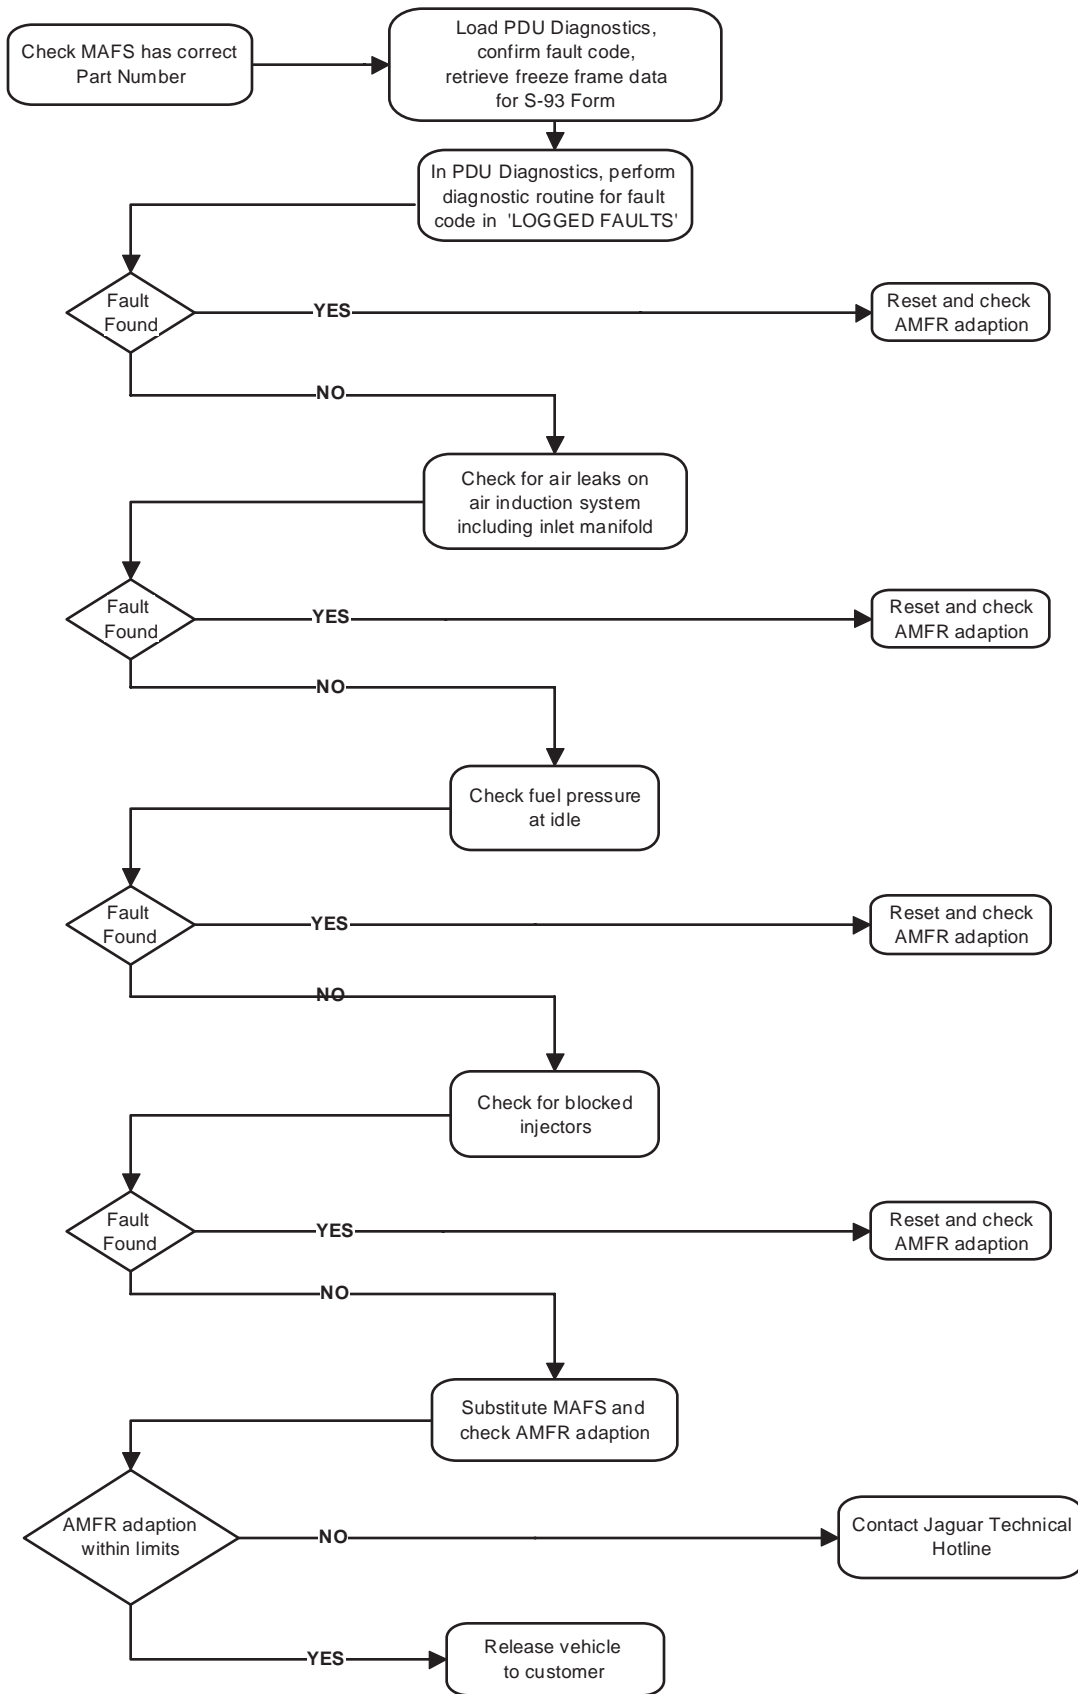
OBD II - DTC P1178 - lean fuelling trim - long term (AMFR)

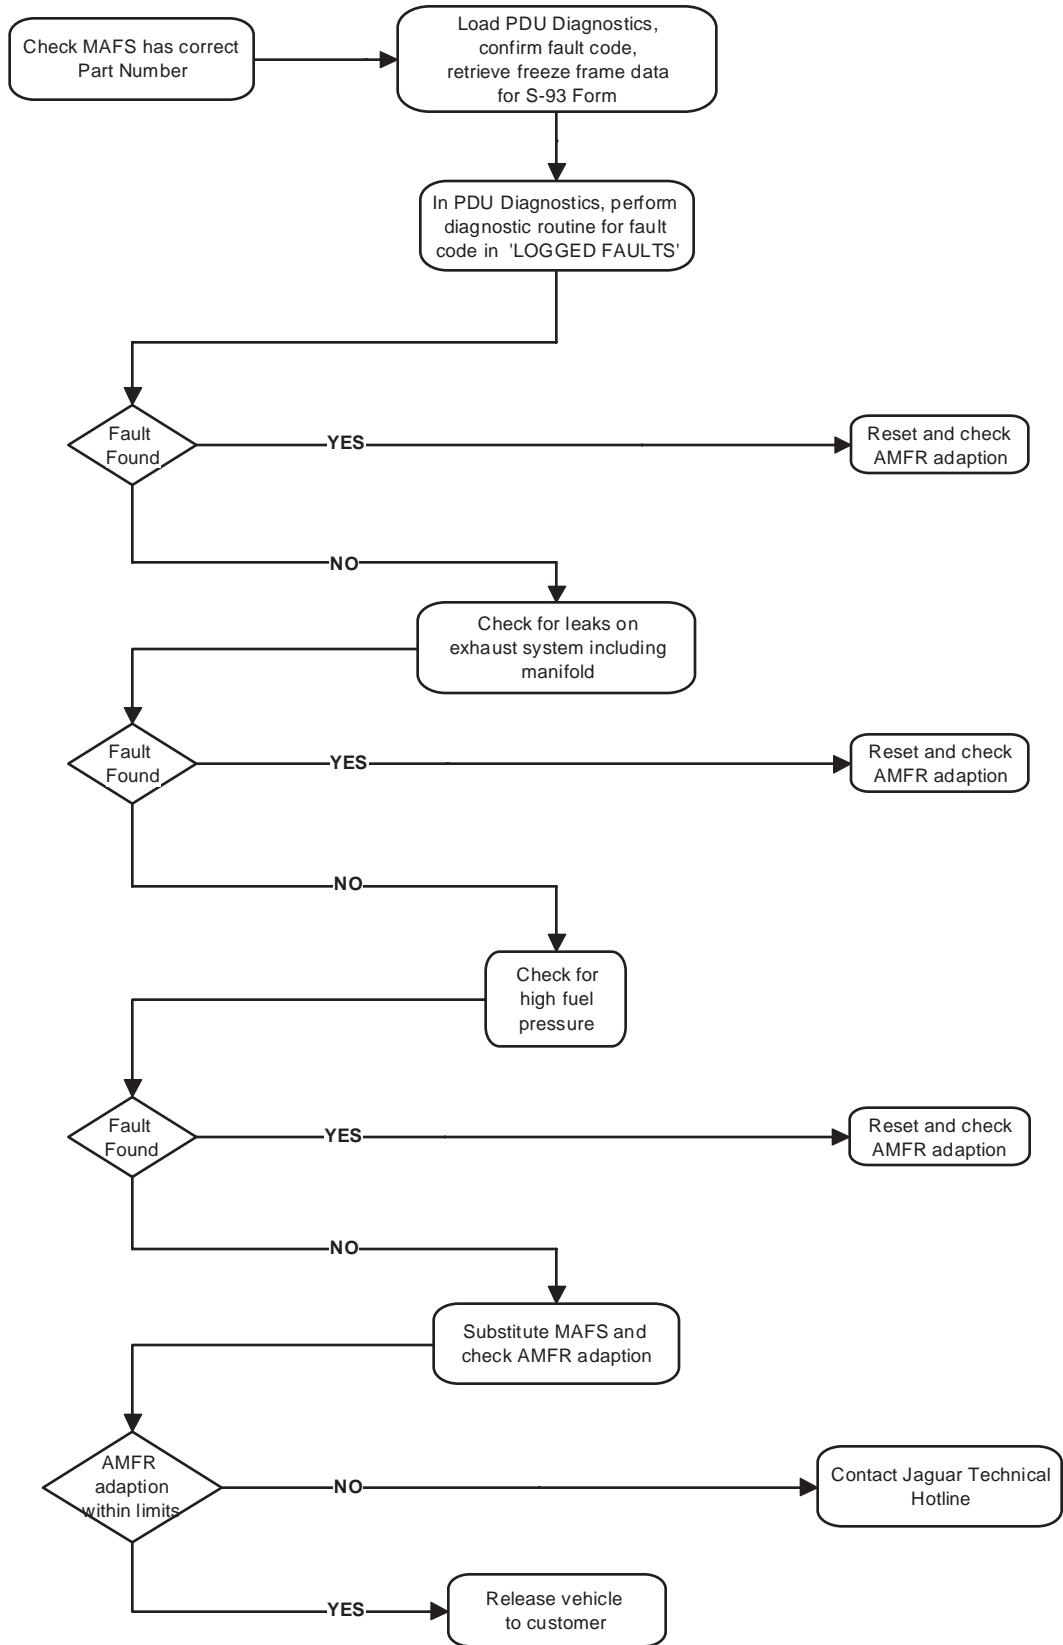
OBD II - DTC P1179 - rich fuelling trim - long term (AMFR)
