05.2-09

**TECHNICAL BULLETIN**

Plenum Chamber Drain Valve –  
Distorted – Water Entering ECM –  
Service Action S619

MODEL 1995 MY  
XJ12 Sedan  
VIN 720001-725767

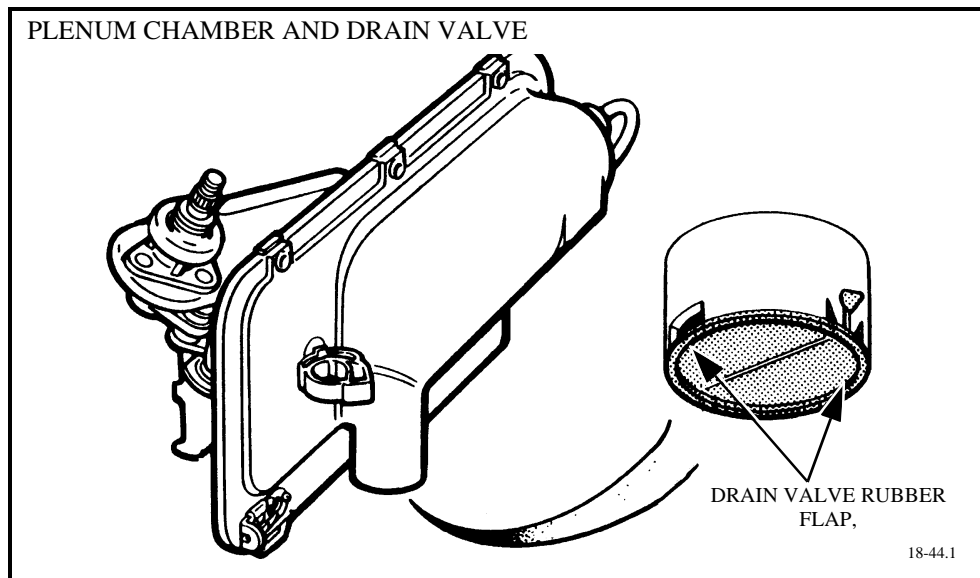
ILLUSTRATION 1

At the next service opportunity, or during PDI, check the plenum chamber drain valve rubber flap (Illustration 1) of all 1995 MY Sedan Range vehicles within the VIN range. Follow the procedure described below.

1. Visually inspect the drain valve rubber flap using a light and mirror.
  - If the drain valve rubber flap is in the correct position, as shown in Illustration 1 above, no further action is required.
