XJ501-22

**TECHNICAL BULLETIN**

**Broken Center Console Lid Handle –  
XJ With 4-Zone Climate Control Only –  
Replace Latch**

MODEL 2004 MY-ON  
XJ range  
VIN G00001-ON

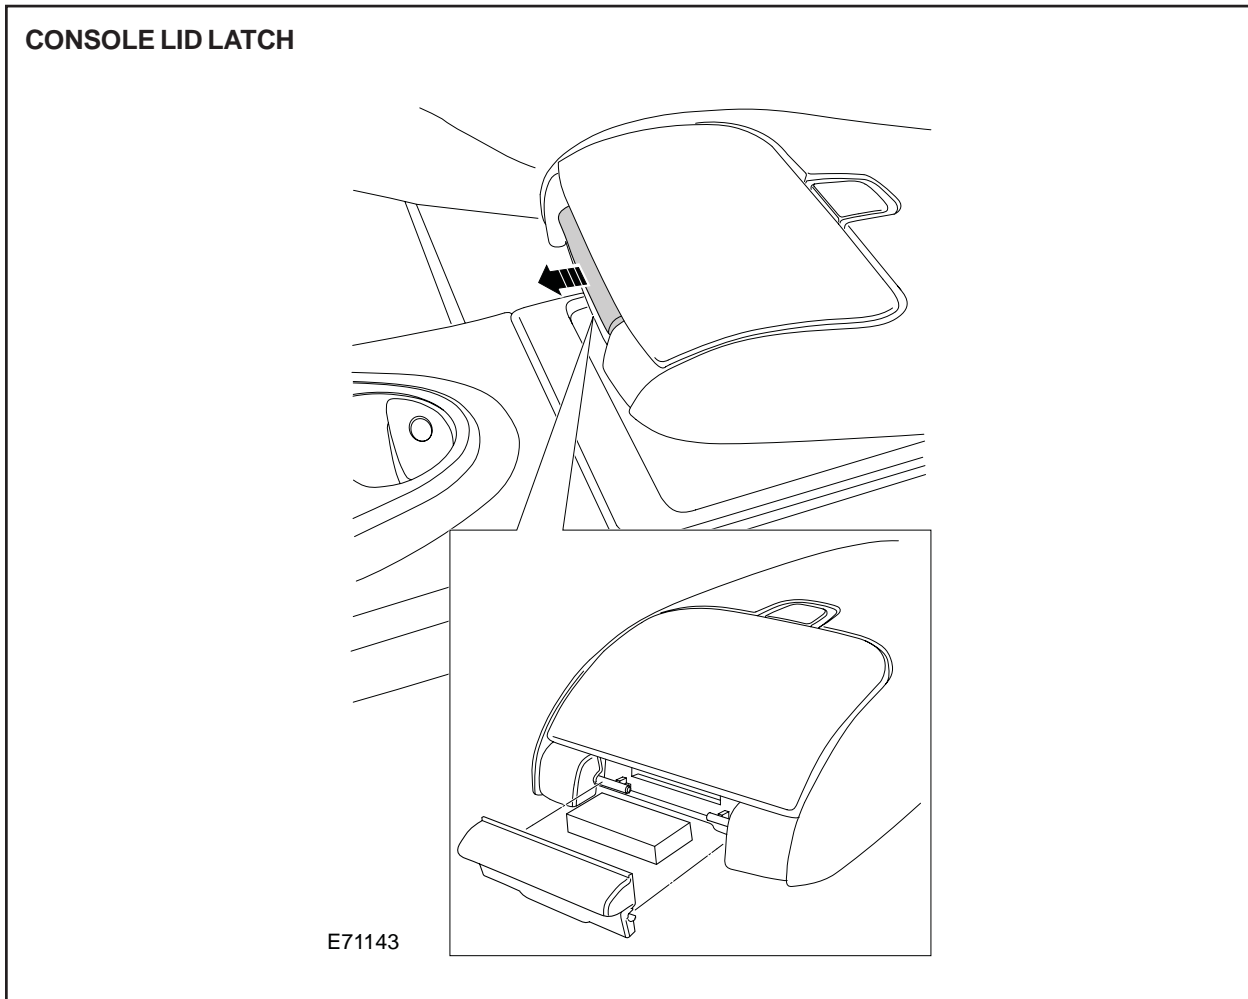
ILLUSTRATION 1

Some 2004 MY-ON XJ range vehicles may exhibit a broken center console lid handle. This condition is caused by deformation of the clipping points on the latch of the centre console lid used with the 4-Zone climate control system.

- Carefully release the two retaining clips and remove the console lid latch (Illustration 1).
