**Spark Plug “Blow-by Stain”/Corona Stain –  
Spark Plug Function Not Affected –  
Replacement Unnecessary**

**MODEL**  
1997 MY-ON XK Range  
1998 MY-ON V8 XJ Series  
**VIN**  
001001-ON  
812256-ON

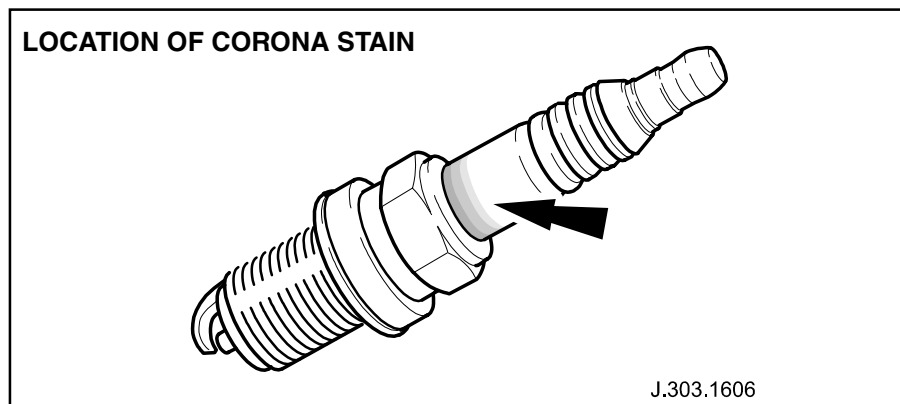
ILLUSTRATION 1

Corona discharge occurs on rainy days or when the insulator surface is dirty. Due to ribbed corrugations at the top portion of the spark plug, corona is prevented from reaching the top of the spark plug which could cause the engine to misfire.

When Corona discharge has taken place, there can be a discoloration of the lower portion of the insulator surface (Illustration 1). This is what is known as ‘Corona stain’ and is orange/gray in color. Corona stain is caused by oil particles in the air that are attracted to the Corona discharge, charged and then adhere to the insulator surface.

The Corona stain has no effect on the function of the spark plug. The spark plug **should not** be changed for this reason.
