BMW/JAGUAR ZF5HP24 "A" CLUTCH DRUM FAILURE

COMPLAINT: A vehicle with a ZF5HP24 comes in with a complaint of little or no movement forward, reverse is good.

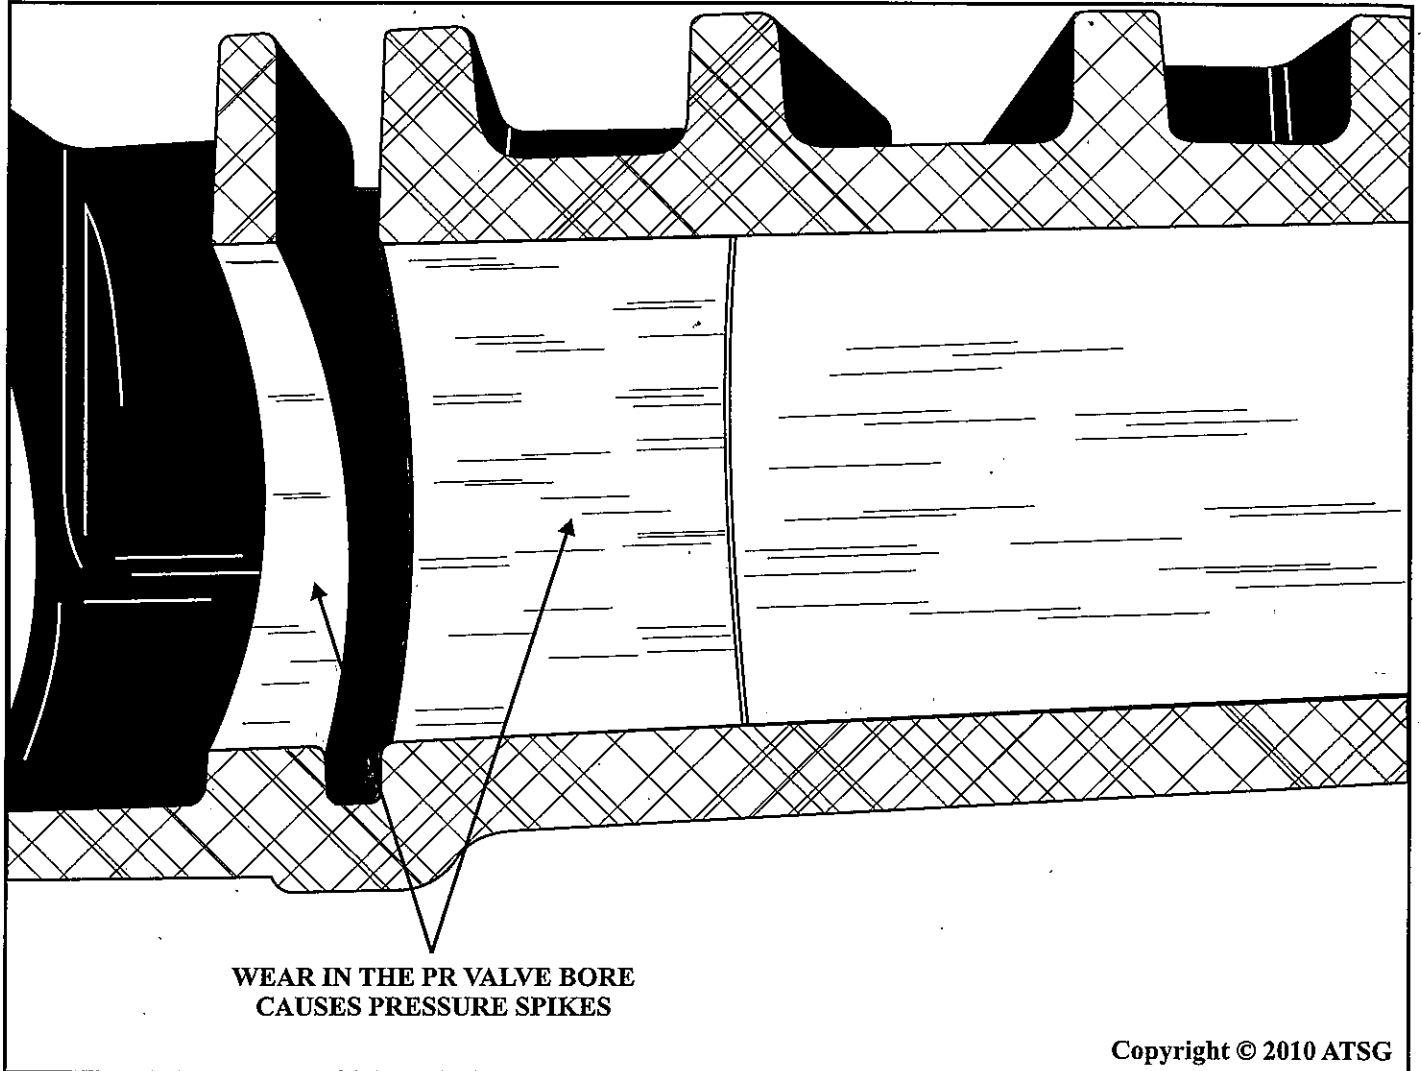
Figure 3

The drum is breaking in the snap ring area due to *un-commanded* pressure spikes. There is an updated pressure regulator valve (See Figure 2) which could help the situation as long as the valve bore is not worn. The pressure spikes can still occur and are caused by wear in the pressure regulator valve bore in the lower front valve body, Refer to Figure 3.

ZF-5HP-24 LOWER FRONT VALVE BODY

Using the part numbers found under Service Information, replace the pressure regulator valve and the lower front valve body.
