© D. Jensen 2005	<b>REPAIR OF RADIO ANTENNA ON '01 XK8 AND XJ6/XJ8s USING SIMILAR HARADA ANTENNAS*</b>	V. 1.0 Dec. 5, 2005
Distribution: www.jag-lovers.com CC: X300/XK8 List Administrators

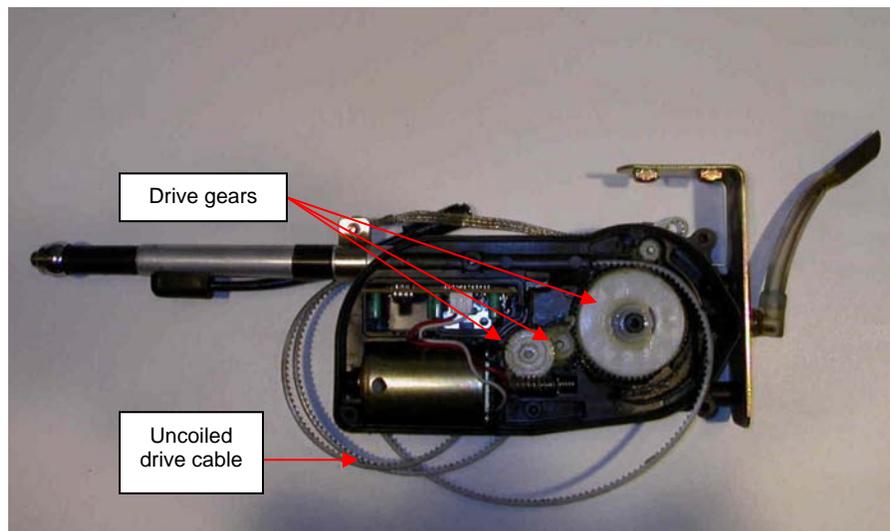
Fig. 7

7. Remove the drive-cable spool and plastic cover, revealing the toothed cable and drive gears (Fig. 7). There are no electrical connections in this area. In my case, the problem turned out to be electrical vs. mechanical, so I merely re-coiled the drive cable in the spool and slipped the pieces back into place.

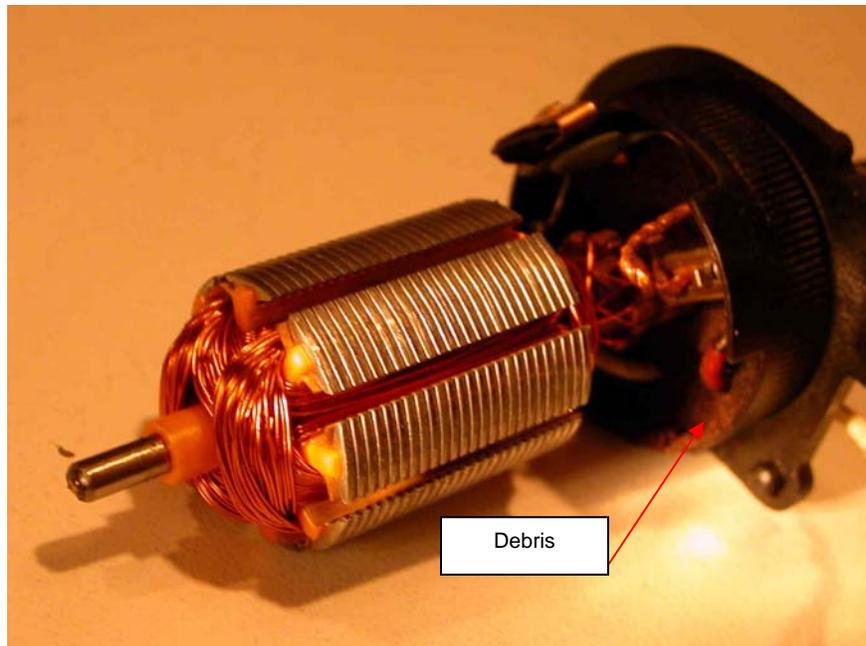
Fig. 10

10. Look closely at the motor windings, brushes, etc. Mine had copper and carbon debris near the brushes and on the black-plastic end piece. I suspected these might be the source of the intermittent operation (Fig. 10). Everything else looked pristine. There were no adjustable components on the circuit board.

11. Clean the commutator, gaps in the commutator, brushes and surrounding area with Q-tips and electrical spray cleaner. I gently pulled an X-Acto blade through the gaps in the commutator to remove residual debris there as well. Figure 11 shows these items during cleaning.
