**Damaged Cupholder –
Replace Mechanism Only –
Repair Procedure**

MODEL 1995-97 MY
Sedan Range
VIN 720001-812255

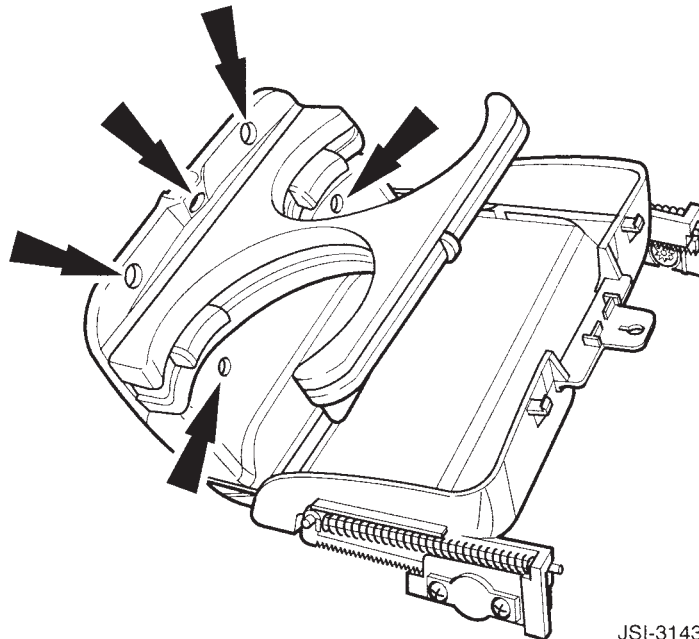
ILLUSTRATION 1

In case of a customer complaint of a broken cup-holder assembly, (shown in Illustration 1), remove the holder and install a new assembly in the cubby box lid as described on the next page.

4. Remove the cup holder latch retaining screw, (Illustration 3).
5. Remove the latch and the cup-holder mechanism with its trim panel from the lid.
6. Remove the five No.T8 Torx head screws, (arrowed in Illustration 1), that retain the trim panel. Remove the panel from the mechanism.
