MODEL
S-TYPE

NUMBER
JTB00103
(Issue 1)

TECHNICAL BULLETIN

Unable to Reduce Climate Control Outlet Temperature - Diagnostic Procedure

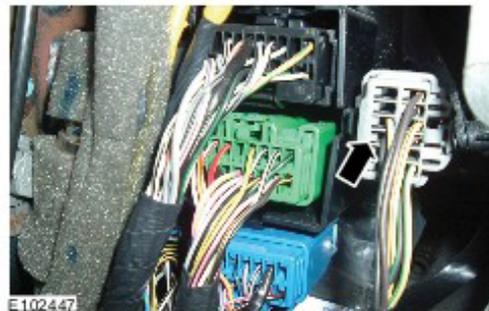
Figure 1

12. Place the IDS current clamp around the brown/green (NG; FC5-11) wire at connector FC5. (Figure 1)

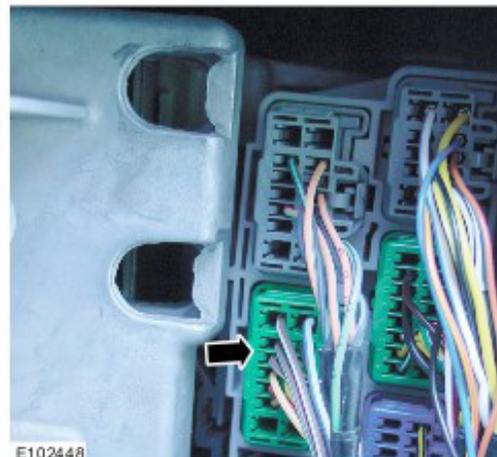
Figure 2

13. Place the IDS current clamp around the brown/green (NG; FC4-9) wire at connector FC4. (Figure 2)
14. Start the engine.
15. Using the Dual Automatic Temperature Control (DATC), select:
 - 'HIGH' temperature
 - 'HIGH' fan speed
 - 'RECIRC' and 'PANEL' modes
16. Move the temperature from 'HIGH' to 'LOW'.
17. Record the current reading.
18. Move the temperature from 'LOW' to 'HIGH'.
19. Record the current reading.
