**Spark Plug "Blow-by Stain"/Corona Stain –
Spark Plug Function Not Affected –
Replacement Unnecessary**MODEL 1995-97 MY
Sedan (4.0L) Range
VIN
720001-812255**ISSUE:**

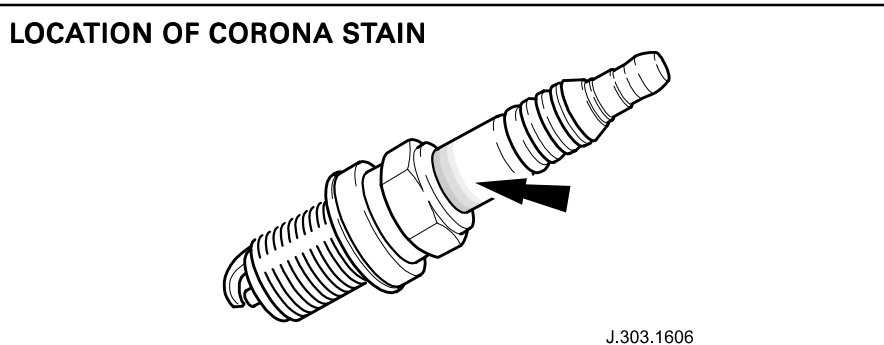
ILLUSTRATION 1

When Corona discharge has taken place, there can be a discoloration of the lower portion of the insulator surface (Illustration 1). This is what is known as 'Corona stain' and is orange/gray in color. Corona stain is caused by oil particles in the air that are attracted to the Corona discharge, charged and then adhere to the insulator surface.

The Corona stain has no effect on the function of the spark plug. The spark plug **should not** be changed for this reason.
