TECHNICAL BULLETIN

No: JTB00066
Issue: 3
Date: 14 MAY 2010

Ticking / Bubbling Noise From Behind Fascia / Instrument Panel

S-TYPE (X200)

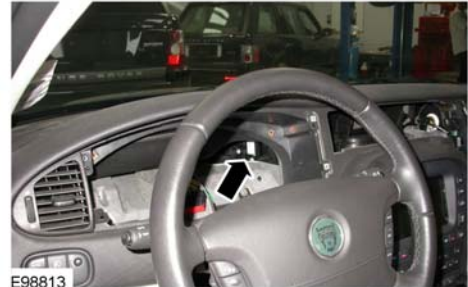
Figure 1

Situation: A ticking or bubbling noise may be heard coming from behind the fascia / instrument panel when using the climate control system. The noise may be the result of one or more of the climate control blend door actuators giving incorrect position feedback to the climate control module, causing the blend doors to continually search for their correct position and causing the noise.

3. Refer to Workshop Manual (GTR) section 413-01, *Instrument Cluster* (88.20.01), and remove the instrument cluster.
4. Remove the defrost vent / register blend door actuator (Figure 1):
 - Disconnect the electrical connector.
 - Remove the three retaining bolts.
 - Remove the actuator.
5. Disconnect the instrument panel blend door actuator remote linkage (Figure 2):
 - Disconnect the electrical connector.
 - Disconnect the instrument panel door actuator remote linkage.
6. Remove the instrument panel blend door actuator (Figure 3)
 - Remove the retaining bolts.
 - Remove the actuator.
7. To install new actuators, reverse steps 1 - 6.
