XJ413-02

TECHNICAL BULLETIN

Multiple Warnings On Instrument Cluster – Poor Pin Connections – Check & Repair Pins

MODEL 2004 MY
XJ range

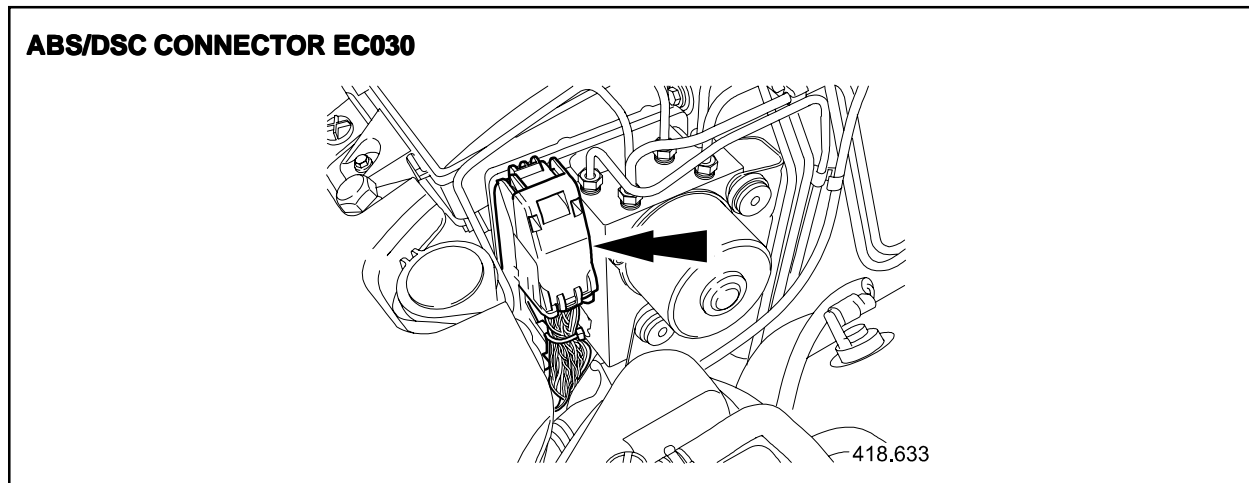
ILLUSTRATION 1

5. Disconnect the Anti-lock Braking System (ABS)/Dynamic Stability Control (DSC) module electrical connector EC030 (black 47 way) (Illustration 1).

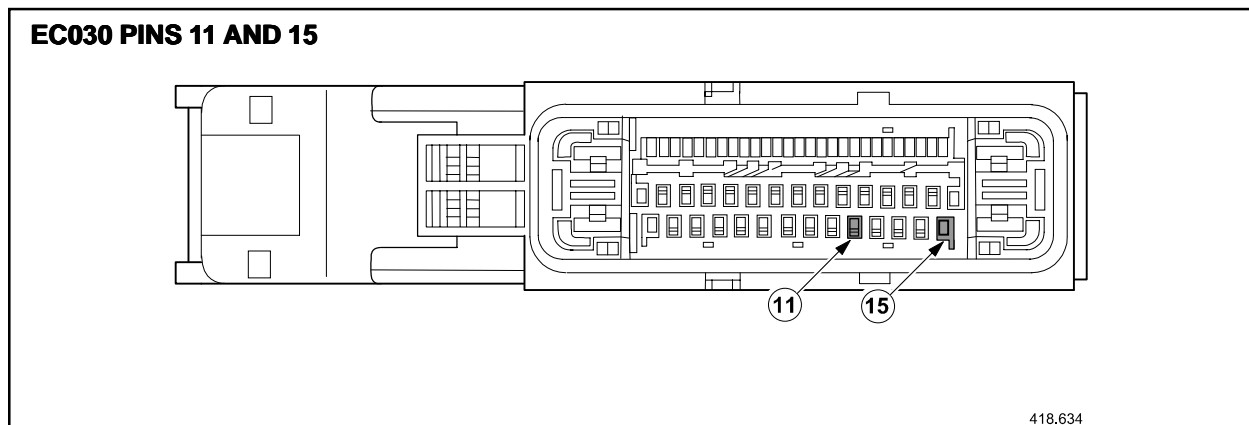
ILLUSTRATION 2

6. Use a male pin 418-411-47 from the harness repair kit, to check the integrity of pins 11 and 15 (Illustration 2).

Note: The male to female electrical connection must be very firm, and be felt for the full length of the electrical connector. If there is initial resistance then the pin slips freely into the female pin, replace the female pin. If there is any doubt replace the female pin. Repeat this check with the new pin to verify a proper fit.

If pins are OK, continue with inspection of electrical connector IP055, if not, replace any faulty pin(s) using preterminated end **418-411-74** as follows:

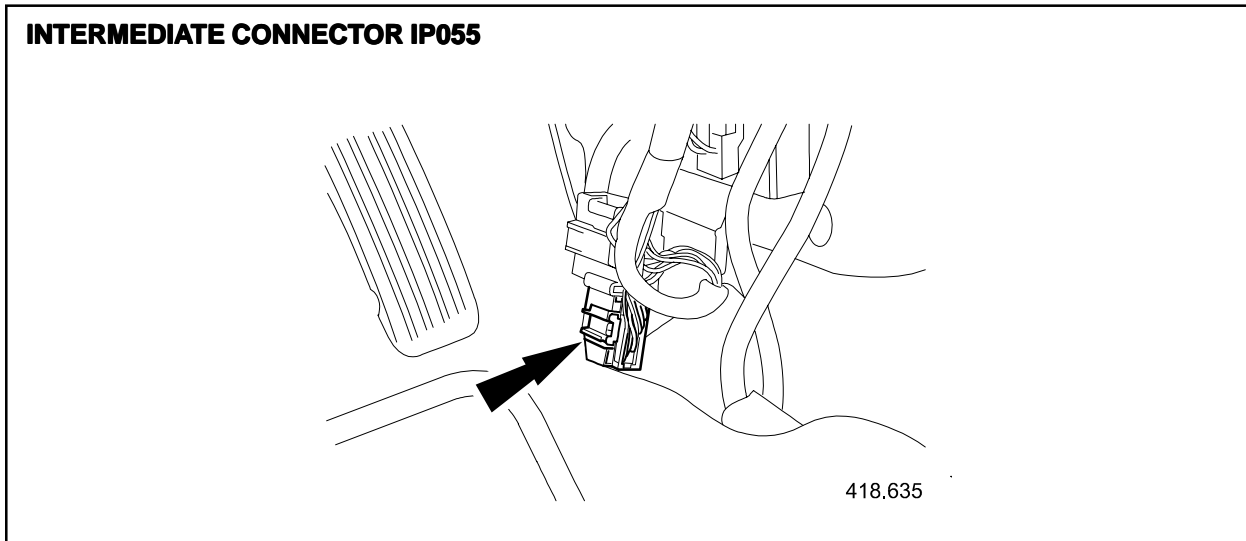
ILLUSTRATION 3

3. Displace the intermediate connector IP055 (black 22 way) from the mounting tang (Illustration 3).

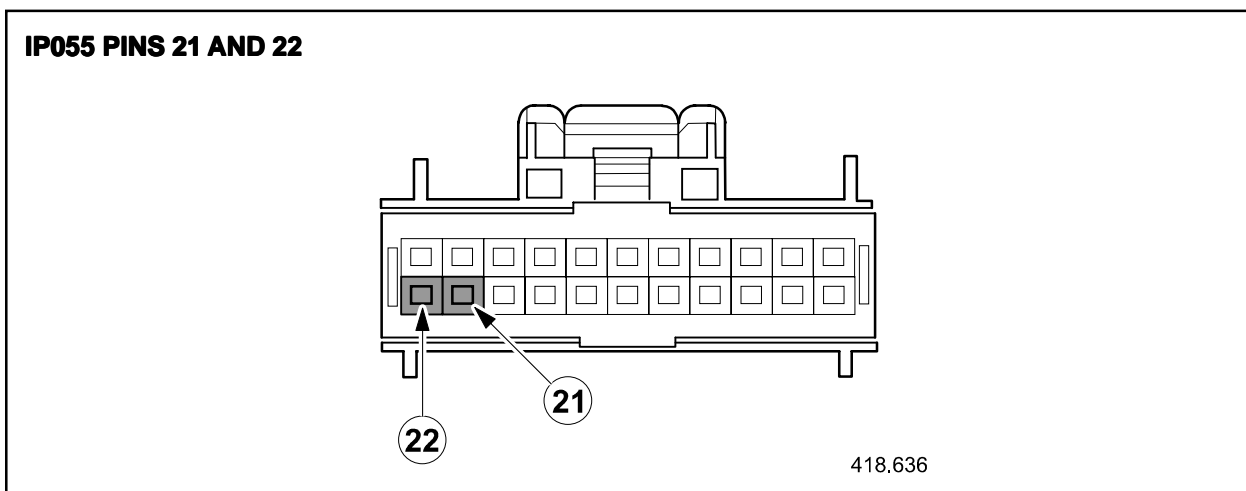
ILLUSTRATION 4

4. Disconnect the intermediate connector IP055.
5. Position harness for access.
6. Use a male pin 418-411-47 from the harness repair kit, check the integrity of pin 21 and 22 (Illustration 4).

Note: The male to female electrical connection must be firm, and be felt for the full length of the electrical connector. If there is initial resistance, then the pin slips freely into the female pin, replace the female pin. If there is any doubt replace the female pin. Repeat this check with the new pin to verify a proper fit.

7. If pins require replacing, strip back the harness tape to adequate length to facilitate repair. If not, continue with step 20 of this procedure
8. Remove the anti-back-out device from the electrical connector.

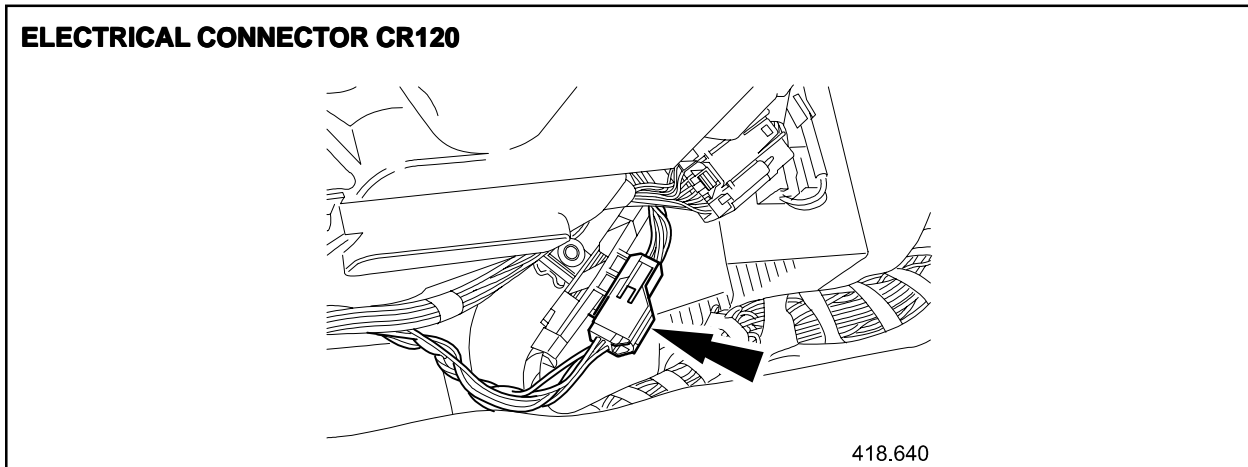
ILLUSTRATION 5

2. Disconnect electrical connector CR120 (black 8 way) (Illustration 5).

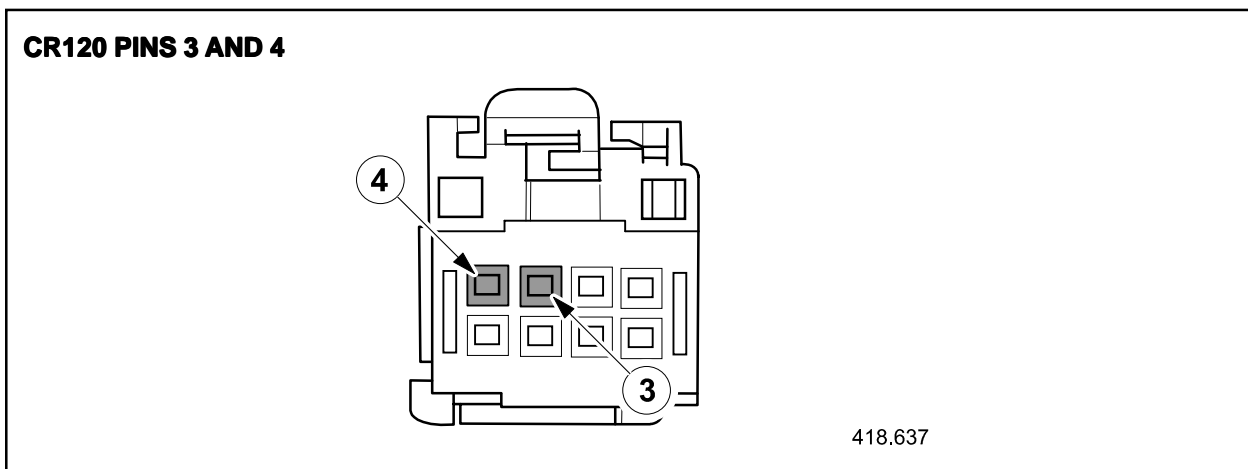
ILLUSTRATION 6

3. Use a male pin 418-411-47 from the harness repair kit to check the integrity of pin 3 and 4 (Illustration 6).

Note: The male to female electrical connection must be firm, and be felt for the full length of the electrical connector. If there is initial resistance, then the pin slips freely into the female pin, replace the female pin. If there is any doubt replace the female pin. Repeat this check with the new pin to verify a proper fit.

4. If pins require replacing, strip back the harness tape to adequate length to facilitate repair. If not, continue with step 17 of this procedure.
5. Remove the anti-back-out device from the electrical connector.
6. Displace affected pin(s) from the electrical connector using special tool 'A' from the harness repair kit.
7. Unwind the affected cable from the Controller Area Network (CAN) bus second cable.
8. Cut back affected cable to the required length to facilitate repair.

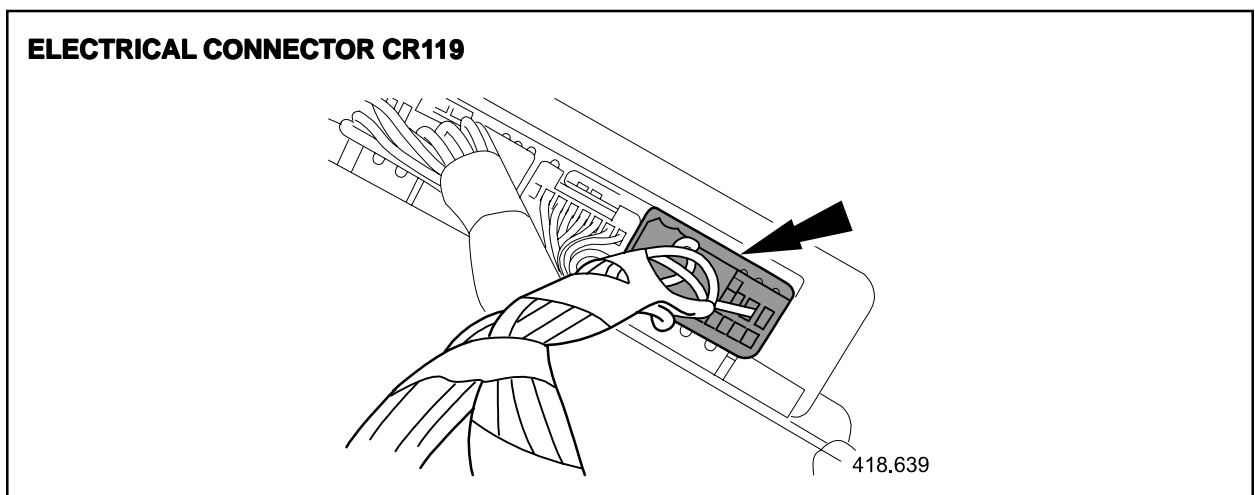
ILLUSTRATION 7

1. Disconnect electrical connector CR119 (gray 22 way) (Illustration 7).

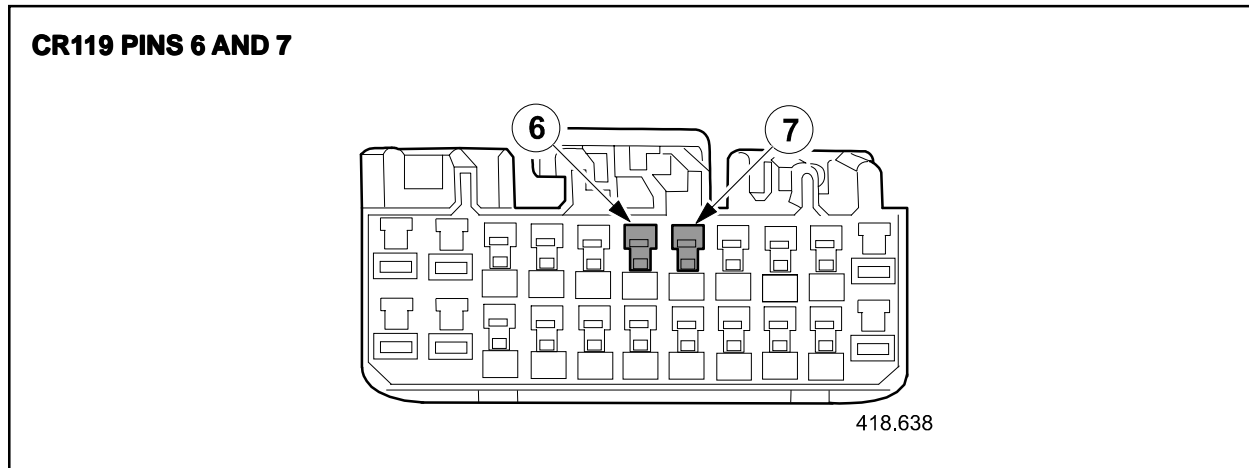
ILLUSTRATION 8

- Using the male pin 418-411-47 from the harness repair kit, check the integrity of pin 6 and 7 (Illustration 8).

Note: The male to female electrical connection must be firm, and be felt for the full length of the electrical connector. If there is initial resistance then the pin slips freely into the female pin, replace the female pin. If there is any doubt replace the female pin. Repeat this check with the new pin to verify a proper fit.

- If pins require replacing, displace anti-back-out device, strip back the harness tape to adequate length to facilitate repair. If not continue with step 18 of this procedure.
