XJ range

XJ413-02

TECHNICAL BULLETIN

Multiple Warnings On Instrument Cluster – Poor Pin Connections – Check & Repair Pins

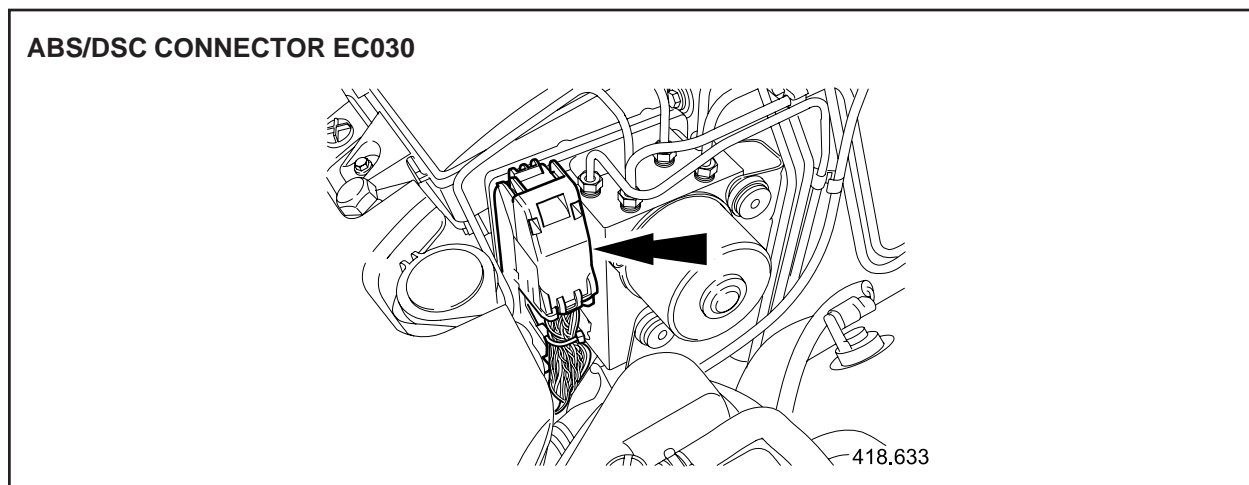
ILLUSTRATION 1

5. Disconnect the Anti-lock Braking System (ABS)/Dynamic Stability Control (DSC) module electrical connector EC030 (black 47 way) (Illustration 1).

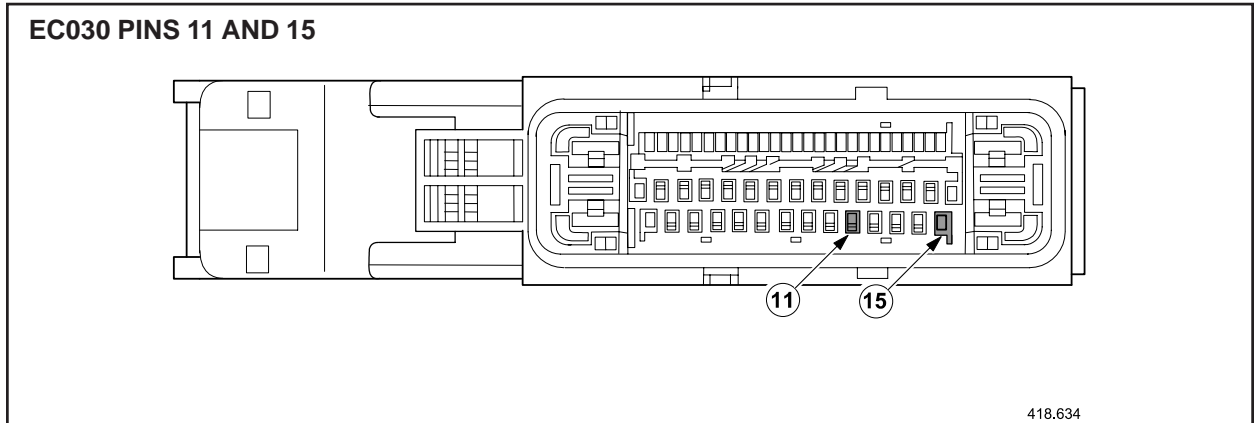
ILLUSTRATION 2

6. Use a male pin 418-411-47 from the harness repair kit, to check the integrity of pins 11 and 15 (Illustration 2).

Note: The male to female electrical connection must be very firm, and be felt for the full length of the electrical connector. If there is initial resistance then the pin slips freely into the female pin, replace the female pin. If there is any doubt replace the female pin. Repeat this check with the new pin to verify a proper fit.

If pins are OK, continue with inspection of electrical connector IP055, if not, replace any faulty pin(s) using pre-terminated end **418-411-74** as follows:

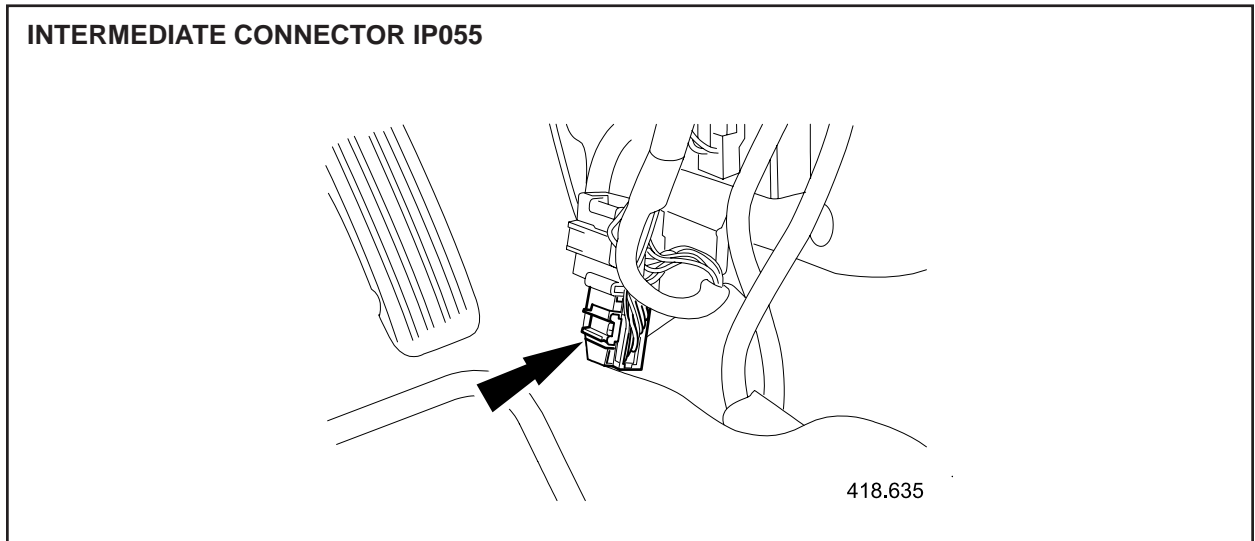
ILLUSTRATION 3

3. Displace the intermediate connector IP055 (black 22 way) from the mounting tang (Illustration 3).

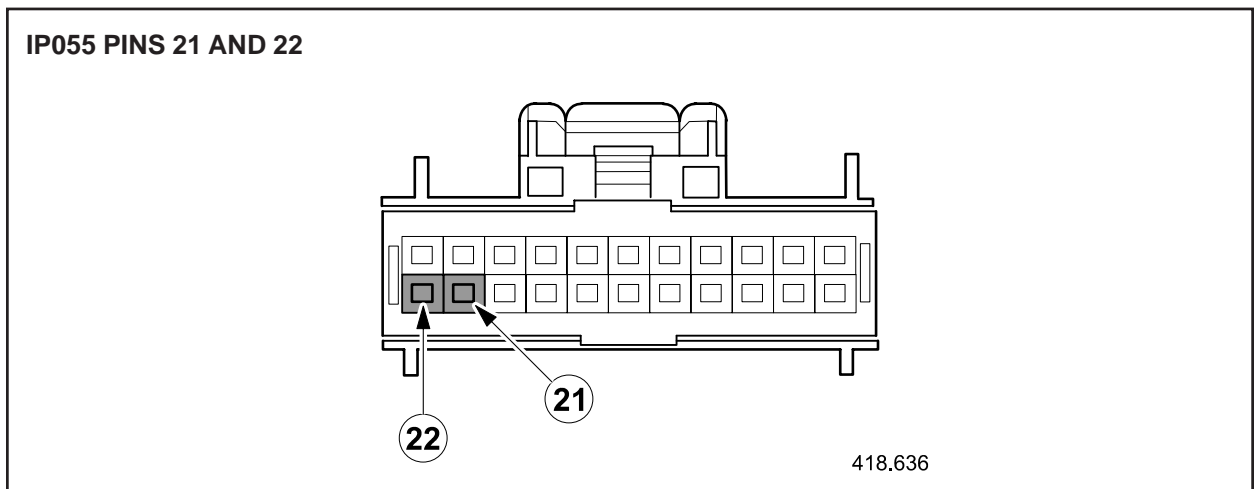
ILLUSTRATION 4

4. Disconnect the intermediate connector IP055.
5. Position harness for access.
6. Use a male pin 418-411-47 from the harness repair kit, check the integrity of pin 21 and 22 (Illustration 4).

Note: The male to female electrical connection must be firm, and be felt for the full length of the electrical connector. If there is initial resistance, then the pin slips freely into the female pin, replace the female pin. If there is any doubt replace the female pin. Repeat this check with the new pin to verify a proper fit.

7. If pins require replacing, strip back the harness tape to adequate length to facilitate repair. If not, continue with step 20 of this procedure
8. Remove the anti-back-out device from the electrical connector.

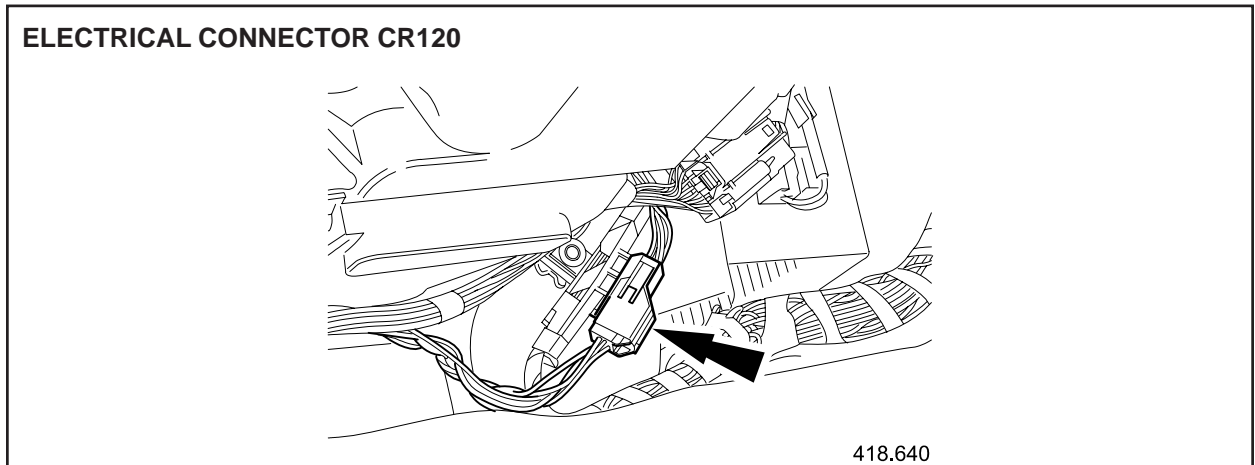
ILLUSTRATION 5

2. Disconnect electrical connector CR120 (black 8 way) (Illustration 5).

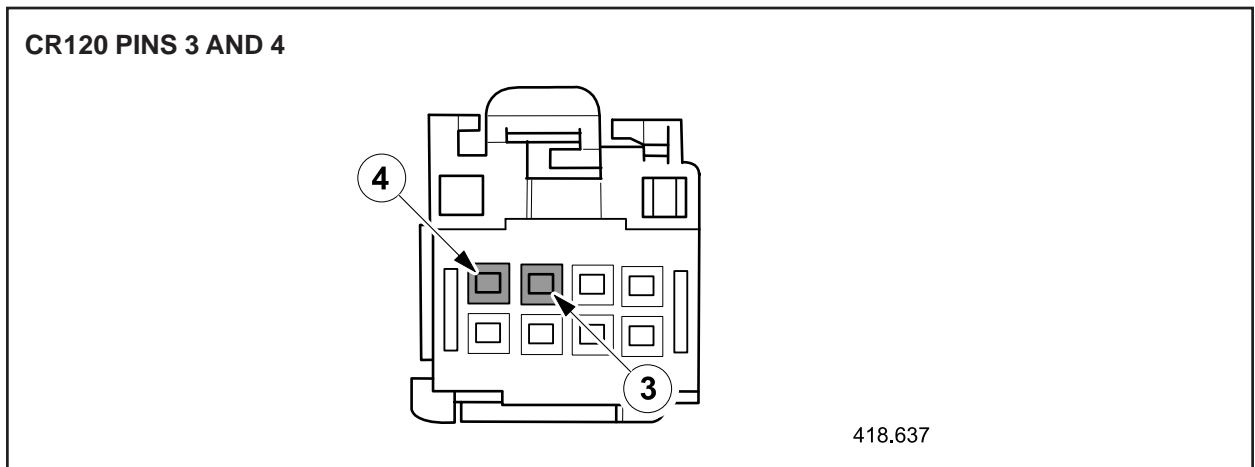
ILLUSTRATION 6

3. Use a male pin 418-411-47 from the harness repair kit to check the integrity of pin 3 and 4 (Illustration 6).

Note: The male to female electrical connection must be firm, and be felt for the full length of the electrical connector. If there is initial resistance, then the pin slips freely into the female pin, replace the female pin. If there is any doubt replace the female pin. Repeat this check with the new pin to verify a proper fit.

4. If pins require replacing, strip back the harness tape to adequate length to facilitate repair. If not, continue with step 17 of this procedure.
5. Remove the anti-back-out device from the electrical connector.
6. Displace affected pin(s) from the electrical connector using special tool 'A' from the harness repair kit.

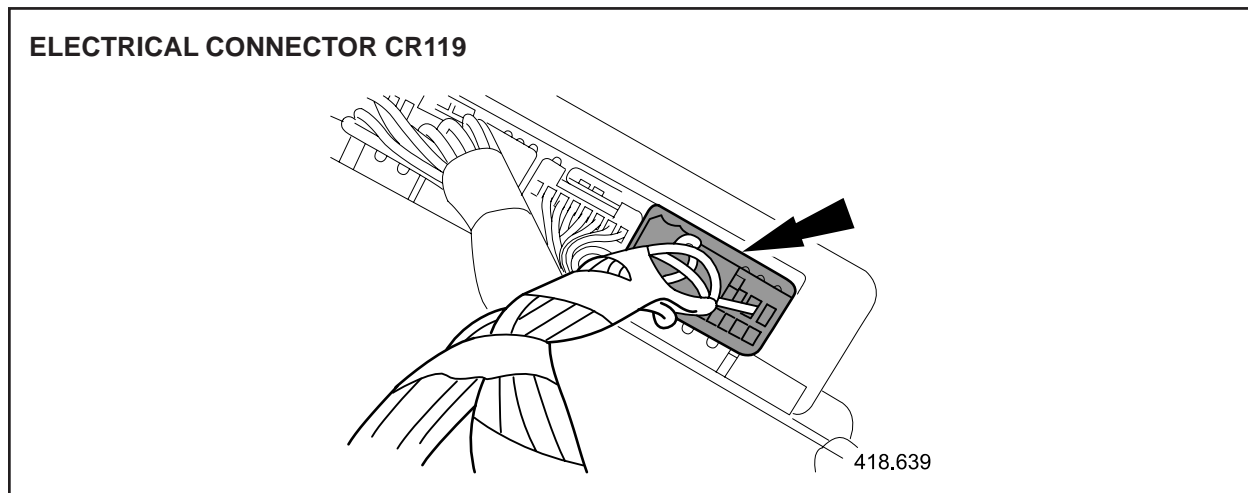
ILLUSTRATION 7

1. Disconnect electrical connector CR119 (gray 22 way) (Illustration 7).

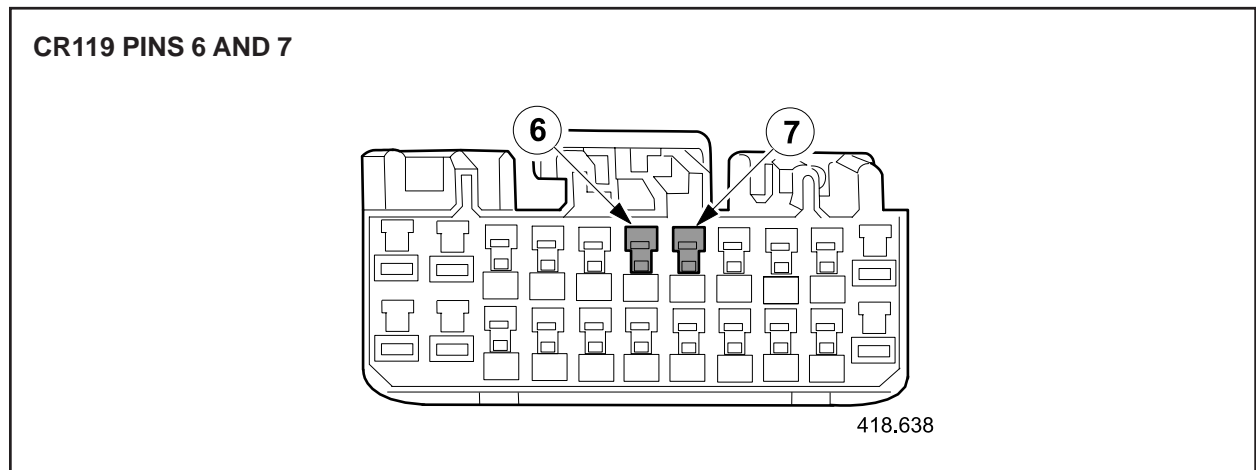
ILLUSTRATION 8

- Using the male pin 418-411-47 from the harness repair kit, check the integrity of pin 6 and 7 (Illustration 8).

Note: The male to female electrical connection must be firm, and be felt for the full length of the electrical connector. If there is initial resistance then the pin slips freely into the female pin, replace the female pin. If there is any doubt replace the female pin. Repeat this check with the new pin to verify a proper fit.

- If pins require replacing, displace anti-back-out device, strip back the harness tape to adequate length to facilitate repair. If not continue with step 18 of this procedure.

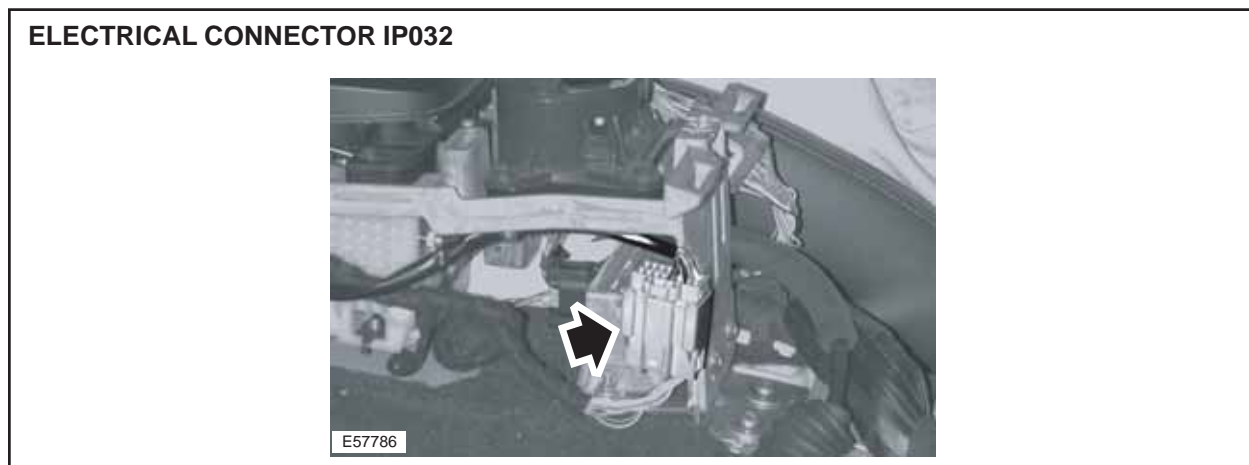
ILLUSTRATION 9

7. Disconnect electrical connector IP032 (green 16-way) Illustration 9.
8. Using the male pin 418-411-12 from the harness repair kit, check the integrity of pins 11 and 12) Illustration 10.

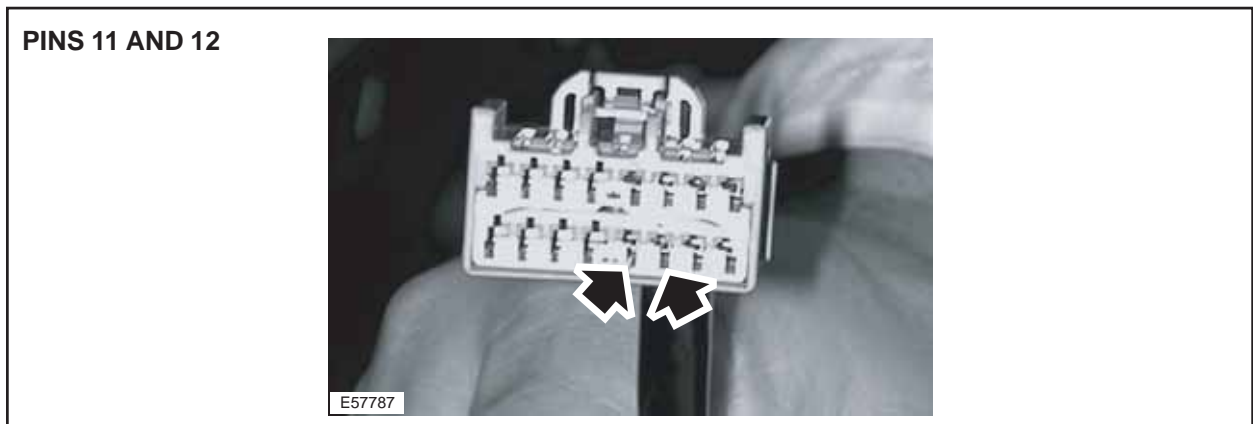
ILLUSTRATION 10

Note: The male-to-female electrical connection must be very firm, and be felt for the full length of the electrical connector. If there is initial resistance then the pin slips freely into the female pin, replace the female pin. If there is any doubt replace the female pin.

9. Replace any faulty pin(s); refer to the Wiring Harness Repair Guide JTP586 in the wiring harness repair kit.
10. Reconnect electrical connector IP032.
11. Install connector to the fir tree fixing.

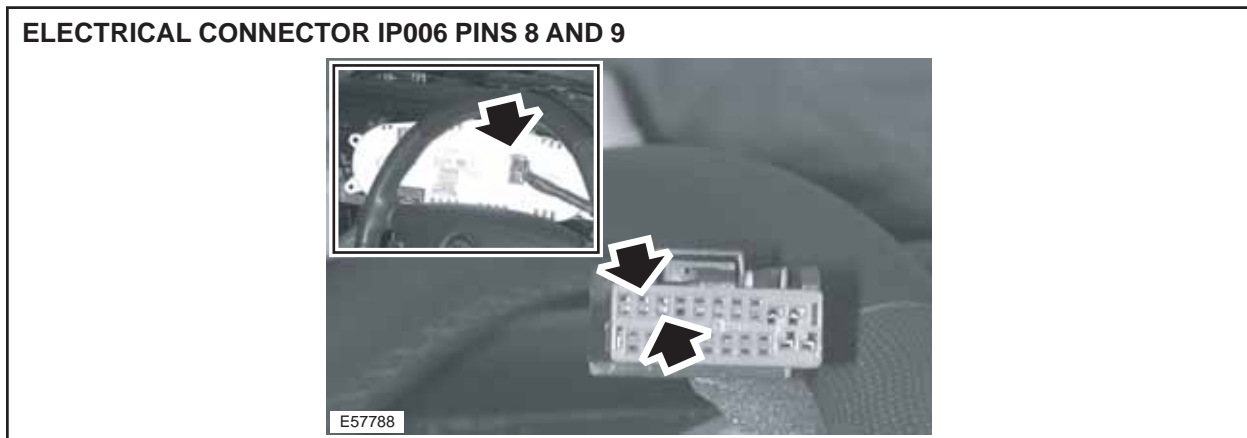
ILLUSTRATION 11

- Using male pin 418-411-47 from the harness repair kit, check the integrity of pins 8 and 9, (Illustration 11).

Note: The male-to-female electrical connection must be very firm, and be felt for the full length of the electrical connector. If there is initial resistance then the pin slips freely into the female pin, replace the female pin. If there is any doubt replace the female pin.

- Replace any faulty pin(s); refer to the Wiring Harness Repair Guide JTP586 in the wiring harness repair kit.
- Install the rear vent duct and install and tighten securing scrivet.
- Install instrument cluster (see Global Technical Reference GTR Workshop Manual, section 413-01).
- Install floor console (see Global Technical Reference GTR Workshop Manual, section 501-12).
- Connect battery (see Global Technical Reference GTR Workshop Manual, section 414-01).
- Power steering column to the original position.
- Close driver door.
