Intermittent Sticking Of Switches—
Upper Center Console –
Repair

MODEL 2004 MY
XJ range

VIN G00001-G21479

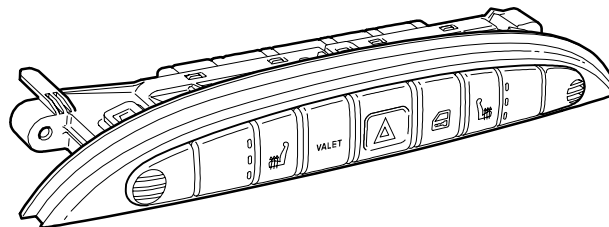
ILLUSTRATION 1

On some 2004 MY XJ range vehicles within the above VIN range, customers may experience intermittent sticking of the switch pack in the upper section of the center console.

This condition is caused by excessive pressure applied to the buttons due to contact between the center console and the switch pack bezel.

UPPER CENTER CONSOLE SWITCH PACK

A new modified switch pack for the upper center console is now available to rectify this concern.

In case of a verified customer complaint of the above condition on a 2004 MY XJ range vehicle within the above VIN range, replace the switch pack as described below:

2. Remove the two center console upper switch pack securing screws.
3. Remove the upper switch pack.
4. Install and align the new upper switch pack.
5. Install and tighten the two upper switch pack securing screws.
6. Install the instrument panel console (see Workshop Manual, JTIS CD ROM, section: 501-12, SRO 88.20.34).
