XJ501-08

# TECHNICAL BULLETIN

Floor Console Trim Separating –  
Not Adhering –  
Repair

MODEL 2004 MY  
XJ range

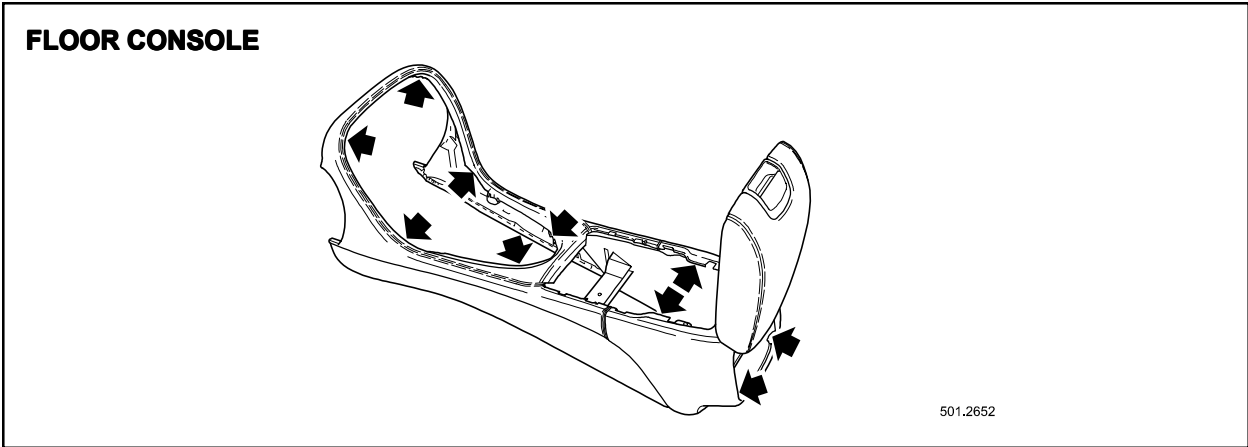
ILLUSTRATION 1

Some customers may have concerns with the floor console trim separating. This is not a split in the material but is caused by the material not being correctly adhered to the floor console.

4. Carefully turn back the trim at the affected areas as required (Illustration 1 shows likely areas of concern).
5. Apply suitable adhesive to exposed console and trim rear faces as required.

6. Allow adhesive to dry completely.
7. Apply another coat of adhesive to exposed console and trim rear faces.

8. Apply tension to trim and adhere to console by pressing down thoroughly.
9. If required, install the console glovebox.
10. Install floor console (see Workshop Manual, JTIS CD ROM, section: 501-12, SRO 76.25.01).
11. Connect the battery (see Workshop Manual, JTIS CD ROM, section: 414-01, General Procedures).
