XJ range

XJ501-17

TECHNICAL BULLETIN

Windshield Wiper Performance Issues –
KATS Contamination/Debris/
Rubber Deterioration – Recommendations

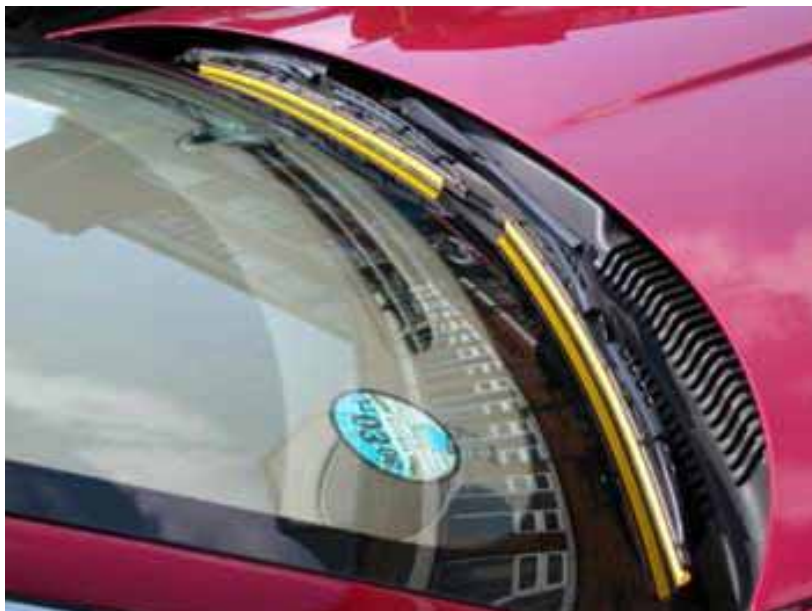
ILLUSTRATION 1

WIPER BLADE PROTECTORS AS LOCATED ON VEHICLE.

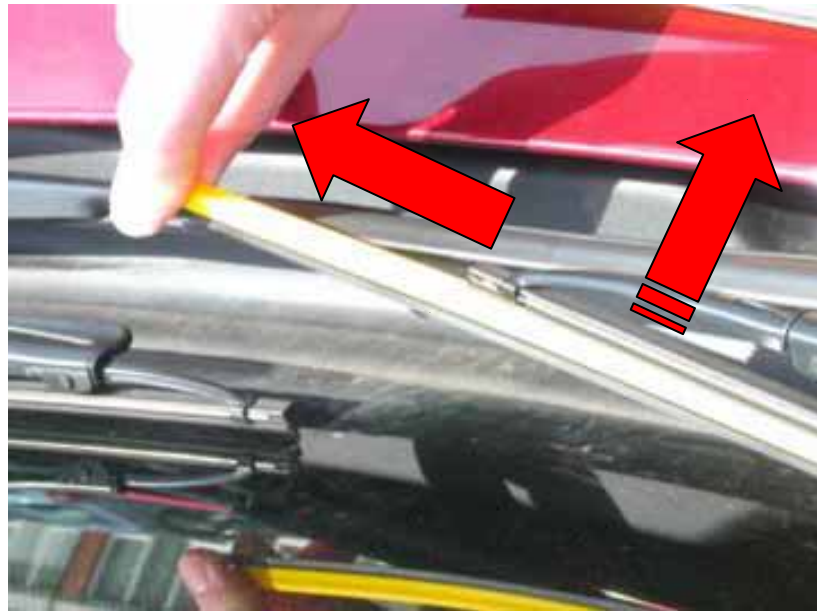
ILLUSTRATION 2

REMOVING WIPER BLADE PROTECTOR - RIGHTSIDE

To remove the protector, lift the wiper blade and pull the crimped end as shown in Illustration 2.

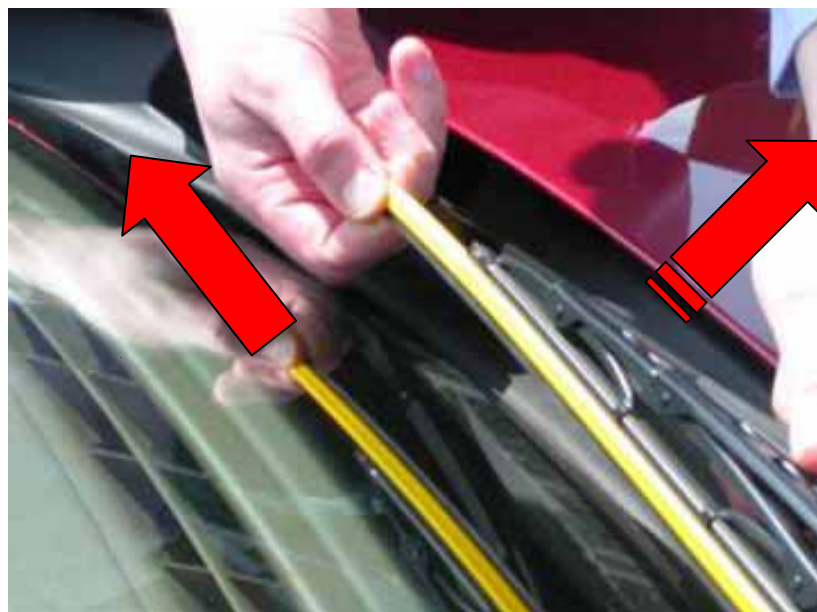
ILLUSTRATION 3

REMOVING WIPER BLADE PROTECTOR - LEFT SIDE

Repeat the procedure to remove the left side protector, Illustration 3.
