MODEL
XJ Range

NUMBER
XJ501-025

TECHNICAL BULLETIN

'Click' from Front Seat Rear Rise/Fall

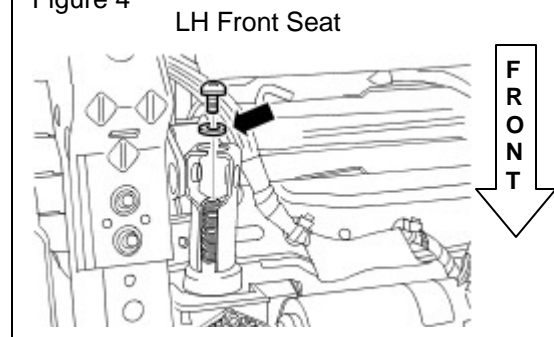
Figure 4

Situation: A customer may report a concern of a 'click' noise being heard during the downward travel of the rear height adjustment on a front seat. A metal washer on the attachment bolt for the rear height adjustment motor drive shaft may be contacting the guide leg.

8. Remove the bolt at the end of the motor drive shaft to access the metal washer. (Figure 4)
9. Remove and discard the metal washer, ensuring that the nylon washer remains in place on the drive shaft. (Figure 4)

10. Install the bolt, ensuring that the nylon washer is in the correct position on the drive shaft, and tighten the bolt to **7 Nm (+/- 1Nm) [5.2 lbf-ft (+/- 0.7 lbf-ft)]**. (Figure 4)
