S-TYPE

S204-07

TECHNICAL BULLETIN

Vibration Felt Through Steering Wheel or
Seats – Wheels/Tires –
Diagnostic Procedure

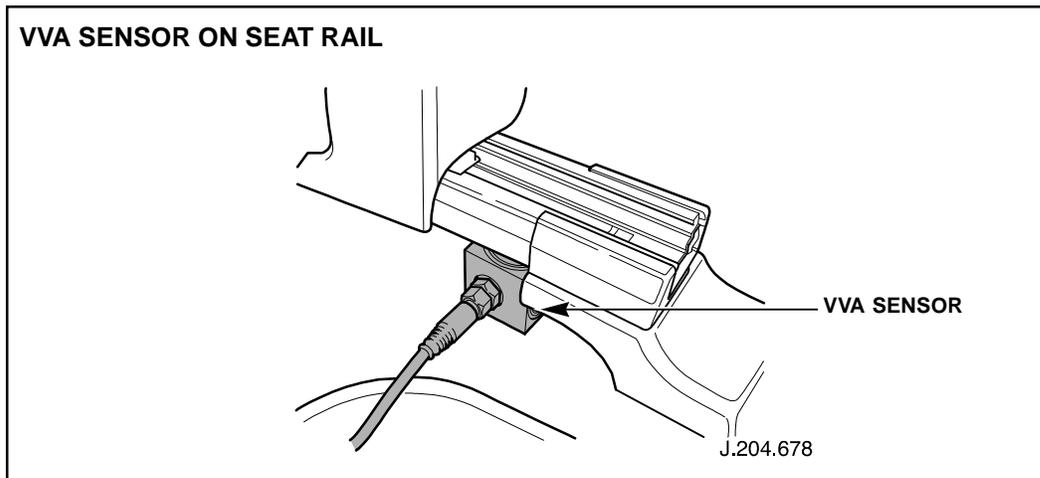
ILLUSTRATION 1

Note: In the first instance the VVA sensor should be mounted on the seat rail in the X-axis (fore/aft) orientation. If there is no reading in the X-axis orientation, repeat test in the Y-axis (left/right) and Z-axis (up/down) or until a reading is obtained (Illustration 1).
