**S-TYPE**DATE 12/00
Amended 07/02**S303-S139****SERVICE****TECHNICAL BULLETIN****S-TYPE PCM Reflash –
Service Action S139**MODEL 2000-01 MY
S-TYPE

VIN L00001-M02205

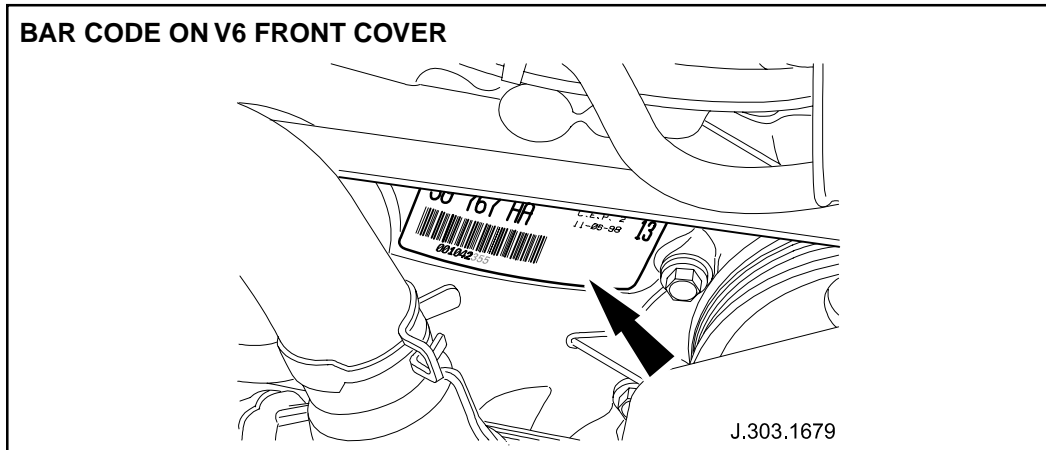
ILLUSTRATION 1

Note: The V6 engine number is located on the bar code label on the engine front cover (Illustration 1) or on the left-hand side of the engine bedplate (Illustration 2). Position the vehicle on a lift as needed to gain access.

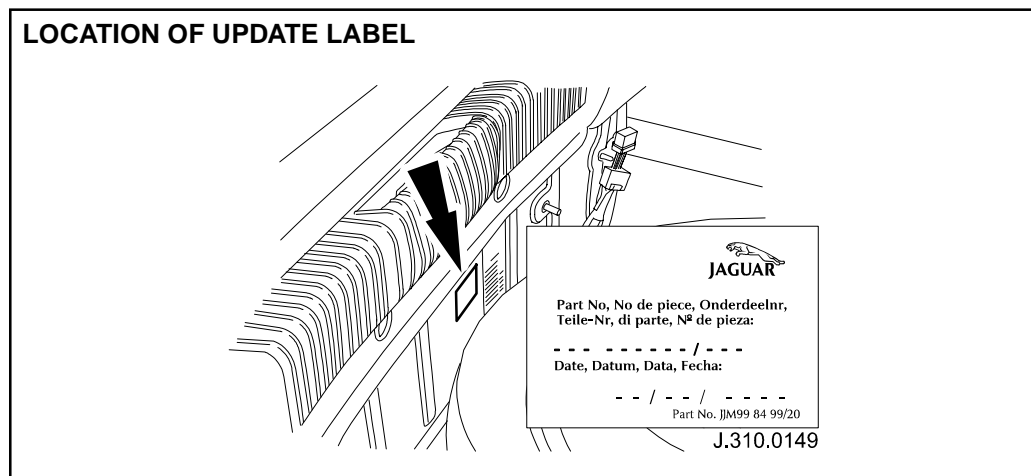
ILLUSTRATION 3

Note: While WDS is reprogramming PCM, apply generic update label (JJM 998499/20) alongside the VCATS label in the trunk with revised part number (as noted in step 24), and date of re-configuration added to label (Illustration 3).

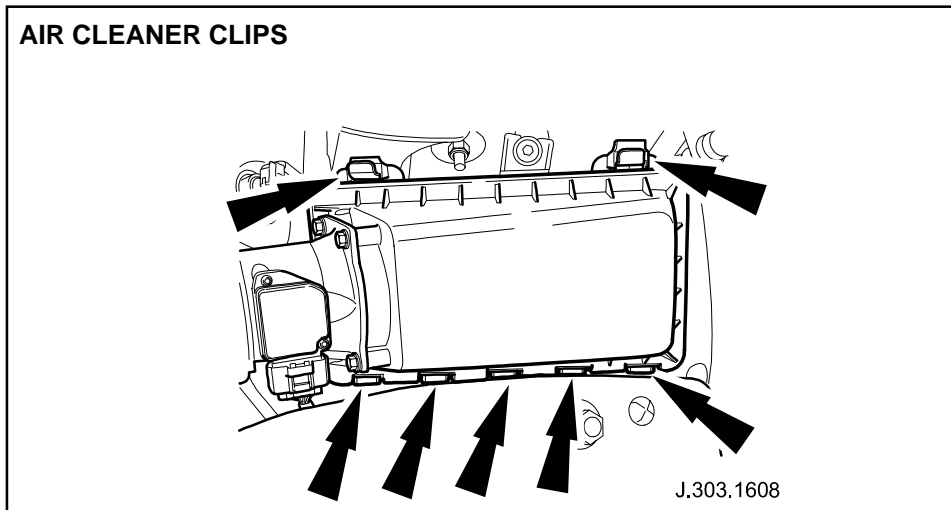
ILLUSTRATION 4

28. On both 3.0L V6 and 4.0L V8 vehicles, visually inspect air cleaner for loose, faulty or damaged clips. (Illustration 4)

Note: Secure any loose clips. If the clips are faulty or damaged, replace as necessary.

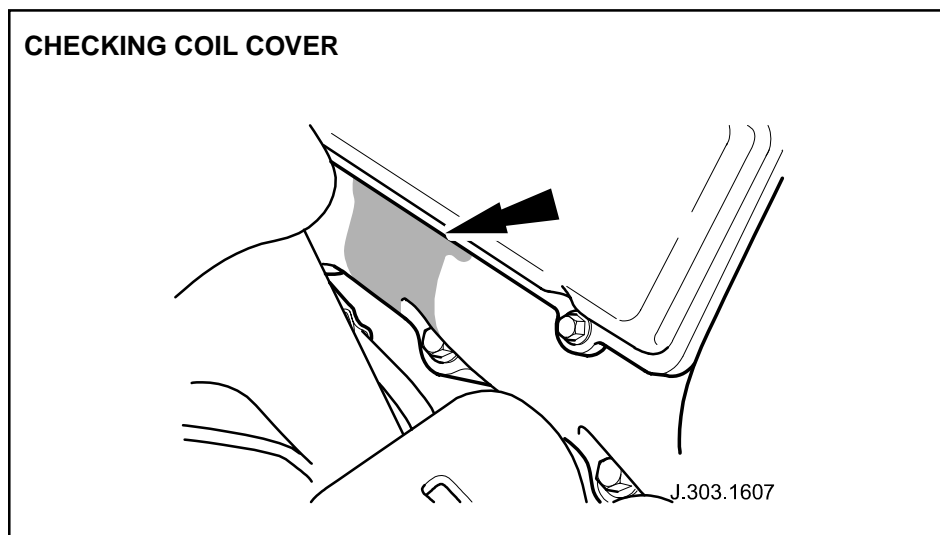
ILLUSTRATION 5

29. If the vehicle is 4.0L V8, visually inspect lower edge of the spark plug coil covers for water seepage. (Illustration 5). If the vehicle is a 3.0L V6, continue to step 28.

Note: If watermarks are visible, remove the coil cover to identify if any coils may be corroded. If corrosion is found, replace any damaged coils, and replace the affected coil cover with part no. AJ8 3078.
