MODEL
S-TYPE
XJ, XK

NUMBER
JTB00070
Version 1

TECHNICAL BULLETIN

Transmission Noise During Gear Shifts – Repair Procedure

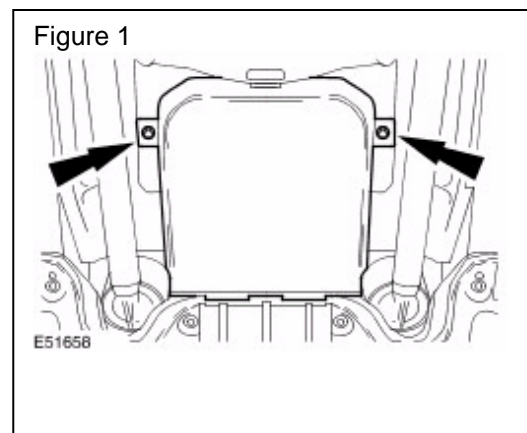
Situation: The customer may complain of a squawk noise from the automatic transmission when changing into third gear. The noise may also occur on kick-down from fourth to third and sixth to third gears. A squawk or chirp noise can also be heard when changing from third to fourth gear at 50% throttle. The likely cause is that the 'E' clutch sticks and releases when engaging and disengaging gear.

1. Raise vehicle on a four-post ramp.
2. If an S-TYPE vehicle is being repaired, remove the engine undertray. (Figure 1)
3. Place clean drain container under the transmission.
