**S-TYPE**

S307-02

SERVICE**TECHNICAL BULLETIN****Stuck Ignition Key –
Modify J-Gate Interlock Lever –
Service Action S114**MODEL 2000 MY-ON
S-TYPE

VIN L00600-L11869

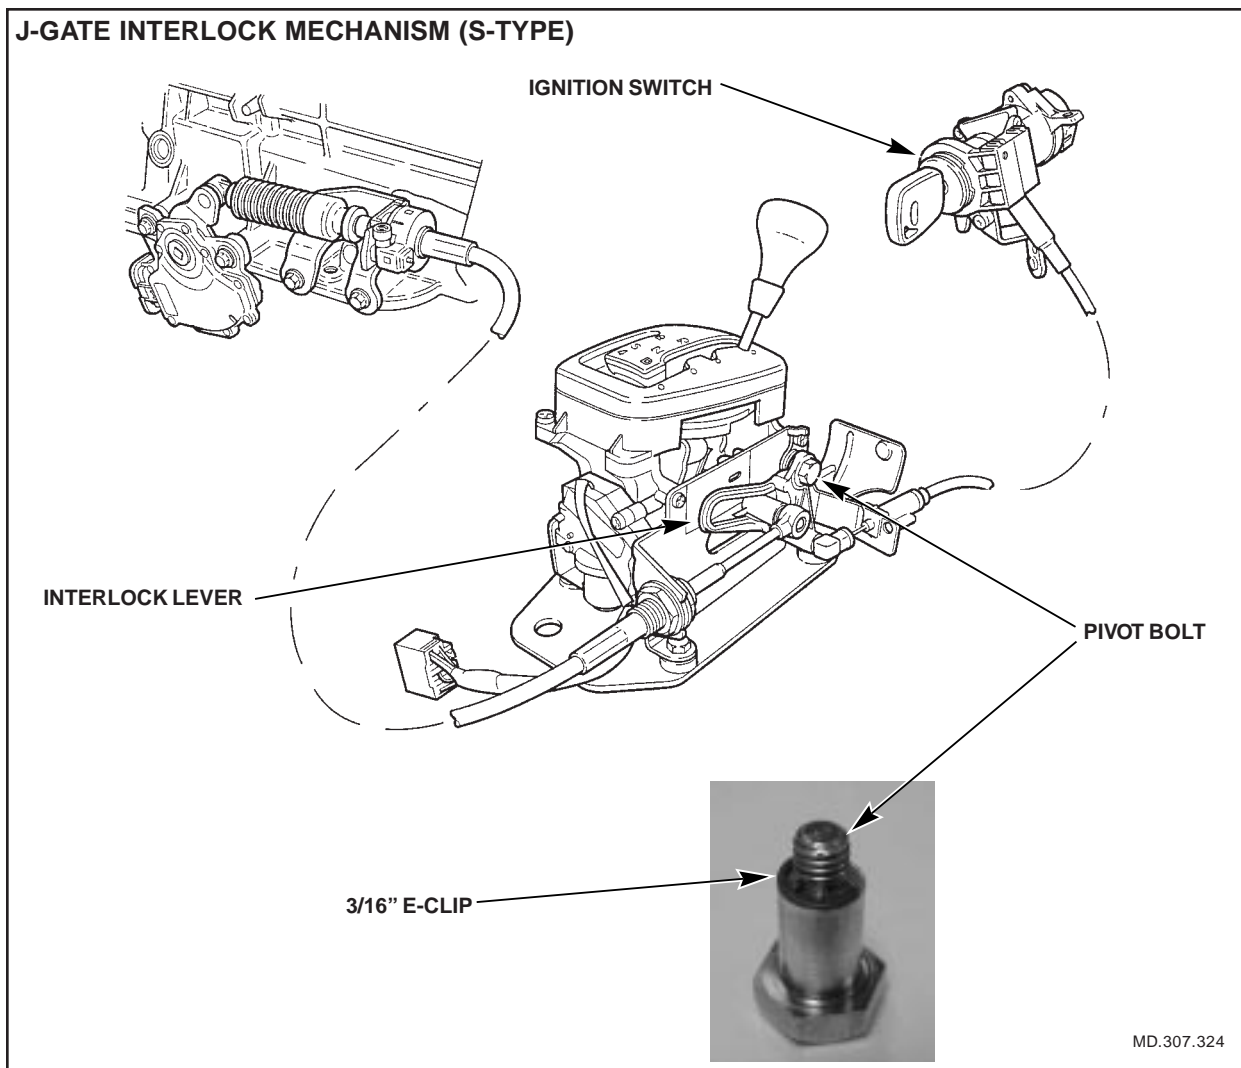
ILLUSTRATION 1

Some 2000 MY S-TYPE vehicles within the above VIN range may, under high temperature conditions, experience a malfunction of the J-Gate interlock mechanism which results in the inability to remove the ignition key when the gear selector lever is placed in 'Park'.

J-GATE INTERLOCK MECHANISM (S-TYPE)

6. On the right side of the J-gate assembly, remove the pivot bolt that retains the interlock lever (Illustration 1).
7. Check for any excess thread locking compound on the interlock lever. Wipe off any excess.
8. Install a 3/16 inch e-clip on to the bolt (Illustration 1), **ensuring that the e-clip does not extend beyond the shank of the bolt. Make sure that the bolt turns freely in the lever.** If necessary, use a reamer to bevel the opening of the lever.
9. Reinstall the bolt. Do not use thread locking compound.
10. Ensure that the interlock lever moves freely and that the key can be easily removed when the range selector lever is in 'Park'.
11. Reassemble the console components in the vehicle.
