S-TYPE

S307-03

TECHNICAL BULLETIN

DTC P0741 –
Torque Converter Clutch Does Not Lock Up –
Missing Seal Ring

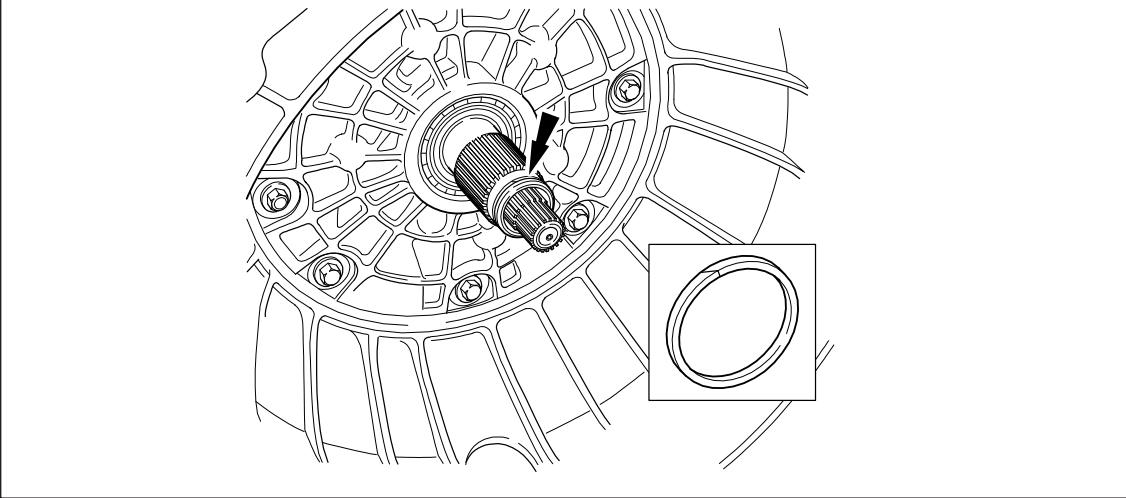
ILLUSTRATION 1

Some 2000-**02** MY S-TYPE vehicles may experience a MIL illumination with diagnostic trouble code (DTC) P0741 stored in the PCM. This condition is most likely to result from the omission of an oil seal on the transmission stator shaft during assembly of the unit. The function of the oil seal is to complete a hydraulic circuit intended to allow transmission fluid under pressure to actuate the lock-up clutch under certain conditions. Omission of the seal allows fluid to by-pass the intended circuit. This fluid then recirculates in the torque converter without actuating the lock-up clutch. The condition will be confirmed by the presence of DTC P0741.

3. Inspect the stator shaft and determine if the seal is damaged or if no seal is present at the location shown in illustration 1.

LOCATION OF OIL SEAL ON STATOR SHAFT

4. If no transmission input shaft seal is installed, install a new seal.
5. Install the transmission torque converter.
6. Install the automatic transmission (see Global Technical Reference GTR Workshop Manual, section: 307-01, SRO 44.20.01).
7. Use WDS to carry out a transmission fluid level check (see Global Technical Reference GTR Workshop Manual, section: 307-01, General Procedures).
8. With WDS already connected, clear all DTCs from the Transmission Control Module (TCM).

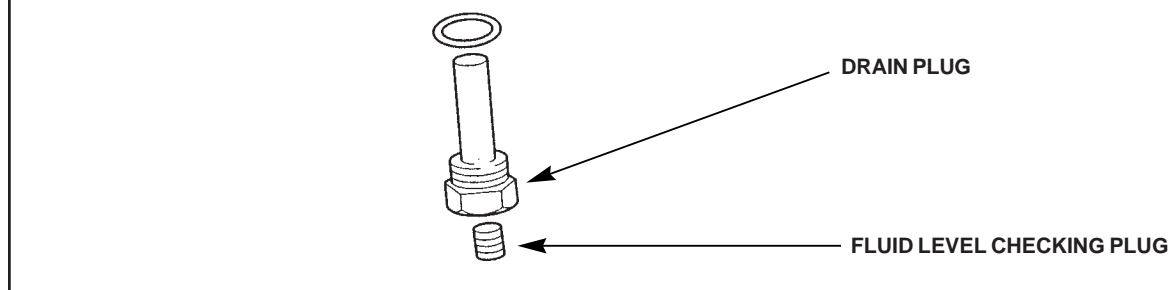
ILLUSTRATION 1

5R55N DRAIN PLUG/FLUID LEVEL PLUG
