S-TYPE

S307-03

TECHNICAL BULLETIN

DTC P0741 –
Torque Converter Clutch Does Not Lock Up –
Missing Seal Ring

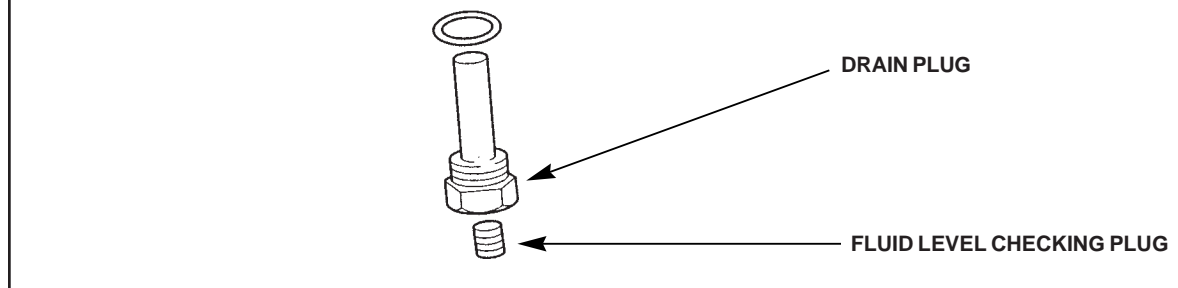
ILLUSTRATION 1

5R55N DRAIN PLUG/FLUID LEVEL PLUG
