**S-TYPE**

S307-12

SERVICE**TECHNICAL BULLETIN**

Driveline Clunk/Knock When Downshifting –
ZF 6HP26 Automatic Transmission –
Repair Procedure

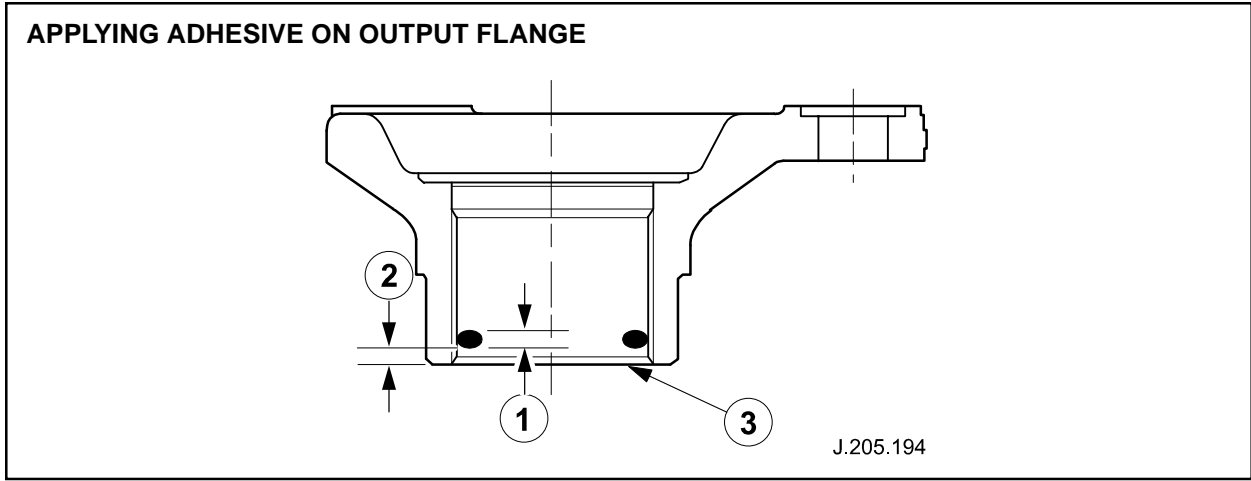
ILLUSTRATION 1

Owners of some 2003 MY-ON S-TYPE vehicles, equipped with the ZF 6HP26 automatic transmission, may complain of a driveline clunk/knock when changing from reverse to drive, or while downshifting from fifth to fourth or second to first when the vehicle is slowing.

- Apply a 4-5 mm wide bead (1, Illustration 1) of Loctite® 648 adhesive around the female spline of the output flange 3-5 mm (2, Illustration 1) inboard of the entrance chamfer of the spline.

Note: Make sure that there is no adhesive on the front face of the output flange facing the transmission (3, Illustration 1).
