**No 4th or 5th gear**

**4-3 Pre-Stroke Valve Spring**

**56947J-S1**

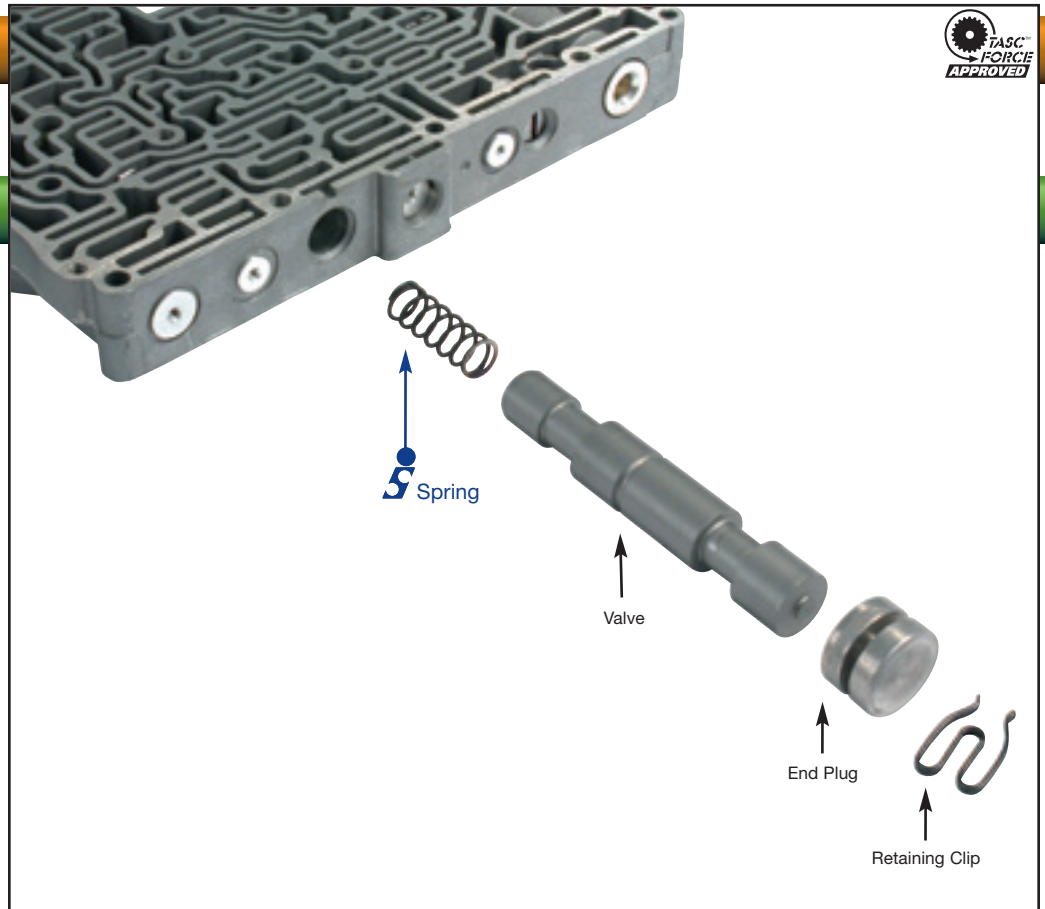
• Codes 734 and/or 735 • Solenoid C Code

Breakage of the 4-3 pre-stroke valve spring prevents proper valve function.

Complaints of no 4th or 5th gear, codes 734 and/or 735, and solenoid C codes can occur on the 5R55N due to a broken 4-3 pre-stroke valve spring. The 4-3 pre-stroke valve controls the apply and release rate of the intermediate servo and direct clutch, which should be applied in 4th and 5th gear. The Sonnax 4-3 Pre-Stroke Valve Spring **56947J-S1** addresses these complaints. This spring is not used on 5R55W & S units.

Replace with the reduced-stress Sonnax spring.
