Fuel Filler Door Inoperative –
Actuator Binding –
Modification Procedure

MODEL 2005 MY
S-TYPE

VIN N13089-N41136

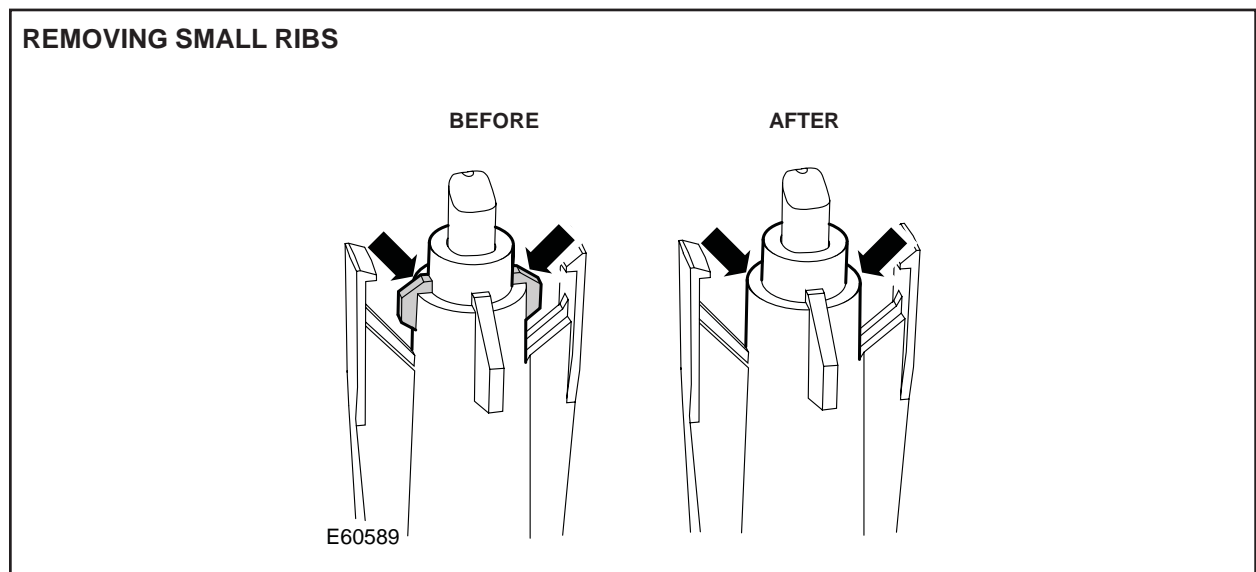
ILLUSTRATION 1

Cause: Fuel filler door actuator being stressed when installed in housing.

1. Using a suitable craft knife, remove the two small ribs from the fuel filler door actuator (Illustration 1).
