S417-04

TECHNICAL BULLETIN

Headlamp Internal Condensation – Acceptable Levels – Repair Guidelines

MODEL 2003 MY-ON
S-TYPE

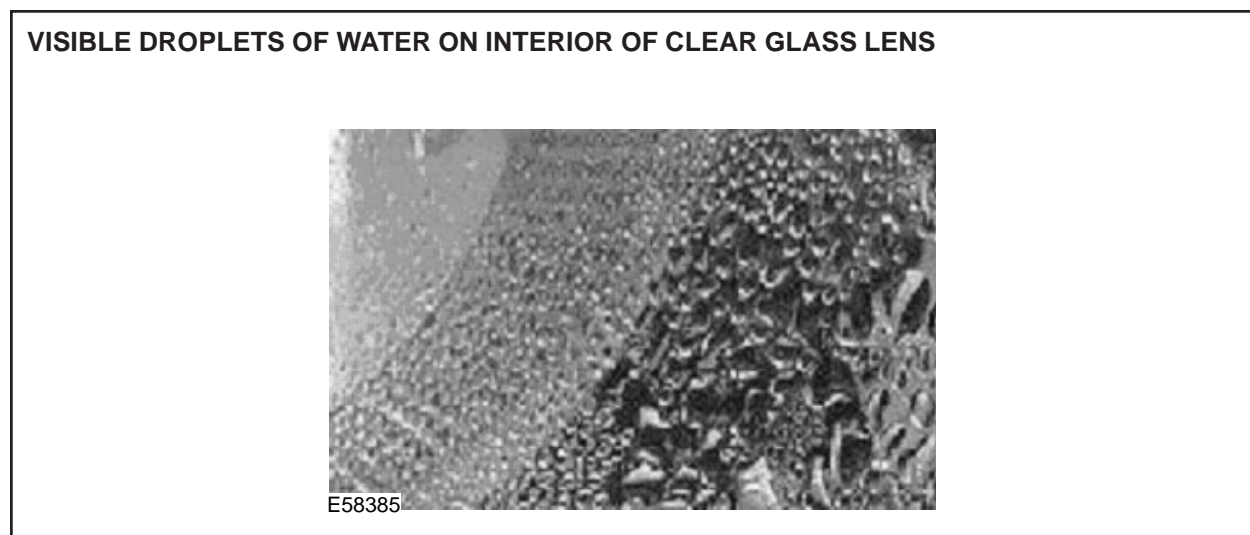
ILLUSTRATION 1

1. Large apparent visible droplets of water on the interior side of the clear glass lens.

1. Turn the headlamp dip and main beam functions 'ON', and run the engine for 30 minutes.
 - If water droplets still remain on the inside of the headlamp glass, the lamp should be renewed.
 - If there is evidence of standing water within the headlamp unit, the unit will also need to be replaced.For additional information, refer to Global Technical Reference (GTR) Workshop Manual, section: 417-05, Headlamp Assembly.
