**Wind Noise –  
Check Door Mirror Gaps –  
Repair Procedure**MODEL 2000 MY-ON  
S-TYPE

VIN L00001-ON

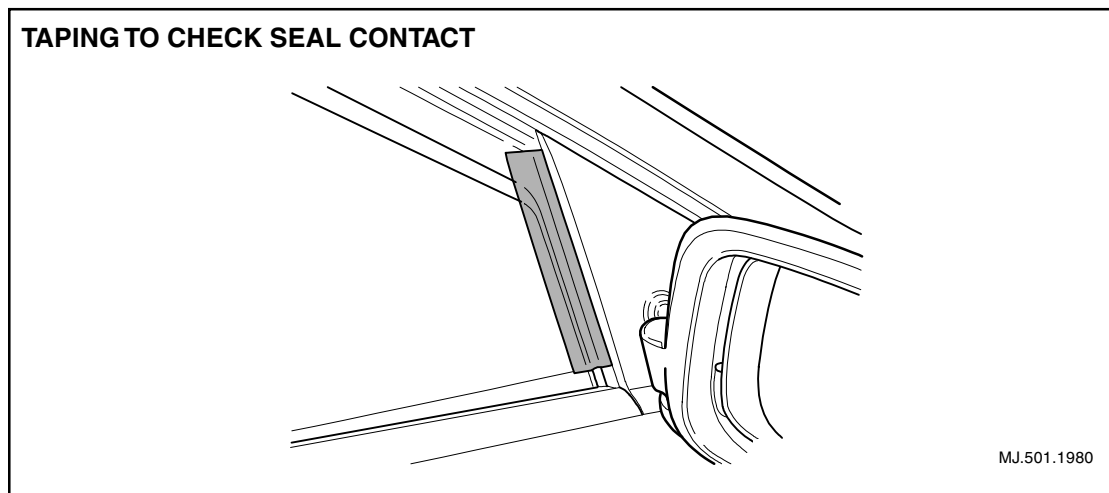
ILLUSTRATION 1

1. Attach a piece of tape across the glass seal and side glass. (Illustration 1).

**Note:** The tape should follow the contours of the seal so as not to change the shape.

2. Test drive the vehicle and evaluate. If there is no longer a noise coming from the seal, a new glass seal is required.

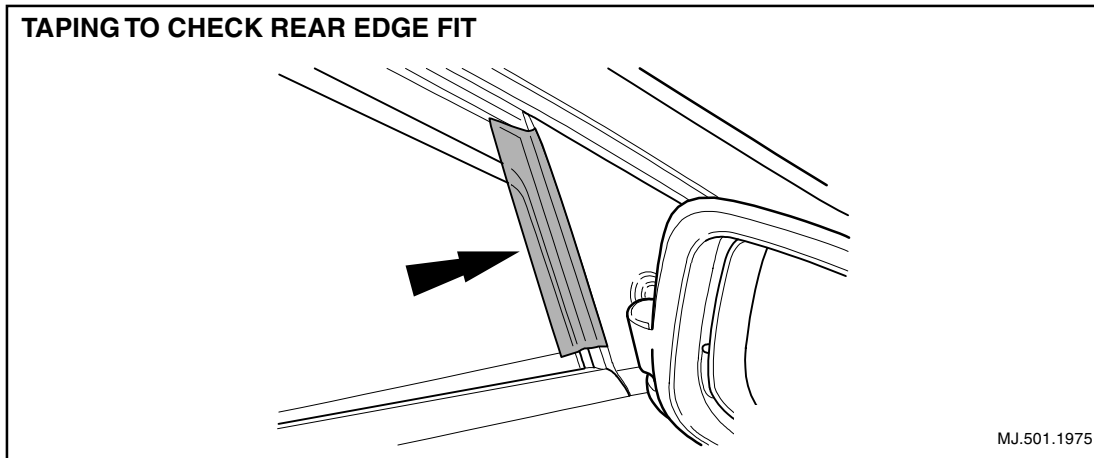
ILLUSTRATION 2

1. Fully tape the rear edge of the mirror base (Illustration 2)

2. Test drive the vehicle and evaluate. If the noise is eliminated investigate further and continue with the procedure below.

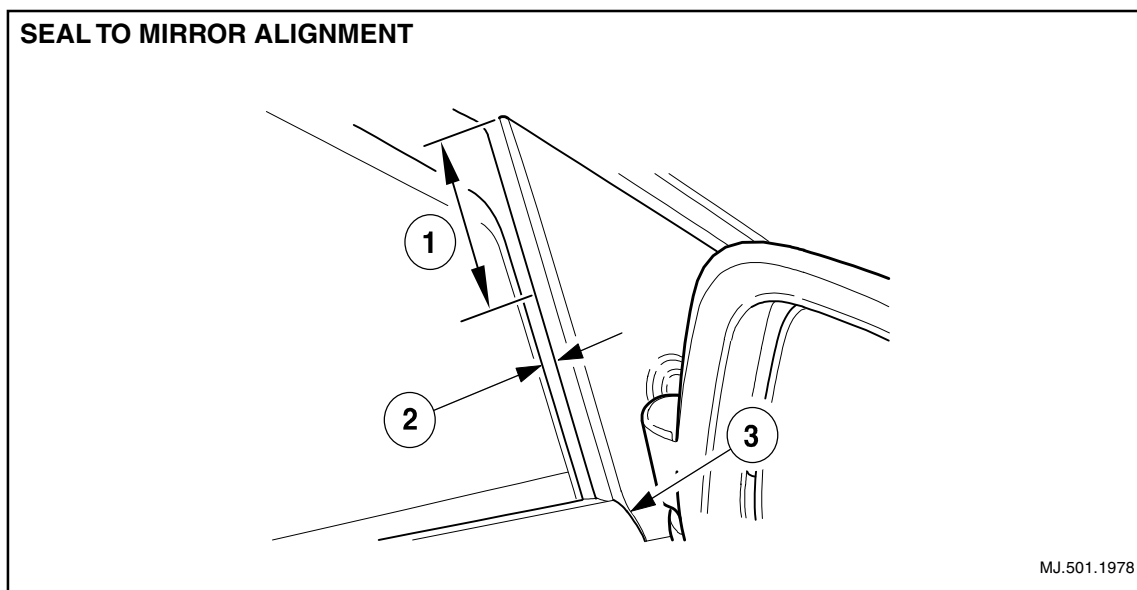
ILLUSTRATION 3

The rear edge of the mirror base should fit approximately 0.5 mm away from the glass seal along the 50 mm length (1, **Illustration 3**). The thickness of visible glass seal along the rear edge should be approximately 4-5 mm wide (2). The mirror base should sit evenly on top of the waist finisher along the length of the flip seal (3).

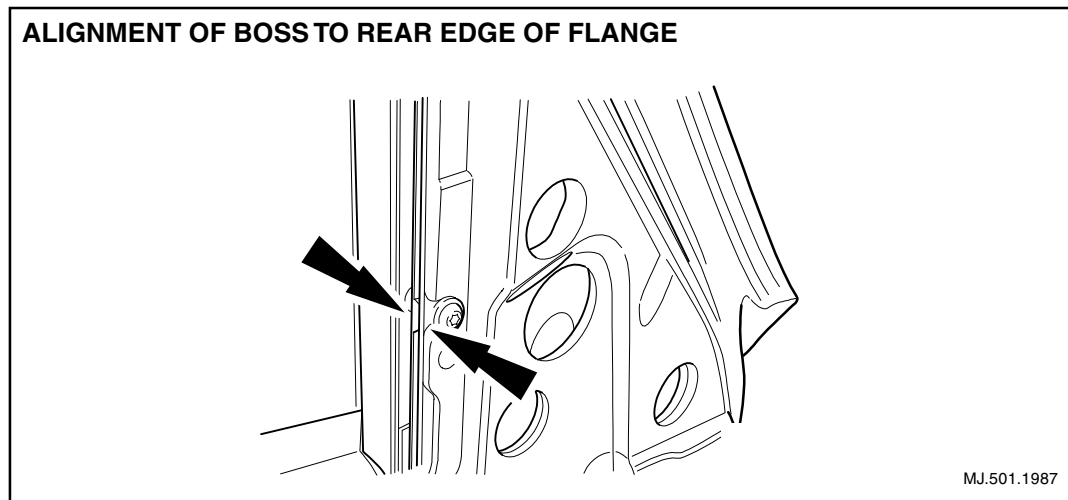
ILLUSTRATION 5

3. Check that the rear of the upper mounting boss of the guide leg is flush with the rear edge of the body flange of the guide leg (see Illustration 5).

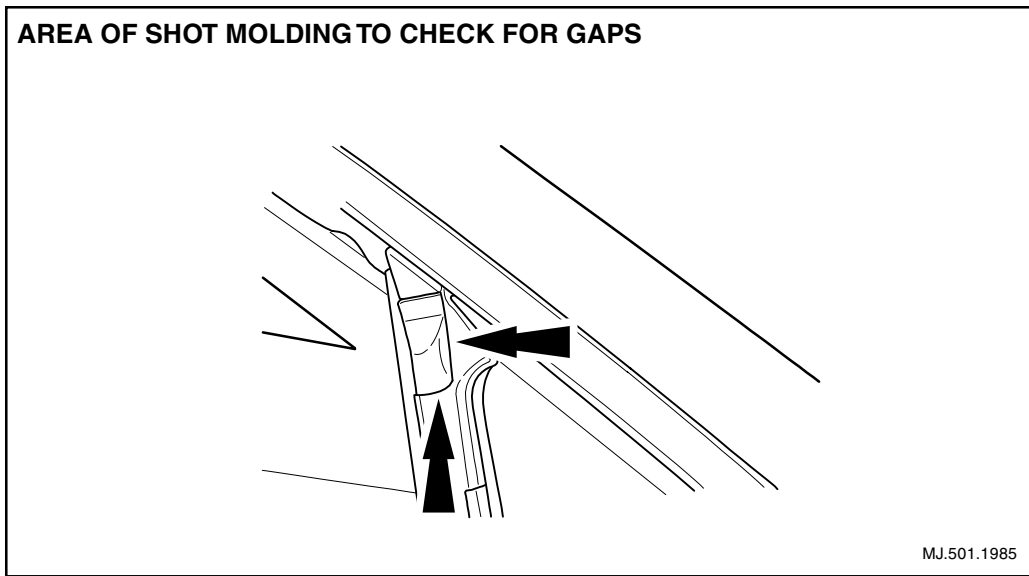
ILLUSTRATION 6

The shot molding must be flush, with no gaps, in the areas indicated by the arrows shown in Illustration 6.

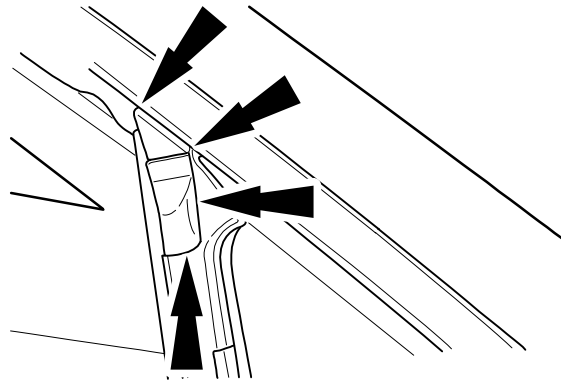
ILLUSTRATION 8

**AREA TO BE SEALED USING SILICONE SEALER**

7. Using a suitable silicone sealant, seal around the areas indicated by the arrows shown in Illustration 8, filling all the joints and holes.

**Note:** When sealing the areas shown in Illustration 8, ensure the sealant will not be visible when the mirror assembly has been re-installed.

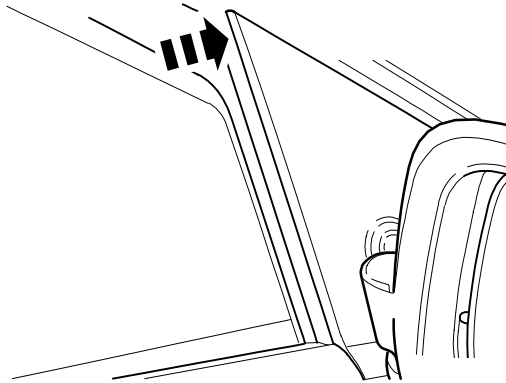
ILLUSTRATION 9

**AREA TO BE SEALED USING SILICONE SEALER**

8. Reinstall the mirror assembly ensuring the mirror base upper corner is forward (See Illustration 9) and the fixing stud contacts the body. (See Workshop Manual, JTIS CD ROM, section 501-09, SRO 76.10.52).
9. Reassess the fit of the mirror base to the glass seal. (Check against the dimensions shown in Illustration 3).
10. Evaluate.
