**Inoperative Windshield Washer –
 Operated While Frozen –
 Upgrade Fuse To 15 amp**

MODEL 2000-01 MY
S-TYPE

VIN L00001-L86901

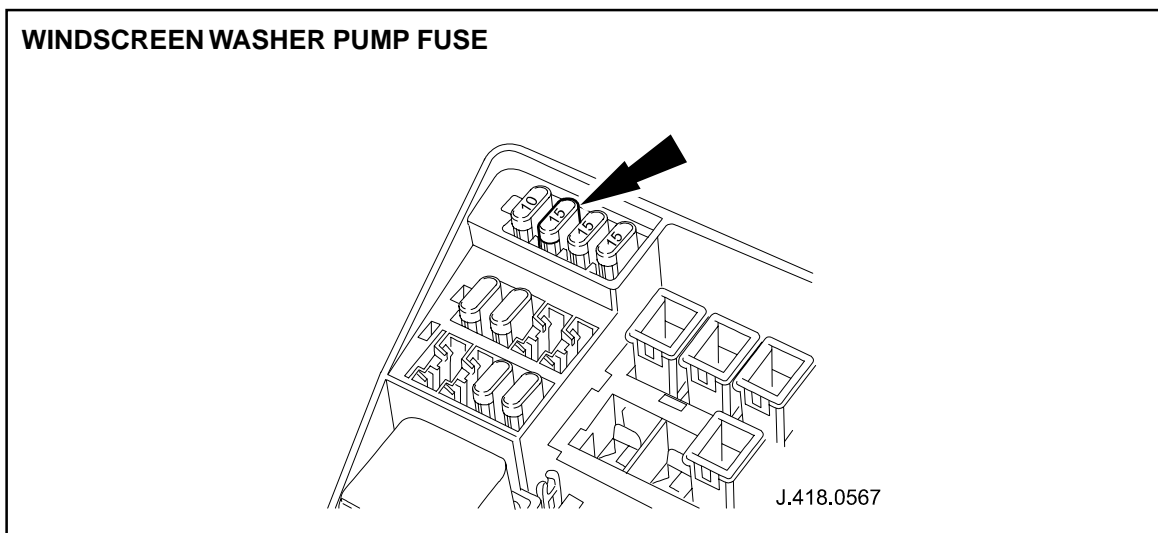
ILLUSTRATION 1

Owners of some 2000-01 MY S-TYPE vehicles within the above VIN range, may experience an inoperative windshield washer system after attempting to operate the systems while it was frozen.

1. Open hood and place covers over fenders.
2. Remove engine compartment fuse box cover.
3. Remove windshield washer pump fuse (10 amp, position 2).

4. Install 15 amp fuse in position 2 (Illustration 1).
5. Install engine compartment fuse box cover.
6. Remove fender covers and close hood.
