**Front Axle Shafts –
Check Retention In CV Joint –
Service Action S930**

MODEL 2002-03 MY
X-TYPE

VIN C00293-C94500

Service Action S930

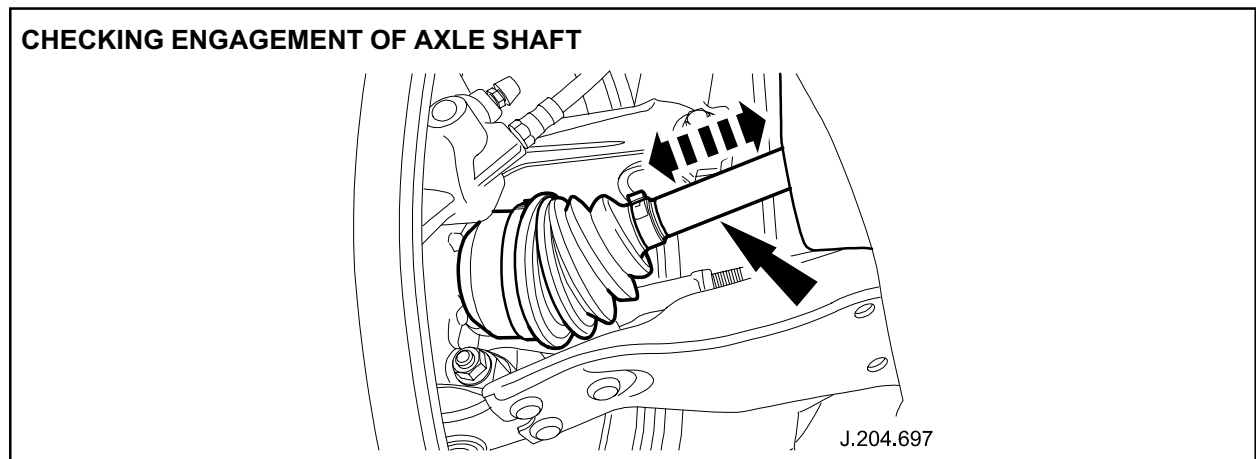
ILLUSTRATION 1

During the manufacturing process it is possible that the front axle shafts may have been disturbed. As a result the splined end may not be fully engaged in the outer Constant Velocity (CV) joint resulting in a loud knocking noise.

2. From under the vehicle grip the first front axle shaft. Push the front axle shaft towards the outer Constant Velocity (CV) joint then pull back the axle shaft towards the transmission (Illustration 1).

Note: Normal hand force of at least 10 kg (22 lbf) is needed to move a non-engaged circlip. (E.g. normal hand force with no special tools.)

3. If movement of more than 1 mm is detected on the outward push, a click indicating engagement of the cir-clip should be felt.
4. If movement is felt on the inward pull and the axle shaft did not come adrift, push it out again to engage.
5. Pull the axle shaft towards the transmission to verify that the axle shaft has engaged. There should now be no movement of the axle shaft.
6. If the axle shaft comes adrift from the outer CV joint when pulled towards the transmission at any time, replace the complete axle shaft.
7. Repeat for remaining front axle shaft.

If one or both axle shafts are not engaged in the outer Constant Velocity (CV) joint, attempt to re-install the shaft by pushing it back in.

If the axle shaft does not lock back into place, install a new axle shaft.
