**Excessive Travel Of Parking Brake Lever –
Internal Clutch Mechanism Wear –
Modification Procedure**MODEL 2002 MY
X-TYPE
VIN C00294-D03127**Issue:**

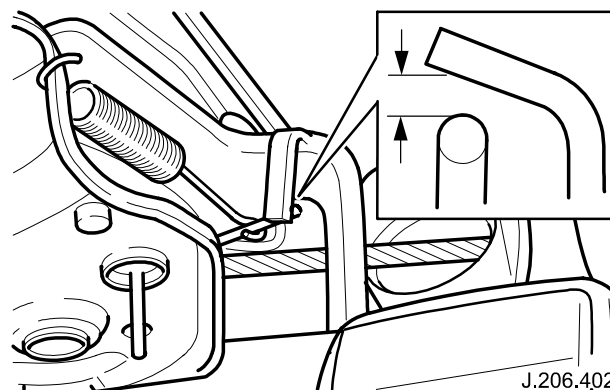
ILLUSTRATION 1

BEND SPRING STOP

4. Using suitable pliers, bend the clutch spring stop away from the clutch spring to obtain a 0.2 mm gap (Illustration 1). Measure gap using feeler gauges.

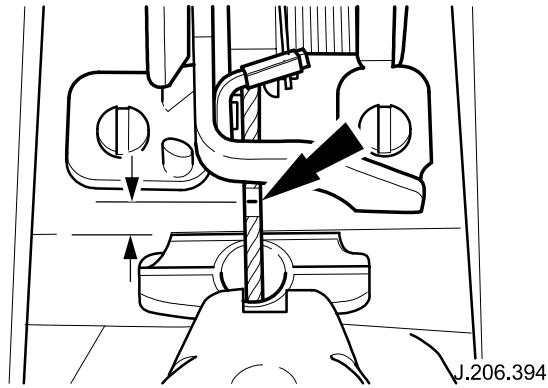
ILLUSTRATION 4

DISTANCE TO MEASURE

9. Apply parking brake lever one notch and measure distance traveled. (Illustration 4)
10. Check the stroke measurement according to the following table.

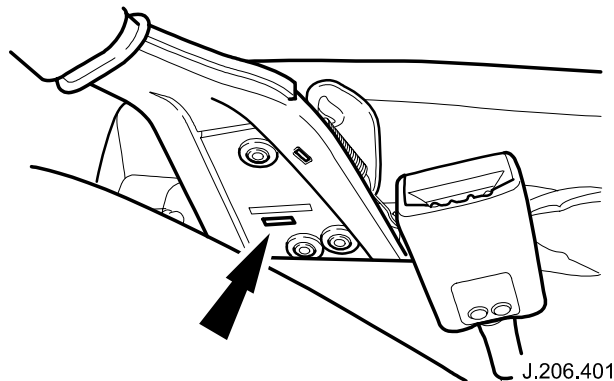
ILLUSTRATION 5

Note: The manufacture date of the parking brake lever can be obtained from the parking brake lever body (Illustration 5).

LOCATION OF MANUFACTURING DATE

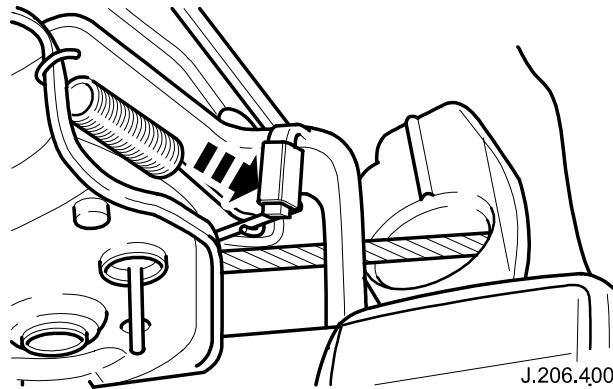
ILLUSTRATION 6

BENDING STOP DOWNWARD

11. If the stroke of the cable is greater than the specified amount, bend clutch spring stop and clip slightly downwards towards the clutch spring until the correct value has been attained (Illustration 6).

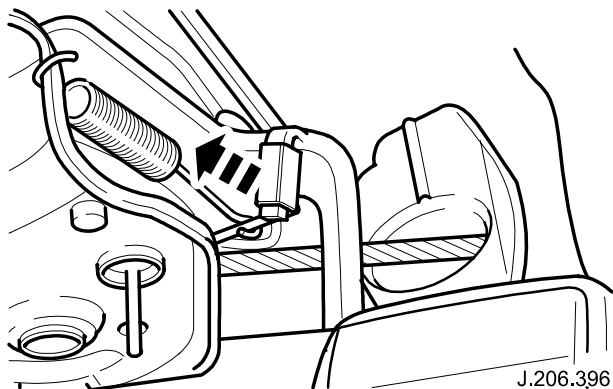
ILLUSTRATION 7

BENDING STOP UPWARD

12. If the stroke of the cable is less than the specified amount, bend clutch spring stop and clip slightly upwards away from the clutch spring until the correct value has been attained (Illustration 7).
13. Install floor console (see Workshop Manual, JTIS CD ROM, section: 501-12, SRO 76.25.01).
14. Connect battery, install battery cover.
15. Remove fender protectors, close hood.
