MODEL
XJ, S-TYPE,
X-TYPE

NUMBER
JTB00055

TECHNICAL BULLETIN

Power Steering System Squeaking Noise Repair Procedure

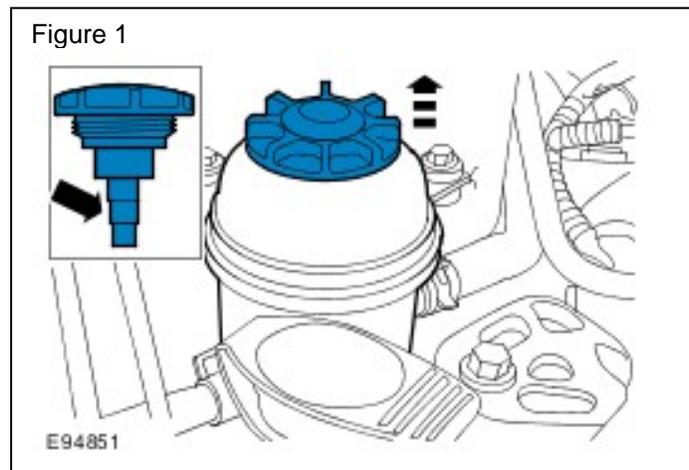
1. Open driver's door.
2. Ensure the gear lever is in either neutral or park, the parking brake is 'ON', and the ignition is 'OFF'.
3. Open hood and install fender protectors.
4. Remove the power steering fluid reservoir cap (and filter mesh on XJ and S-Type vehicles) and ensure the fluid level is correct. (Figure 1)
5. Using a suitable clean syringe, remove 50ml of steering fluid.

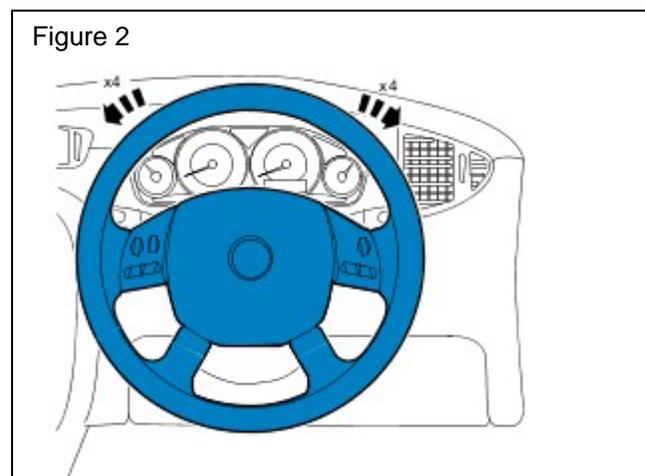
1. Turn ignition 'ON' and start the engine.
2. With the engine idling, turn the steering wheel from lock to lock four times to cycle the fluid additive into the system. (Figure 2)

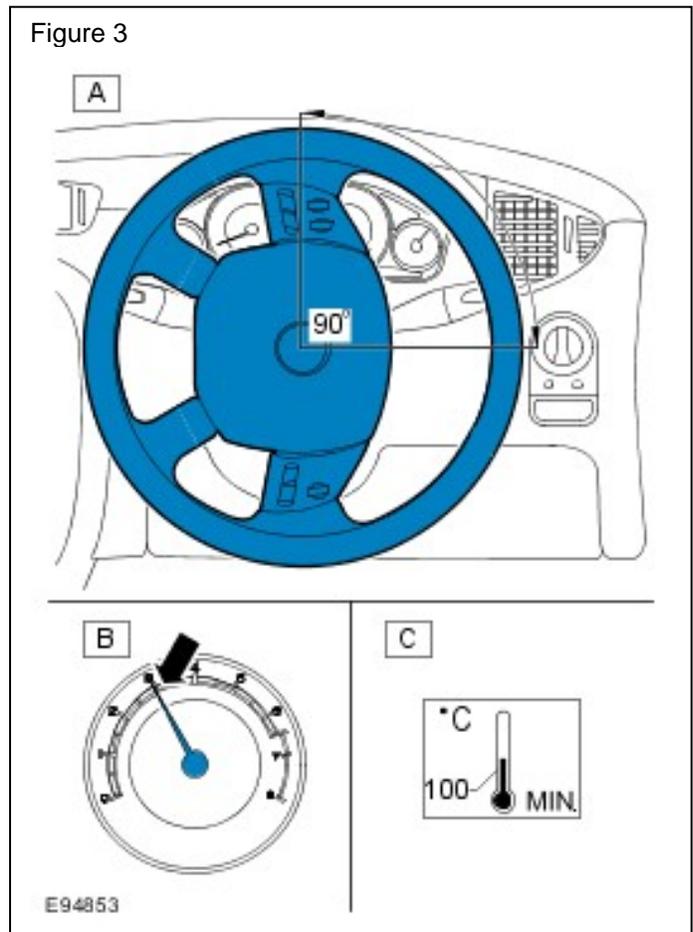
3. While stationary and with the steering wheel in the center position (road wheels in the straight ahead position), turn the steering wheel 90° (quarter turn) right and hold firmly with both hands. (Figure 3)
 - Increase the engine speed to 3000rpm.
 - Monitor the power steering fluid temperature until 100±5°C (212°F±10°F) is reached.
