X-TYPE

XT501-14

TECHNICAL BULLETIN

Washer Fluid Leakage At Front Fender –
Leak At Elbows –
Repair Procedure

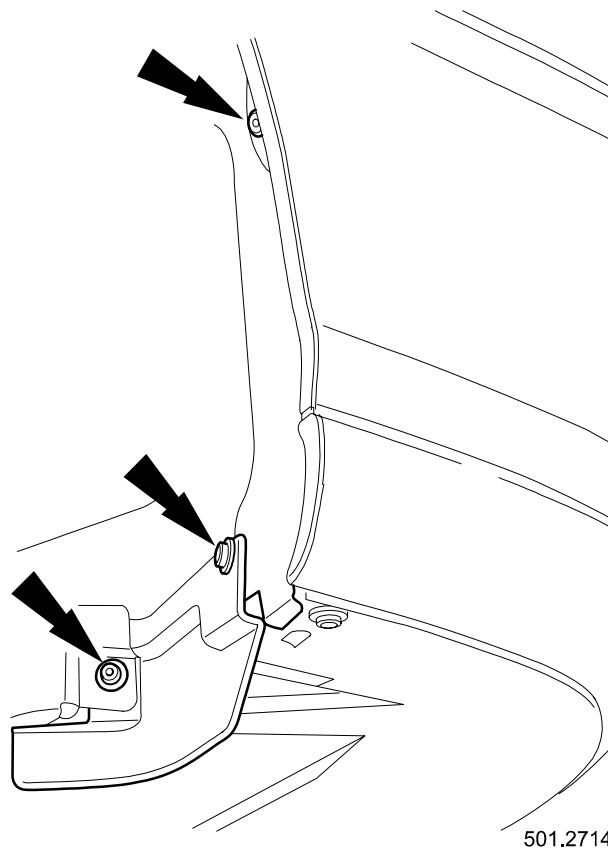
ILLUSTRATION 1

WHEEL ARCH LINER SECURING SCREWS

5. Remove the front section of the right hand wheel arch liner securing screws (Illustration 1).
6. Displace and reposition the wheel arch liner to gain access to windshield washer pump.

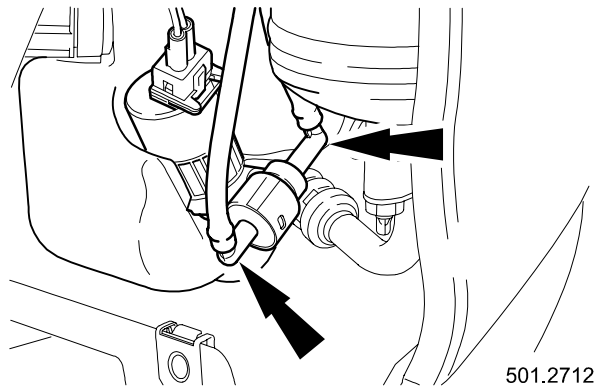
ILLUSTRATION 2

Some 2002-04 X-TYPE vehicles within the above VIN range may exhibit a leak from the area of the windshield washer reservoir.

ORIGINAL CONFIGURATION WITH ELBOWS INSTALLED

7. Disconnect both windshield washer hoses from the windshield washer pump elbows, noting positions of front and rear hoses for reconnection purposes (Illustration 2 - Wagon shown).

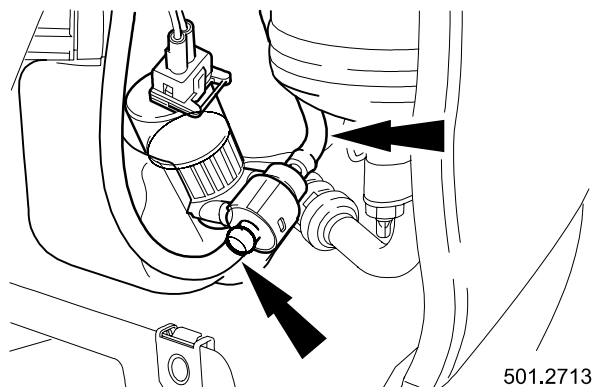
ILLUSTRATION 3

MODIFIED CONFIGURATION WITH ELBOWS REMOVED

8. Remove and discard the windshield washer pump elbows.
9. Connect the windshield washer hoses directly on to the windshield washer pump stub pipes, ensuring the hoses are still slack so that there is no restriction to flow (Illustration 3 - Wagon shown).
