**Water Leaks In Rear Of Wagon Vehicles –  
Possible Causes Of Water Entry –  
Repair Techniques**

MODEL 2004 MY-ON  
X-TYPE Wagon

VIN D77509-ON

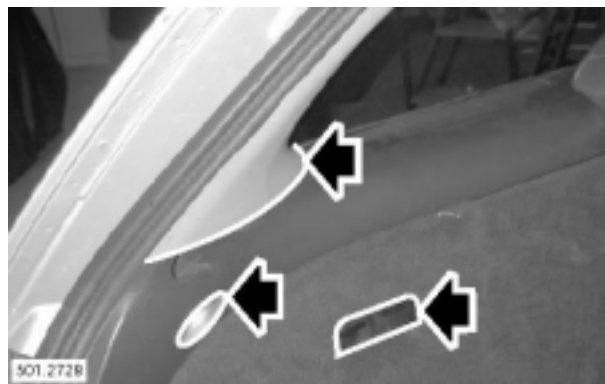
ILLUSTRATION 1

Possible areas where water entry may be apparent (left hand side shown, Illustration 1).

**LOCATIONS WHERE MOISTURE MAY APPEAR**

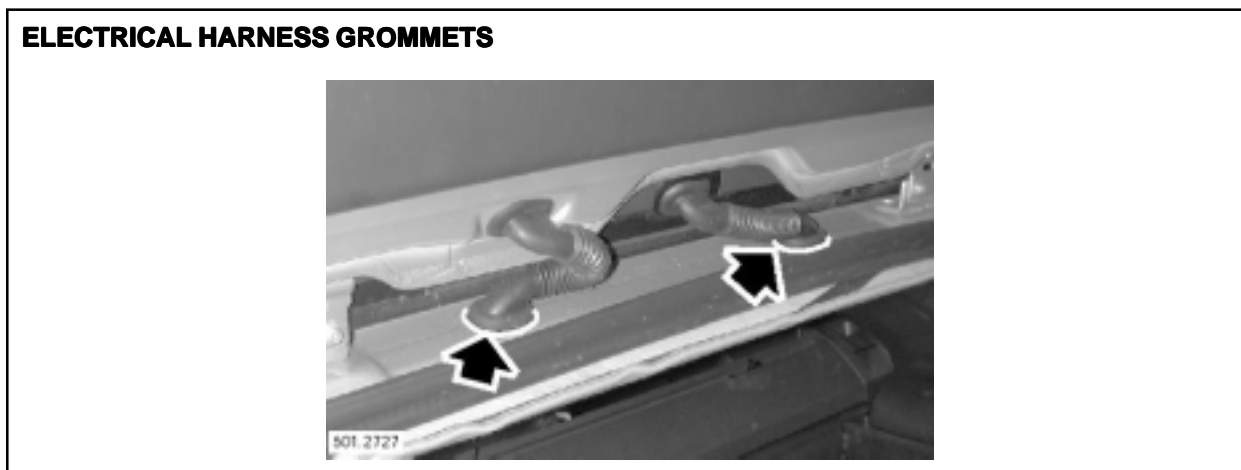
ILLUSTRATION 2

**Condition:** Water ingress into the rear of the headliner.

**Possible cause:** Water ingress point in the liftgate electrical harness grommets (Illustration 2).

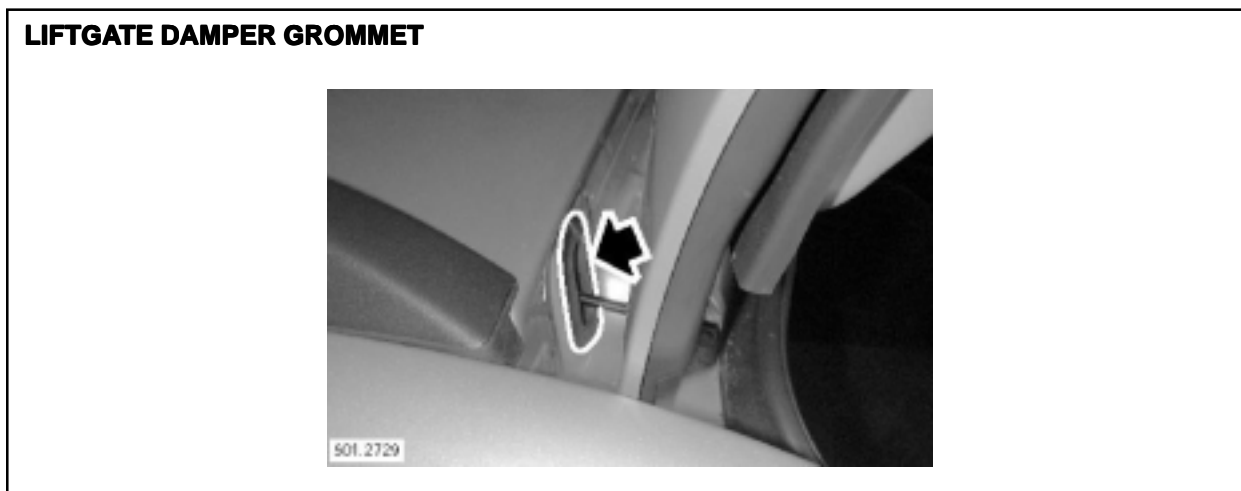
ILLUSTRATION 3

**Condition:** Water ingress into the rear of the headliner.

**Possible cause:** Water tracking underneath one or both of the liftgate damper grommets (Illustration 3).

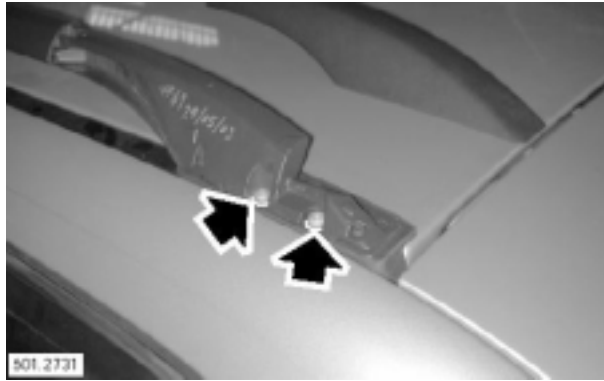
ILLUSTRATION 4

**Condition:** Water ingress into the rear of the headliner.

**Possible cause:** Water ingress through the roof rail mountings (Illustration 4).

**Note:** Remove the roof rail(s) and install new sealing washers (C2S 36952).

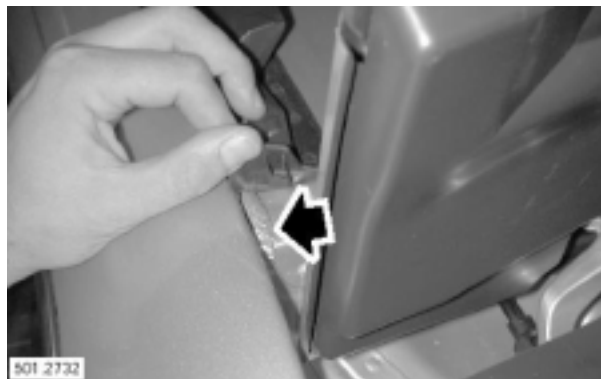
ILLUSTRATION 5

**Condition:** Water ingress into the rear of the headliner.

**Possible cause:** Below the roof rail seal, check condition of the gap in the foot of the rail, and the end of the painted sealing tape (Illustration 5).

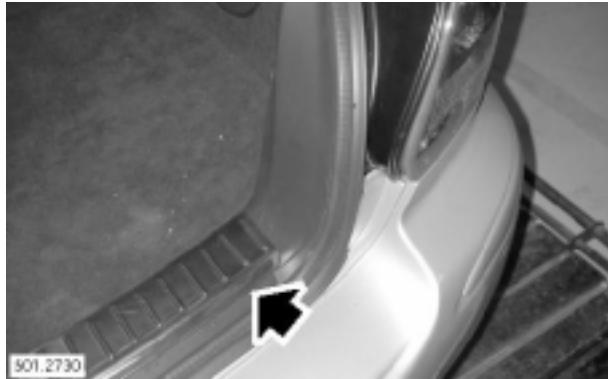
ILLUSTRATION 6

**Condition:** Water ingress into the spare wheel well or by the latch scuff plate (Illustration 6).

**Possible cause:** Water tracking underneath the liftgate aperture seal.

**Note:** Use a suitable cleaner to ensure the liftgate aperture flange is clean, before installing a new liftgate seal.

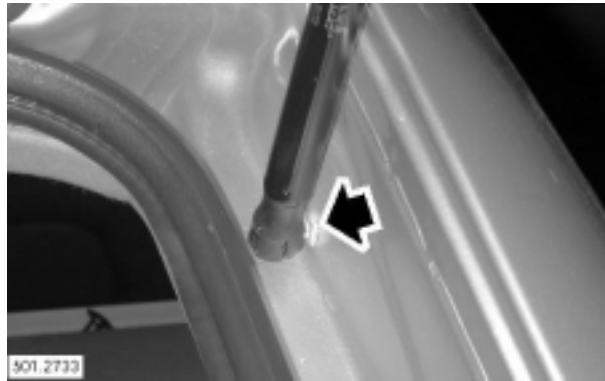
ILLUSTRATION 8

**Condition:** The luggage compartment is wet.

**Possible cause:** Water ingress point between the glass strut ball pin and body (Illustration 8).

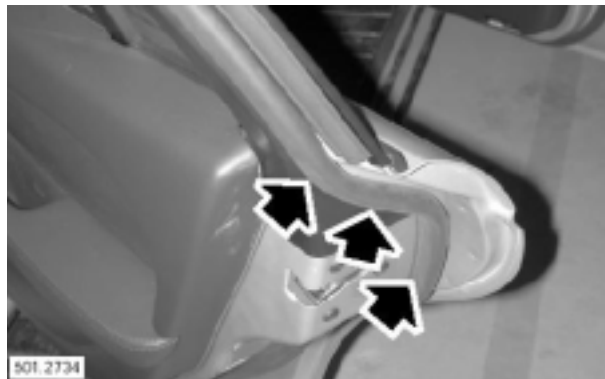
ILLUSTRATION 9

**Condition:** Water ingress into the rear doors and footwells.

**Possible cause:** The rear door seal is distorted (Illustration 9).

**Note:** Finesse the seal in the highlighted area to gain a better seal compression when the door is closed.
