X-TYPE

XT501-S934

TECHNICAL BULLETIN

Change In Specification –
Reprogram RCM –
Service Action S934

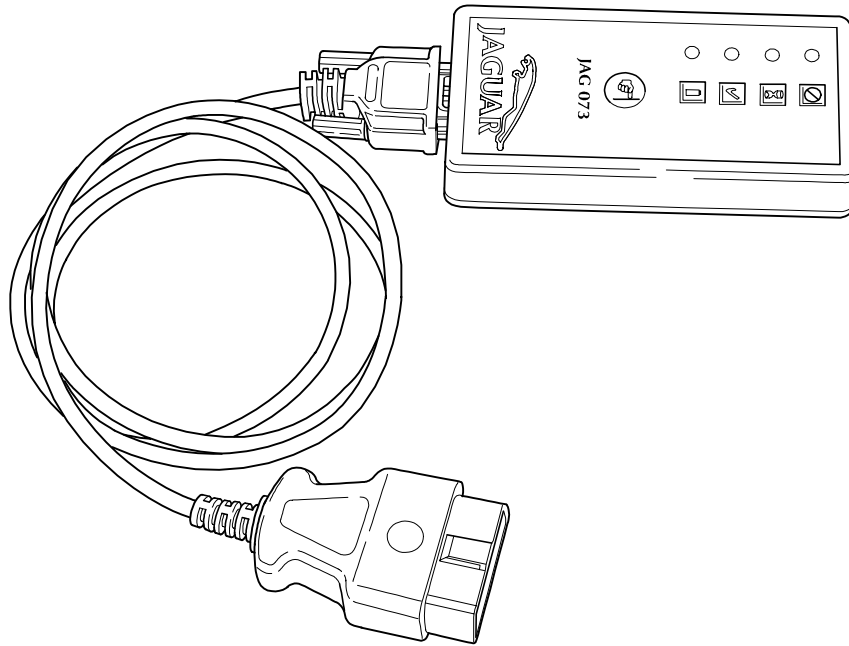
ILLUSTRATION 1

SPECIAL TOOL JAG 073

5. Connect special tool JAG 073 (Illustration 1) to vehicle diagnostic link connector.
