Headlamp Washer Jet Cover Pivot Link –
Change Of Specification –
Service Action S940

MODEL 2002-03 MY
X-TYPE

VIN C00294-D29054

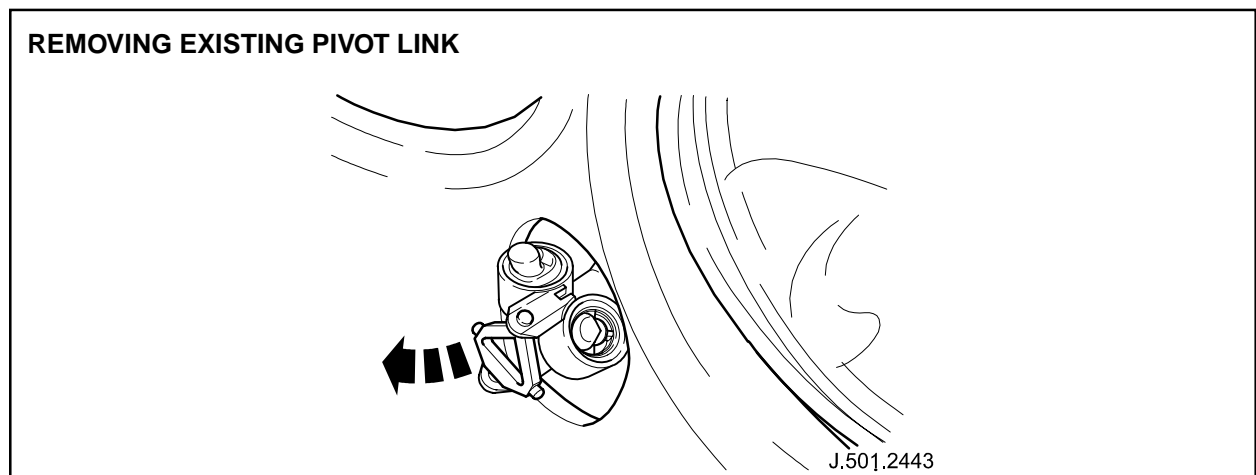
ILLUSTRATION 1

On vehicles fitted with headlamp power wash, there has been a high incidence of headlamp washer jet cover loss; caused by the detachment of the link that attaches the jet telescope to the washer jet cover.

1. Grip headlamp power wash jet cover with fingers and slowly pull headlamp power wash jet out to its operating position.
2. Remove the cover of the headlamp power-wash jet from the link.
3. Remove the link from headlamp power-wash jet. (Illustration 1)
