TECHNICAL BULLETIN

Oil Cooler Feed Pipe/Hose Failure –
Inspect/Replace Hose –
Service Action S846

MODEL 2004-05 MY
XK Range

VIN A39699-A41740

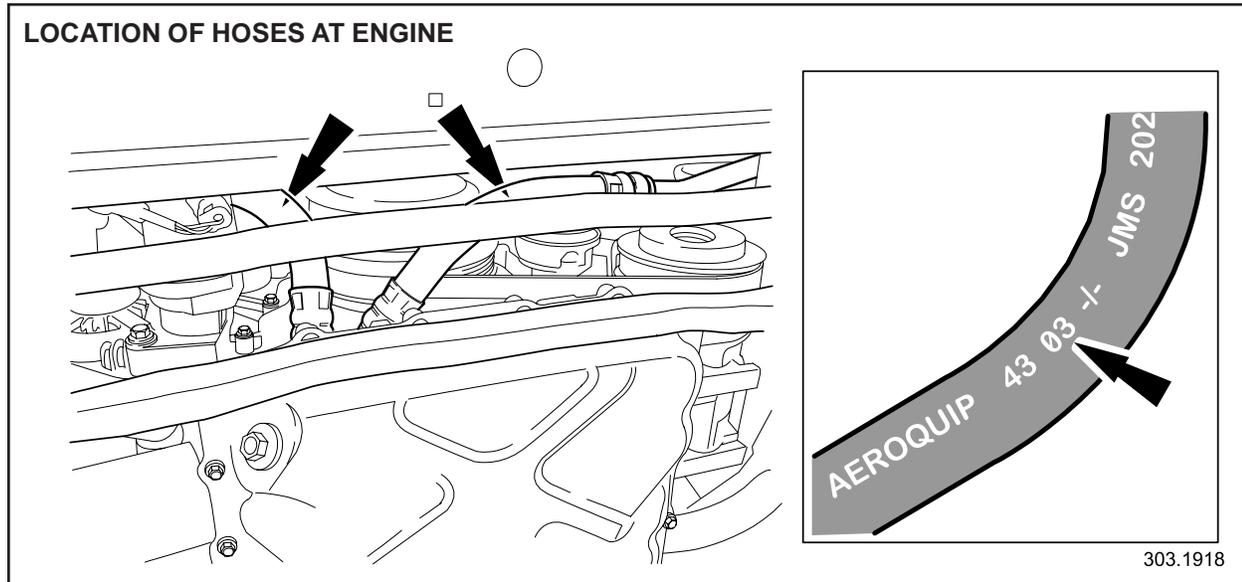
ILLUSTRATION 1

3. Check the date code (Illustration 1) on the oil cooler feed pipe/hose running from the engine to the intermediate connector and on the oil cooler return pipe/hose from the intermediate connector back to the engine. Use a small mirror if required.

4. If the date code displayed is **43 03** or the code cannot be determined, continue to step 5 of this workshop procedure. If the date code displayed is **not 43 03**, no further action is required. Lower the vehicle.
5. Remove the undertray.
6. Place a suitable drain tray under the vehicle.
7. Remove the oil cooler pipe/hose joint retaining plate securing bolt on the front of the engine (Illustration 2).
