# TECHNICAL BULLETIN

## Poor Idle Quality – Normally Aspirated AJ16 Engine – Valve Timing Modification

12-57

MODEL 4.0L Normally Aspirated 1995 MY DATE 8/95

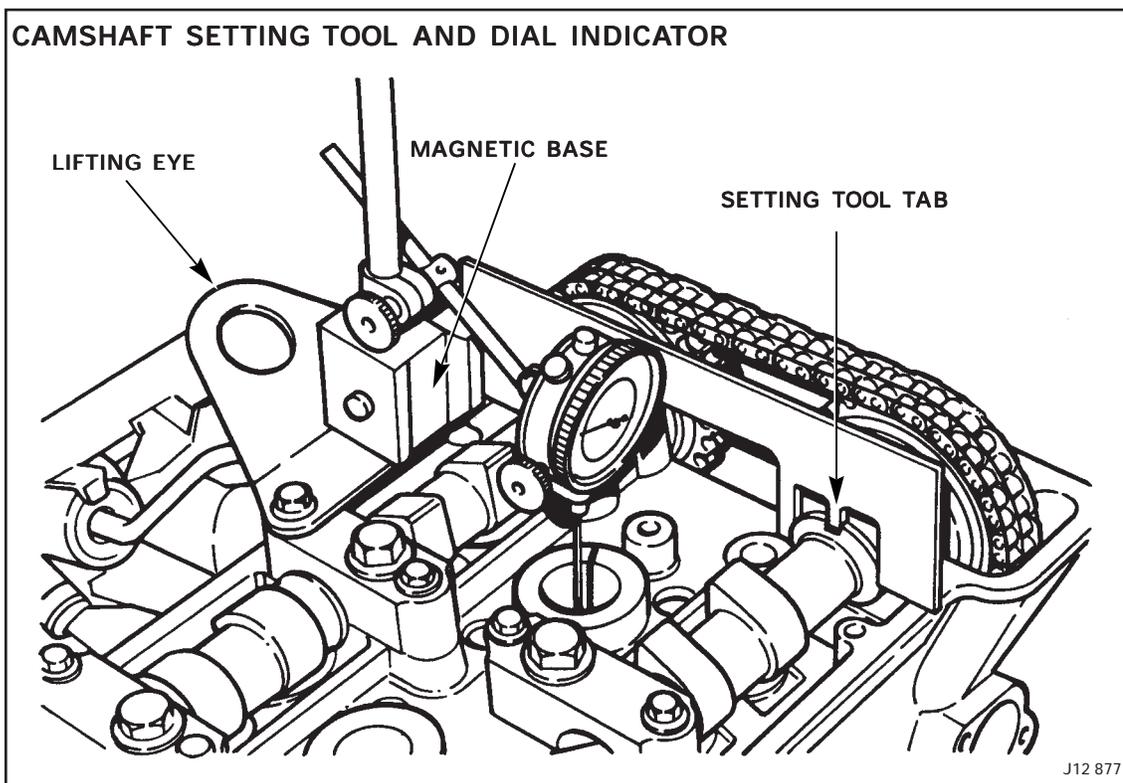
ILLUSTRATION 1

position. The valve timing overlap is reduced from 22 degrees on the 110 camshafts to 14 degrees on the 114 camshafts, Illustration 1.

5. Turn the crankshaft until the No. 1 cylinder is at Top Dead Center (TDC) on the compression stroke, i.e. with the cam lobes on the No. 1 cylinder pointing upwards as in Illustration 1. This position can be checked by temporarily inserting the camshaft setting tool 18G-1433/A into the slot on each camshaft.

7. On all engines, attach an engine lifting eye to the intake camshaft cap as shown in Illustration 1.
8. Position the magnetic base of a dial indicator gauge on the lifting eye.
