TECHNICAL BULLETIN

JAGUAR SERVICE	Recall T493 - 1995 MY/Recall R493 - 1996 MY – AJ16 EGR System – Replace PROMs and EGR Valve	17-12 Amended 08/02
	MODEL 1995-96 MY XJS 4.0L VIN 194775-226645	DATE 11/01

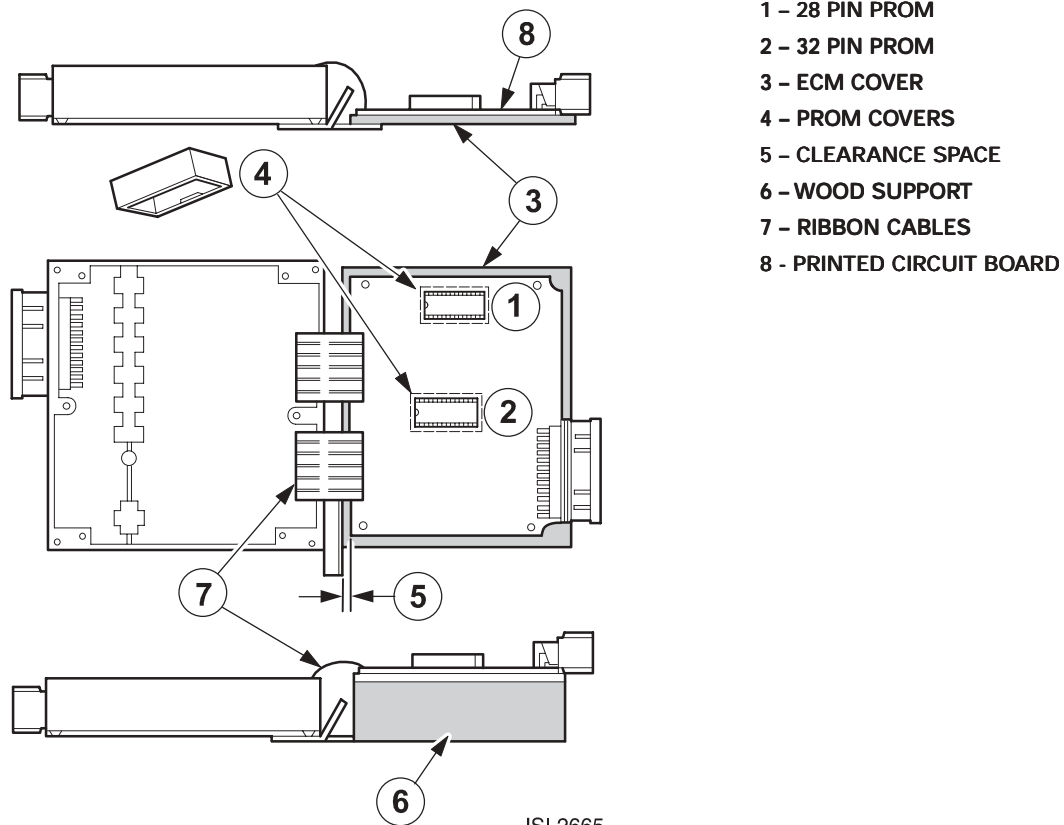
ILLUSTRATION 2

LOCATION OF PROMS IN ECM

5. Remove the seven retaining screws of the printed circuit board (8, Illustration 2). Fold the printed circuit board away from the body of the ECM unit and support it on a block of wood (6, Illustration 2) so that no strain is placed on the ribbon connectors (7, Illustration 2). Allow a clearance space (5, Illustration 2) so that no damage can occur from contact with the mounting brackets.
6. The modification kit contains two microchips, one each of the 28-pin (1, Illustration 2) and 32-pin (2, Illustration 2) design.
7. Remove the covers (4, Illustration 2) from the microchips on the printed circuit board. Remove each cover by applying a side-to-side rocking action, gripping the cover lightly with combination pliers midway along each long side.

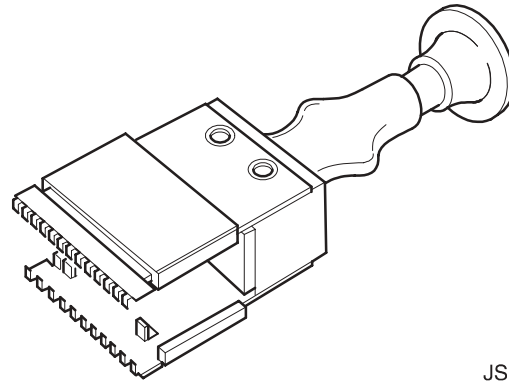
ILLUSTRATION 3

EXAMPLE OF CHIP REMOVAL TOOL

8. Remove the PROM microchips from the printed circuit board using a suitable proprietary removal/reinstallation tool (Illustrations 3 & 4).

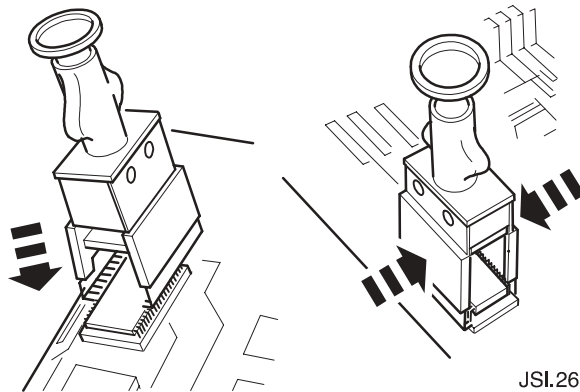
ILLUSTRATION 4

USE OF TYPICAL CHIP REMOVAL TOOL

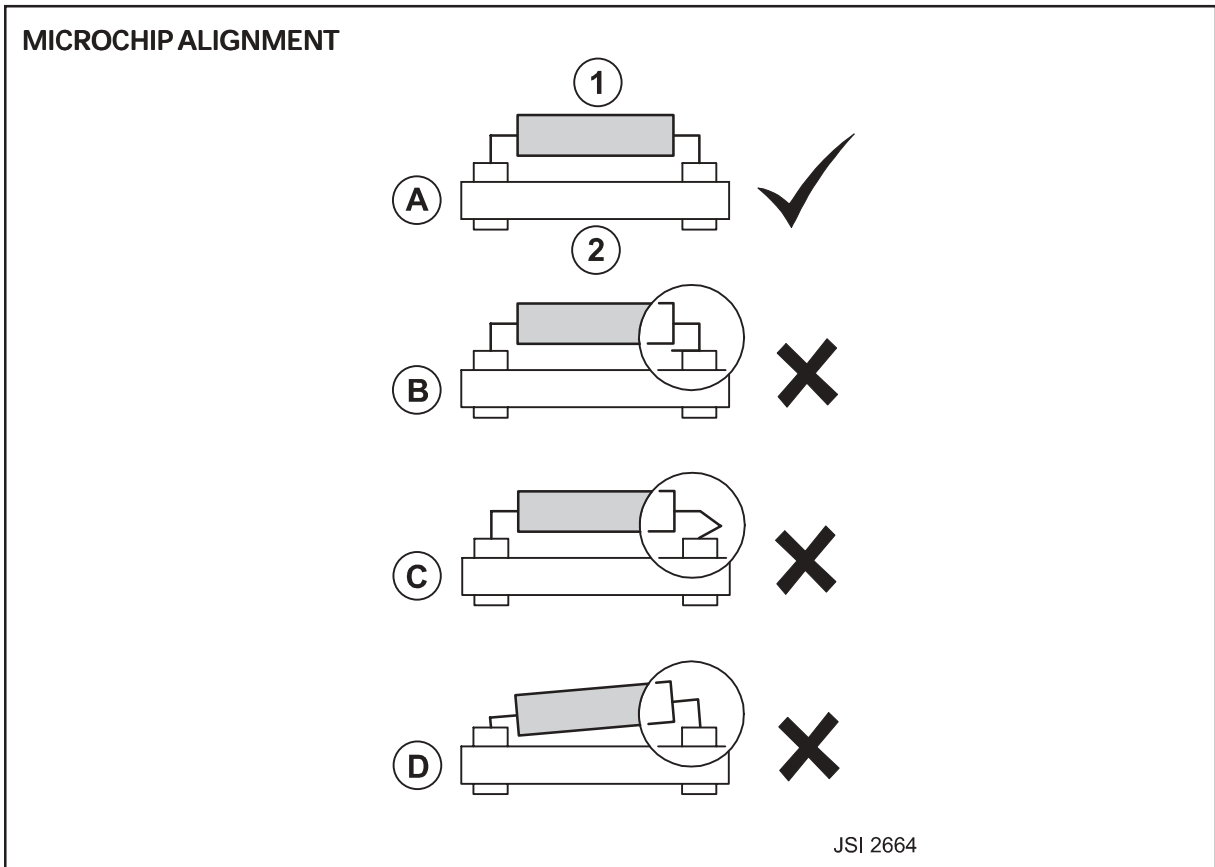
ILLUSTRATION 6

⚠ Caution: Permanent damage to the microchip is likely in conditions B or C. Malfunctions will occur with partial engagement, as in condition D.

12. Use great care to achieve condition '1' in Illustration 6. The microchip must lie parallel to the printed circuit board, with all pins fully engaged into their corresponding locations in the socket.
