TECHNICAL BULLETIN

Spark Plug “Blow-by Stain”/Corona Stain – Spark Plug Function Not Affected – Replacement Unnecessary

18-55

MODEL 1988-94 MY Sedan Range

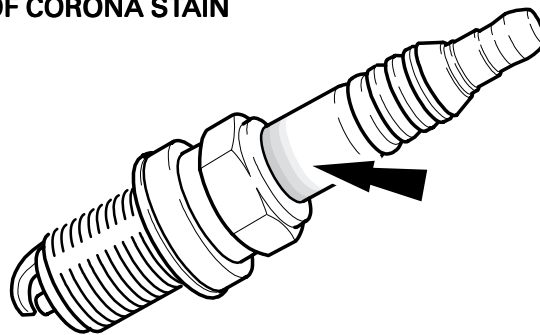
ILLUSTRATION 1

LOCATION OF CORONA STAIN

When Corona discharge has taken place, there can be a discoloration of the lower portion of the insulator surface (Illustration 1). This is what is known as ‘Corona stain’ and is orange/gray in color. Corona stain is caused by oil particles in the air that are attracted to the Corona discharge, charged and then adhere to the insulator surface.

The Corona stain has no effect on the function of the spark plug. The spark plug **should not** be changed for this reason.
