TECHNICAL BULLETIN

Spark Plug “Blow-by Stain”/Corona Stain – Spark Plug Function Not Affected – Replacement Unnecessary

18-55

MODEL 1988-94 MY Sedan Range

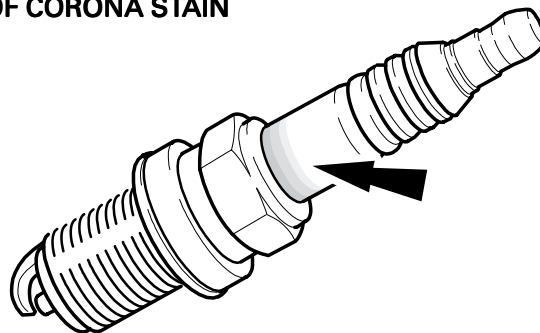
ILLUSTRATION 1

When Corona discharge has taken place, there can be a discoloration of the lower portion of the insulator surface (Illustration 1). This is what is known as ‘Corona stain’ and is orange/gray in color. Corona stain is caused by oil particles in the air that are attracted to the Corona discharge, charged and then adhere to the insulator surface.

The Corona stain has no effect on the function of the spark plug. The spark plug **should not** be changed for this reason.
