# TECHNICAL BULLETIN

## Intermittent High Idle – Replace Throttle Return Springs

19-33

MODEL XJ12 (6.0L) 1994 MY

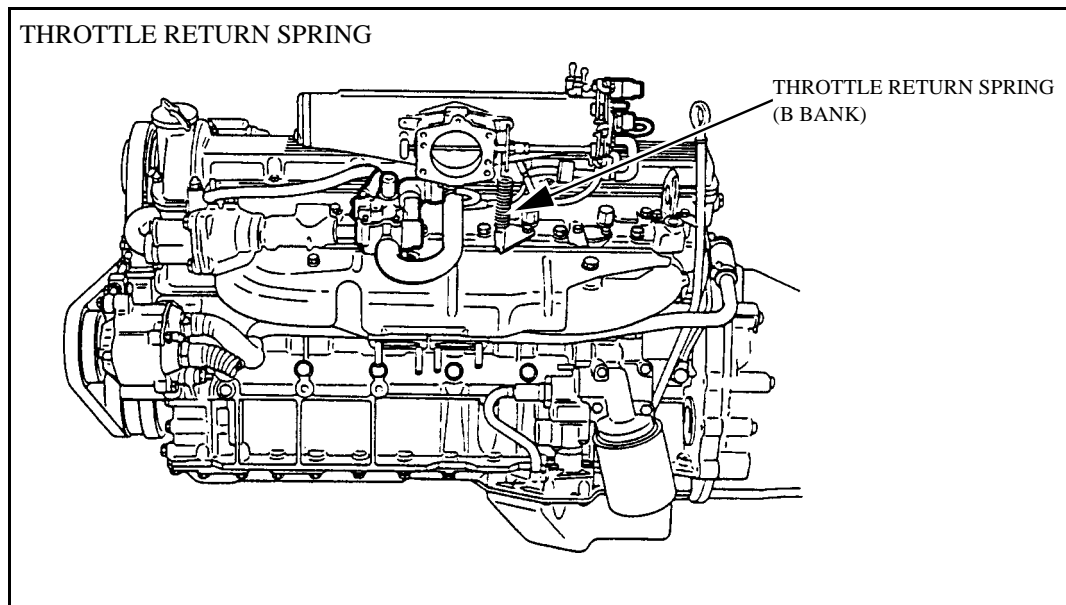
ILLUSTRATION 1

Some 1994 MY XJ12 Sedan Range vehicles may experience an intermittent high idle speed of approximately 900 rpm (normal idle speed, 750 rpm in neutral). This condition occurs when slowly returning the throttle to the idle position.

1. Remove throttle return spring from the throttle body, Illustration 1.
2. Install the new spring first to the bracket, then to the throttle lever.
3. Repeat the procedure on the throttle body on the opposite bank.
4. Check for correct throttle return operation.
