# TECHNICAL BULLETIN

<b>JAGUAR SERVICE</b>	<b>Poor Drivability – Check Throttle Synchronization</b>	<b>19-36</b>
	MODEL <b>XJ12 Sedan 1994 MY</b> <b>XJ12 Series III</b> <b>XJSV12</b>	DATE <b>10/95</b>

This Bulletin applies to the following vehicles:  
All 1994 MY XJ12 Sedan (VIN 673299-708757)  
All Series III XJ12 Sedan (up to VIN 487641, 1979-92 MY Canada,  
1979 MY USA)  
All Jaguar XJS V12

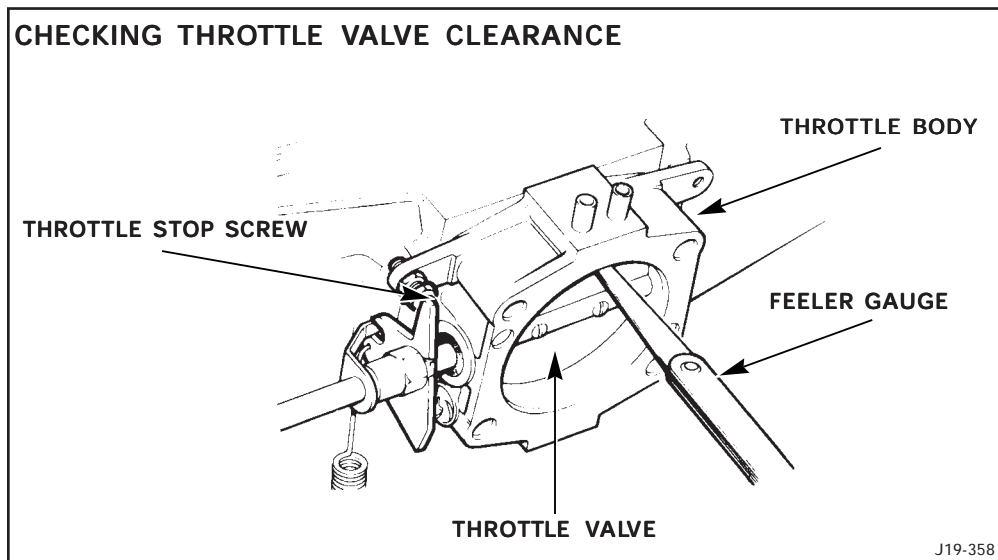
ILLUSTRATION 1

1. Check that both throttle valves are centered horizontally and vertically in the throttle bodies.
2. With the throttle valve closed, use a feeler gauge to check the clearance between the throttle valve and the throttle body (Illustration 1).

Check the clearance at the bottom as well as at the top of the throttle valve. If a significant difference is found between the top and bottom measurements, the throttle valve may be offset on its shaft. If both measurements are within the above range, do NOT adjust the throttle stop screw (Illustration 1).

3. If adjustment is necessary, set the throttle stop screw to achieve the following throttle valve clearance range:

Throttle valve setting clearance: 0.001 - 0.0015 inch (0.025 - 0.040 mm).

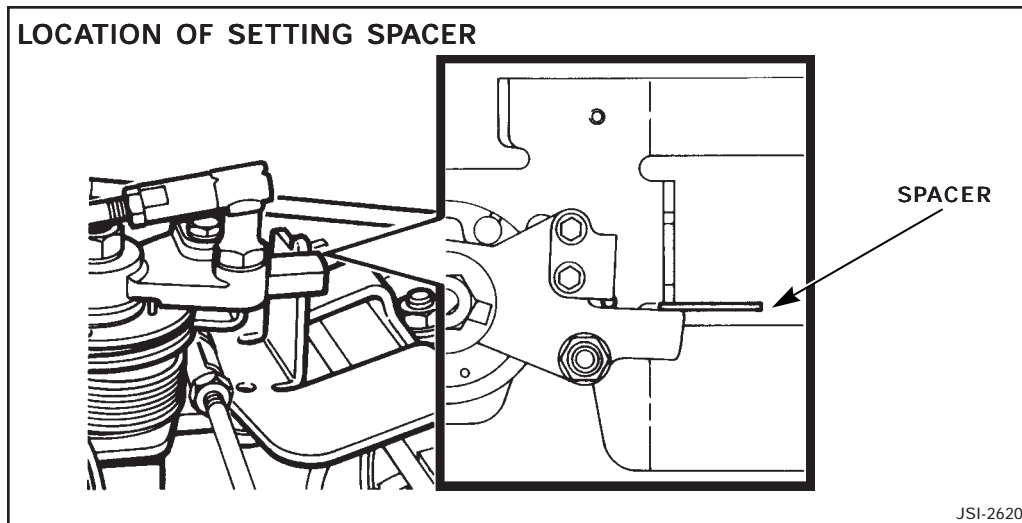
ILLUSTRATION 2

1. Loosen both locknuts on the two linkage rods between the center throttle turntable and the throttle levers.
2. Disconnect one linkage rod from its ball pin on the linkage rod bracket.
3. Position a 0.079 inch (2.00 mm) spacer between the linkage rod bracket and its stop (Illustration 2).
