# TECHNICAL BULLETIN

## Automatic Transmission – Engine Stalls When Engaging “R” or “D” – Repair Procedure

**44-23**

MODEL All 4.0L with Auto Trans

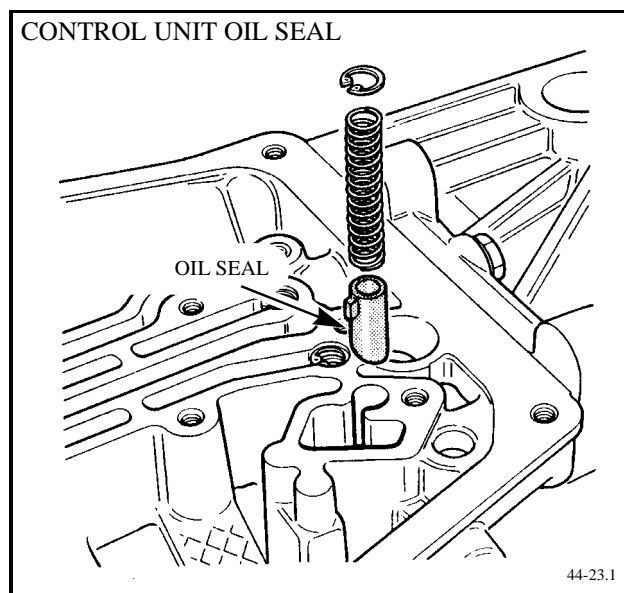
ILLUSTRATION 1

1. Remove the transmission valve body following the instructions in the Service Manual, section 44.2 (R.O. number 44.40.01).
2. Remove the control unit oil seal (part number JLM 863) shown in Illustration 1.

**CAUTION:** If the seal is incorrectly fitted or restricted, the lockup clutch may partially engage causing the engine to stall.

3. Install a new control unit oil seal
4. Reassemble the transmission following the instructions in the Service Manual.

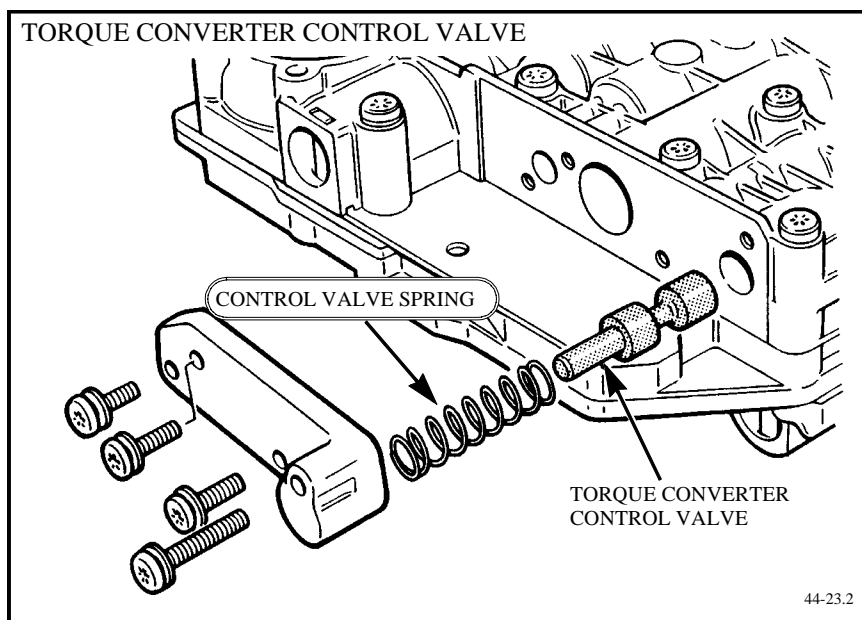
ILLUSTRATION 2

1. Remove the transmission valve body following the instructions in the Service Manual, section 44.2 (R.O. number 44.40.01).
2. Remove the torque converter control valve from the valve body (Illustration 2).

3. Clean the valve and valve bore. The valve must slide freely in the bore.
4. Refit the control valve using a new spring (part number JLM 11573).
5. Install the valve body.

**NOTE:** Torque the valve body securing screws to 6 lb ft (8 Nm).

6. Install a new transmission oil filter and reassemble following the instructions in the Service Manual.
