# TECHNICAL BULLETIN

## Automatic Transmission – Defaults To “Limp Home” in Wet Weather – Repair Procedure MODEL Sedan Range (4.0L) up to 93 MYDATE 1/95

44-24

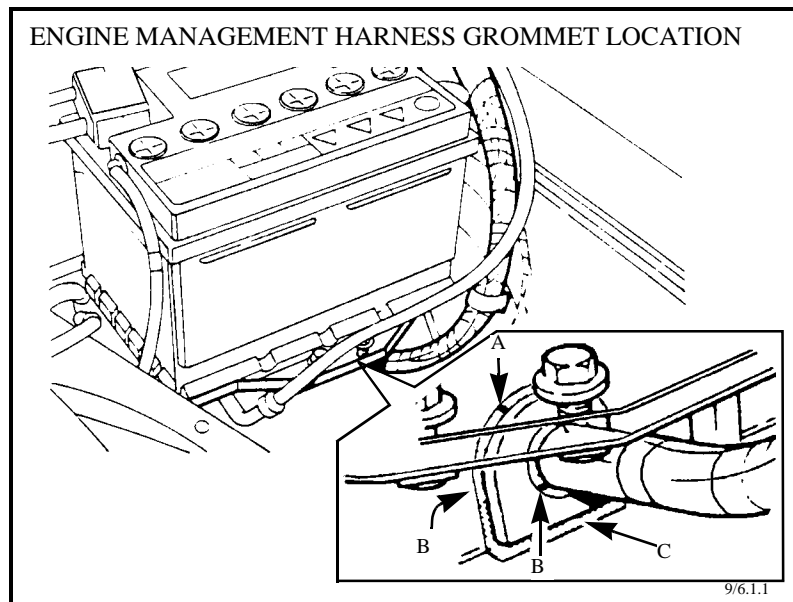
ILLUSTRATION 1

The Transmission Failure malfunction indicator lamp (MIL) illuminates and the transmission defaults to the “Limp Home” mode during rain or after using a car wash.

Water can enter the vehicle through the engine management harness grommet in the vacuum tank under the battery tray. The water can drip onto the Transmission Control Module (TCM) causing it to illuminate the transmission MIL and default to the “Limp Home” mode.

1. Record the preset radio stations (including X-mem) and remove the battery from the vehicle.
2. Remove the battery tray, disconnect the EMS harness from the vacuum tank and remove the vacuum tank
3. Inject a liberal amount of Bostik Alpha Seal 132 or an equivalent sealant into the areas shown in Illustration 1.

A. - Around the vacuum tank inner recess for the grommet.

B. - Around the EMS harness at the front and back of the grommet

C. - Between the EMS harness grommet and the body panel face
