TECHNICAL BULLETIN

ZF Automatic Transmission – Noise in Reverse After Cold Start in Cold Weather – Repair Procedure

44-25

DATE 3/95

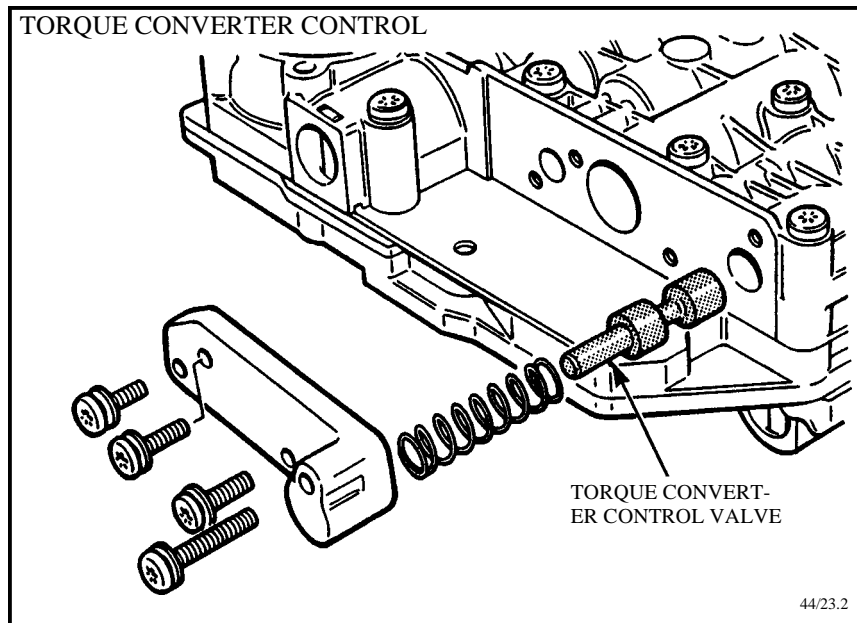
ILLUSTRATION 1

Noise when reverse gear is selected or the vehicle is driven slowly in reverse following a cold start during cold weather.

All 4.0L automatic transmission equipped vehicles up to the VINs listed below may be effected. The noise is caused by air circulating with the cold transmission fluid. The noise has no detrimental effect on the transmission.

5. Remove the 4 screws shown in Illustration 1. Replace the existing torque converter control valve with a new control valve (part number NHD 5602AA).

6. Remove the 4 screws shown in Illustration 1 above. Replace the existing torque converter control valve with a new control valve (part number NHD 5602AA).
