TECHNICAL BULLETIN

<p>JAGUAR SERVICE</p>	<p>ZF 4HP 24 E9 Automatic Transmission – Poor Shift Quality in R, 3-4</p> <p>MODEL Sedan (4.0L) Range 1990 - 94 MY DATE 6/95 XJS (4.0L) Range 1993 - 94 MY Up to trans. serial no. 158813</p>	<p>44-27</p>
--	--	---------------------

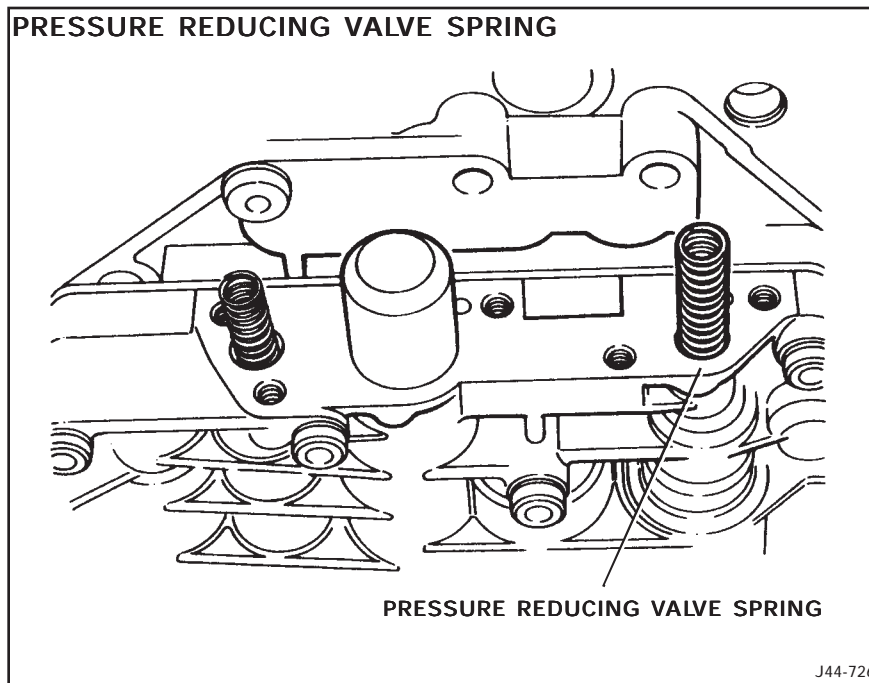
ILLUSTRATION 2

Some vehicles may exhibit harsh 3-4 upshifts or slip/judder when shifting into reverse. This condition affects automatic transmission vehicles only with transmission unit serial numbers up to 158813.

8. Remove and discard the pressure reducing valve spring from the right side location (Illustration 2).
9. Make sure that the pressure reducing valve behind the right side spring moves freely in its bore.

10. Install a new spring, part no. NHD 5601AA, into the bore of the pressure reducing valve.
11. Reinstall the valve body end plate and the clip for the speed sensor harness. Thread, but do not fully tighten, the retaining bolts.
